**Arborist Report
3215 Porter Dr.
Palo Alto, CA**

Stanford Real Estate is planning to redevelop the site at 3215 Porter Dr. in Palo Alto, CA. The building on the site was demolished for development of the adjacent site; the parking area and landscaping remain. HortScience | Bartlett Consulting was asked to prepare an **Arborist Report** for the site as part of the development application to the City of Palo Alto.

STANFORD REAL ESTATE

ARB RESUBMITTAL, MAJOR - REVISION 2

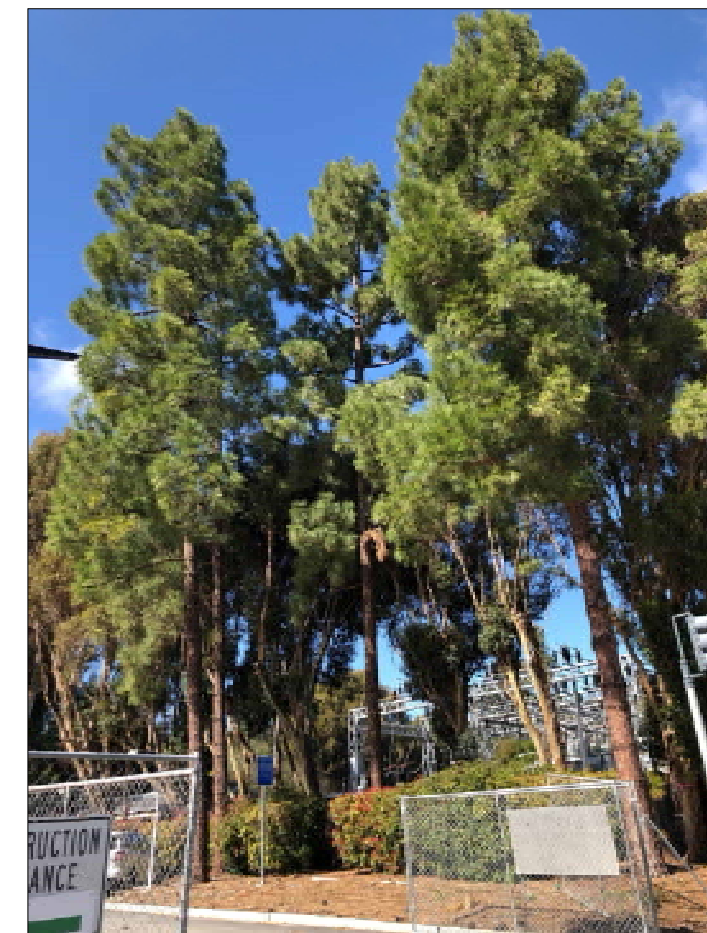
Canary Island pine comprised most of the trees on site, with 14 trees. Trees were mature, with trunk diameters ranging from 13 to 29 inches. Canary Island pines were mostly in good condition with good form and structure and dense crowns (Photo 1). Two trees in fair condition (#95, 140) had slightly thin crowns.

Photo 1 (right): Canary Island pines #94-97 were in good and fair conditions.

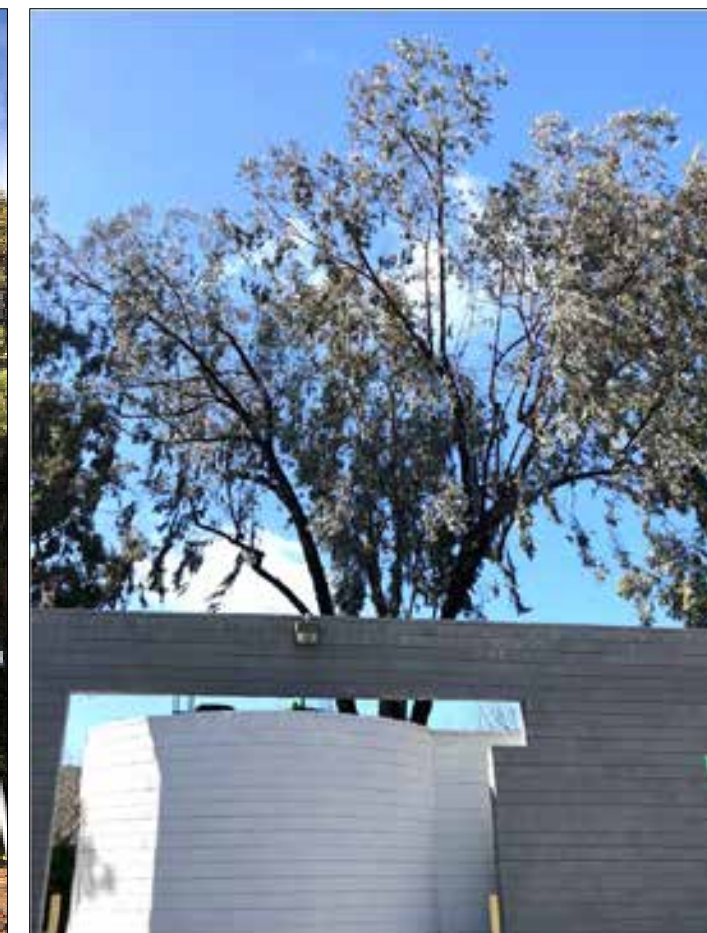
Red ironbark (#143) was the only other on-site tree located along the west property line against the fence. It had multiple trunks of 20, 20, and 18 inches and was in fair condition with a thinning crown (Photo 2).

Photo 2 (far right): Red ironbark #143 was in fair condition with a thinning crown and fair structure.
