Storm Drain Master Plan Update

June 2015

Public Works Department/Engineering Services Division

Schaaf & Wheeler CONSULTING CIVIL ENGINEERS

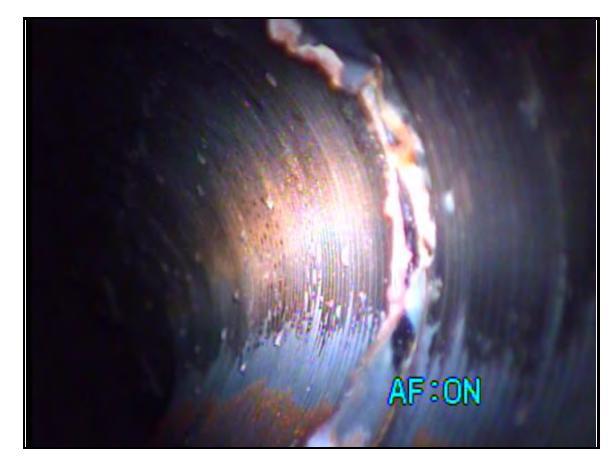
Possible deterioration at joint (viewed from inlet).

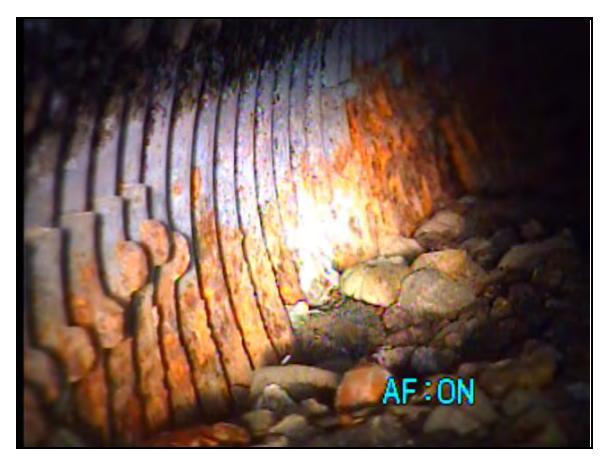
View inside outlet. Note moderate corrosion.

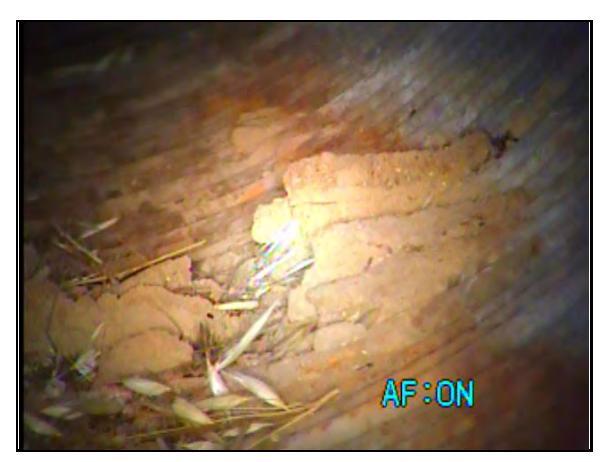
View inside inlet. Possible corrosion through pipe wall.

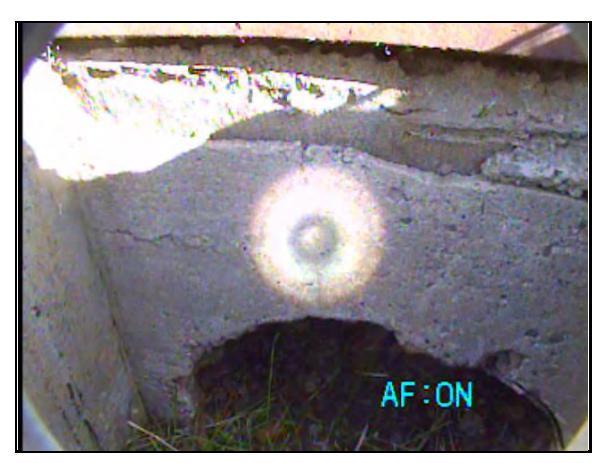
Concrete spalling on wall above outlet of structure.

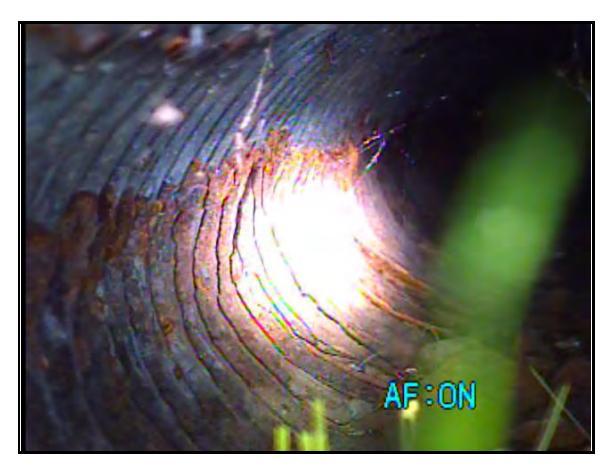
View inside downstream pipe. Significant corrosion and apparent deflection.

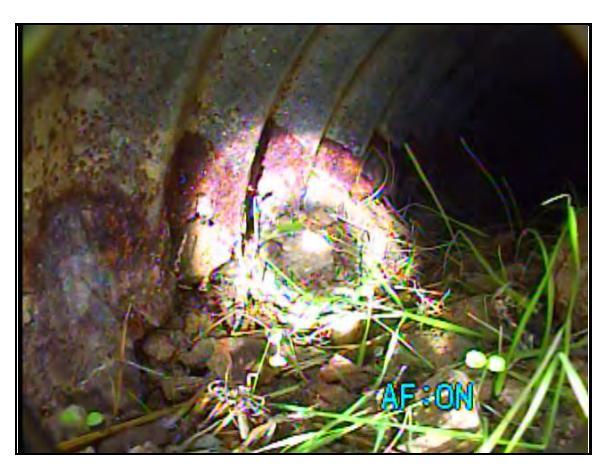
View inside downstream pipe. Significant corrosion.

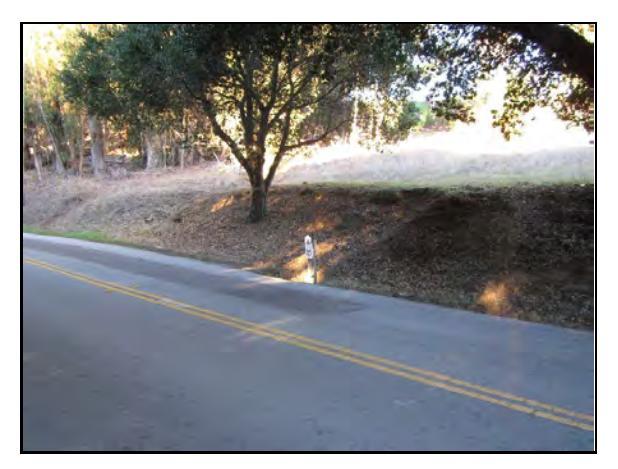
Area near inlet. Note patch in pavement over apparent trench; construction may have damaged culvert.

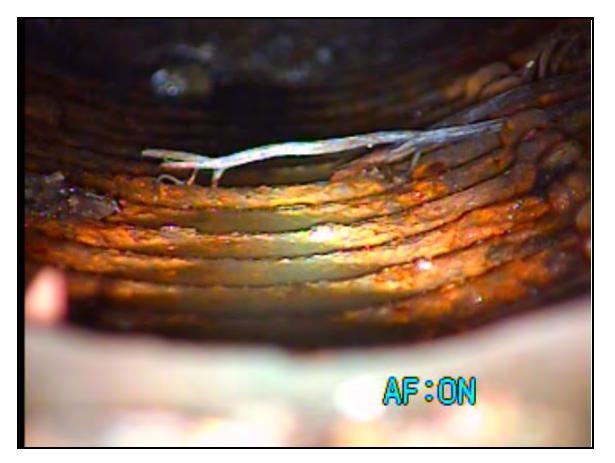
View inside inlet. Offset joint at transition to CMP. CMP appears to be significantly corroded.

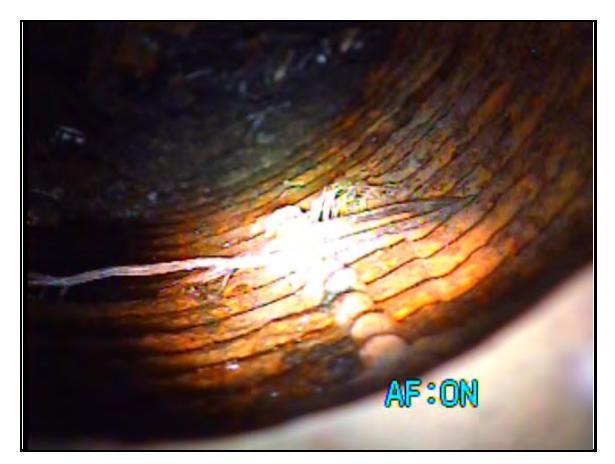
View inside inlet. Offset joint at transition to CMP. CMP appears to be significantly corroded.

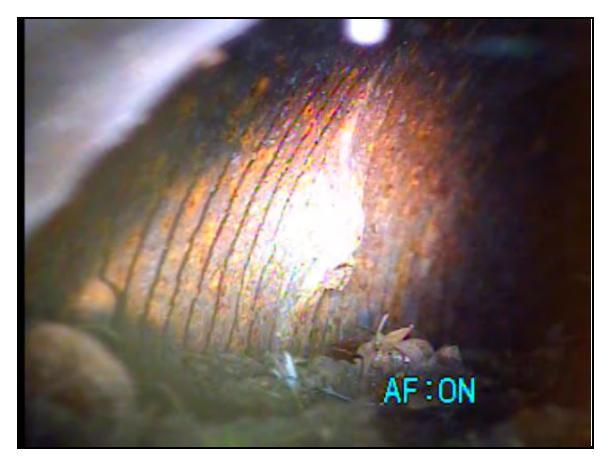
View inside outlet. Offset joint at transition to CMP.
