TREE PROTECTION REPORT

660 UNIVERSITY AVENUE

PALO ALTO, CALIFORNIA (511 BYRON ST., 660 & 680 UNIVERSITY AVE.)

David L. Babby Registered Consulting Arborist[®] #399 Board-Certified Master Arborist[®] #WE-4001B

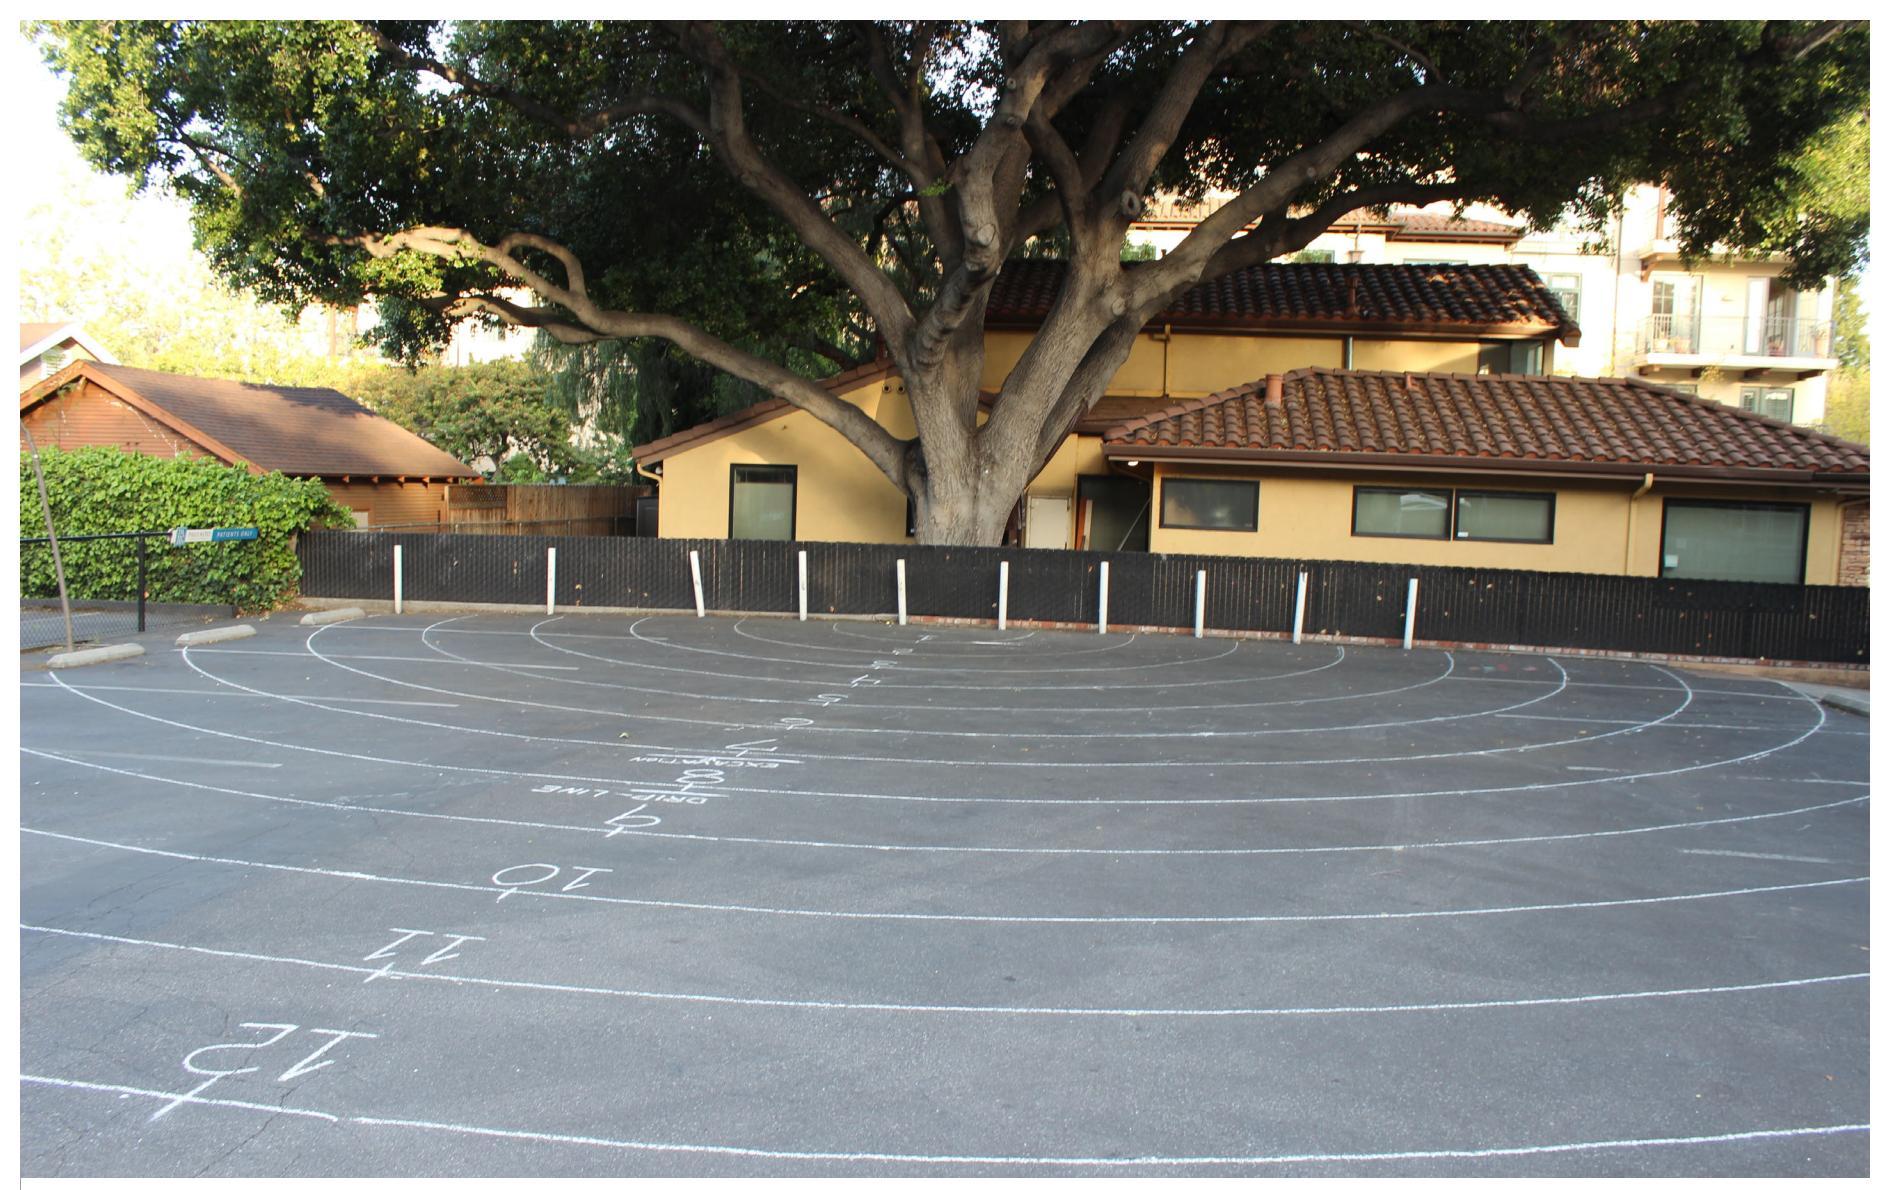
These chalk lines represent the locations of half circle scans. Scan #8 represents the edge of the canopy drip-line. Scan #7 represents the edge of the proposed excavation for the below ground garage about 30 feet away from the Oak tree.
