**City of Palo Alto
Foothills Park Trails Maintenance Plan**

January 29, 2002

Prepared for
The City of Palo Alto
by
Amphion
with
Thomas Reid Associates &
Steve Singer

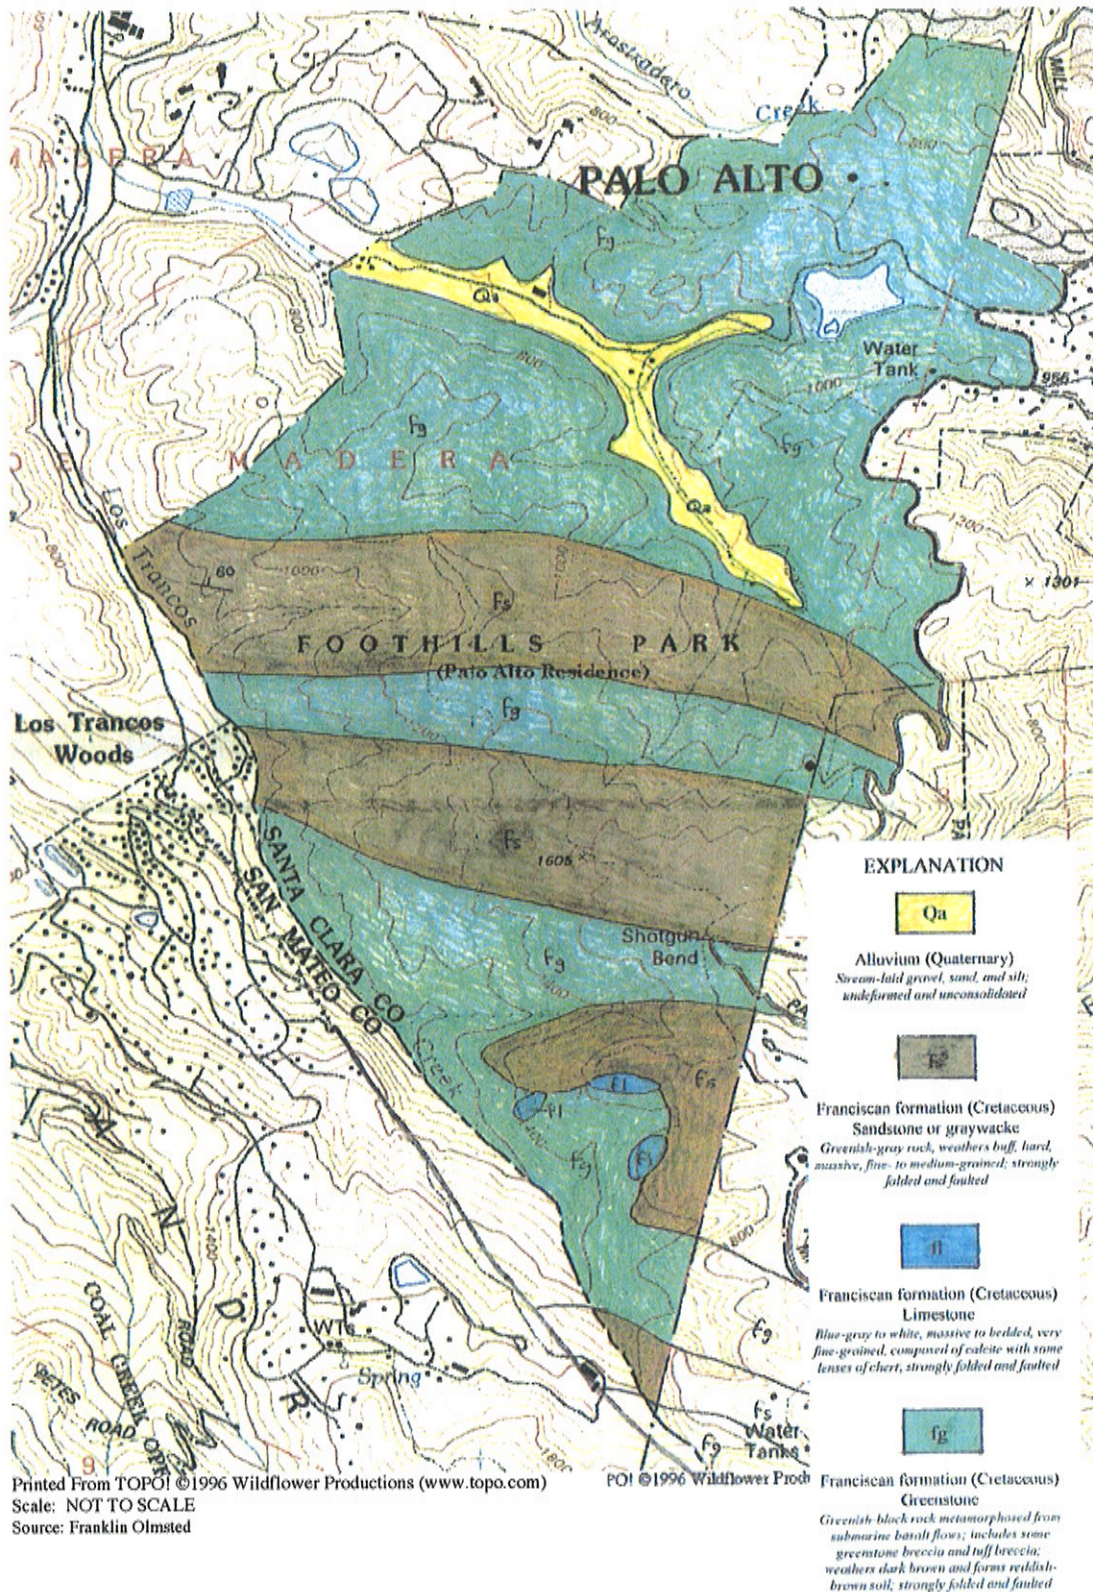
Map 4-2 GEOLOGIC MAP OF FOOTHILLS PARK

Los Gatos gravelly loam 50 to 75 percent slopes: "This well-drained soil is moderately fertile and holds about 4 to 7 inches of water plants can use. Subsoil permeability is moderately slow and surface runoff is very rapid. Erosion hazard is very high. Rooting depth is moderately deep to deep.... This soil is used mostly for wildlife, recreation and watershed."

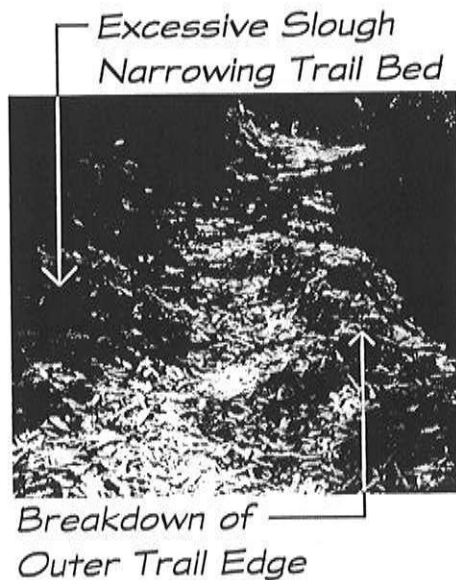
Figure 6-3
Trail Creep/Over Narrow Trail

Whether caused by excessive sloughing onto the trail tread, or by trail construction that has resulted in too narrow a trail, the resulting trail creep can result in a breakdown of the outside edge of the trail. This can lead to deterioration of the trail bed.

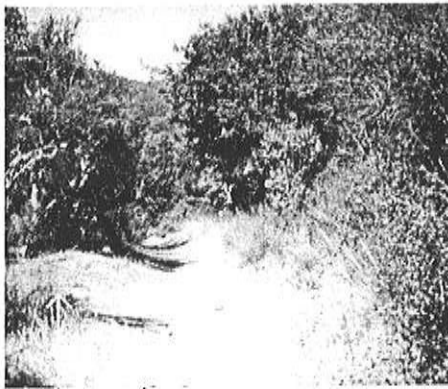
└ *Entrenched Tread*
└ *Berm of Displaced Soil*

Heavily used trails will often develop a narrow trench in the center of the trail. The entrenched trail collects and concentrates runoff water. This water is forced to run down the tread itself, gathering volume and soil as it goes. This condition is a natural consequence of tread surface erosion and redeposition, and of inadequate compaction during construction. The resulting berms will form a barrier that prevents water from running off the trail and can lead to severe erosion of the trail bed. Unless corrected, this condition can become more pronounced by the channeling of water until the water can find a weak area along the outer edge of the trail. At this point the water will spill off the trail taking loose soil with it.

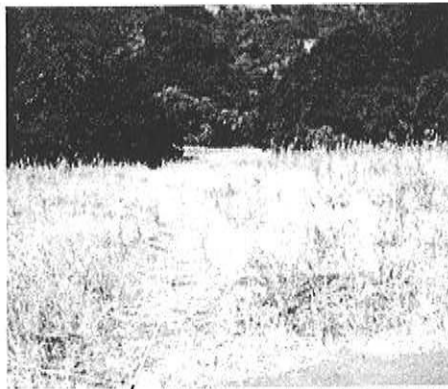
└ *Renegade Shortcut Trail*

It is human nature to take the easiest and shortest path between two points. If there are no natural barriers in the way and people can see the trail above or below them, then people will tend to take shortcuts. The problems resulting from switchback shortcutting include serious soil erosion, vegetation loss, safety hazards, and visually unattractive trails.

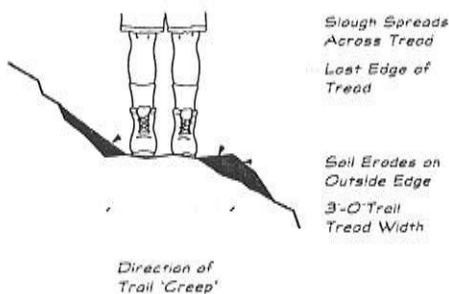
Figure 6-9
Tread Creep

Maintenance Technique - To outslope the trail bed, smooth the trail tread to remove minor ridges, or rills that can cause the water to stand or flow along the trail length.

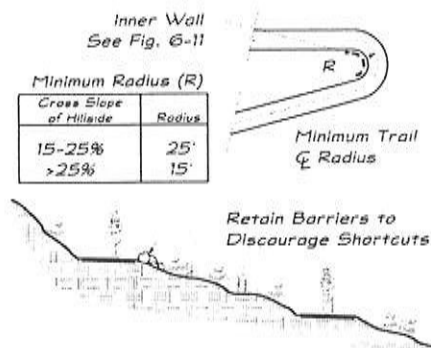
Figure 6-11
Switchbacks

Switchback legs should be situated so that they are not visible from each other. If this is not possible, rock or log barriers should be placed between the upper and lower legs of the switchback.

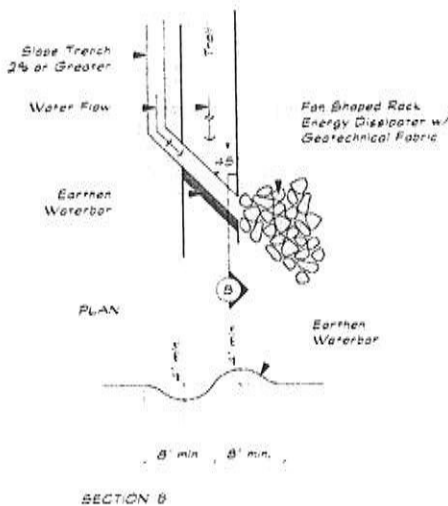
Figure 6-15
Water Bars

Construction Technique - Create a shallow ditch that crosses the trail to direct water to the downhill side of the trail on running slopes greater than 10% where slopes are too steep for drain dip. Use excavated material to build a berm on the downhill side of the ditch. On the uphill side of the water bar the tread should be graded several feet down into the trench. The trench should be deep enough to contain about 1/2 of the diameter of a log water bar or 2/3 of the height of rocks used for the rock water bar. All excavated soil and rock should be placed on the downside of the bar and packed so the tread is flush with the top of the water bar.

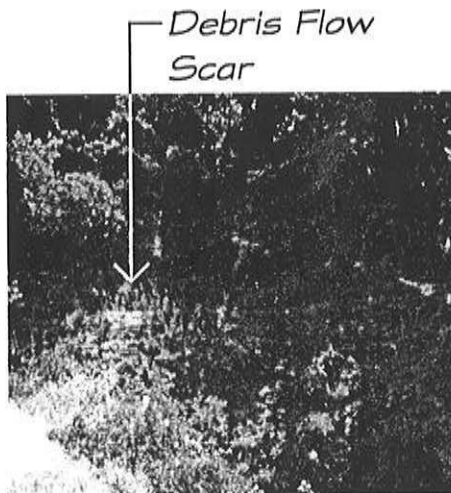
Figure 6-17
Debris Flow Scars

Description - Trails that pass over debris flow scars will have unique maintenance requirements. A good example of a major debris flow scar crossed by a trail is on the Los Trancos Trail approximately 0.5 mile from the junction with Trappers Trail.

Recommendations for addressing *debris flow scars* include:

- Maintaining the trail in such a manner as to prevent water from collecting or ponding in the slide zone
- Avoiding cutting into the hillside to widen the trail bed
- Constructing slough containment walls and retaining walls to maintain a stable trail tread of adequate width for safe passage
- Monitoring trail conditions after high-intensity rain storms to see if additional slope movement has occurred
- Installing an interpretive sign about debris flows at the trailhead
- Discouraging access to trails with these conditions during the rainy season.

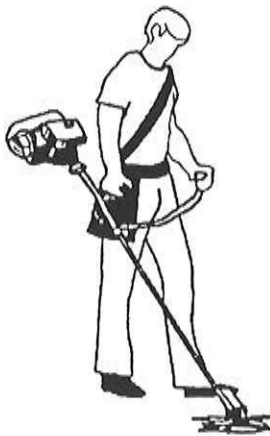
Figure 6-21
Weed Whip

Mowing with Weed Whips – Weed-whips, also known as “weed eaters”, have cutting heads that are flat and cylindrical in shape, and hold two or more mono-filament nylon lines that radiate out from the head and cut the weeds as the head spins. Weed whips are gas or electric powered and hang from a shoulder strap or harness at the balance point on a shaft, usually at hip level.

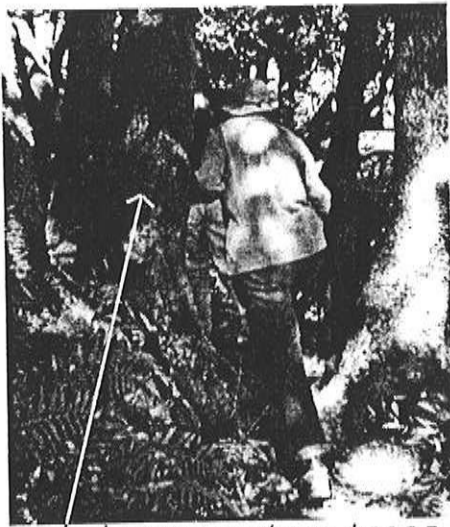
— Leave mature trees within trail tread that do not pose a safety hazard

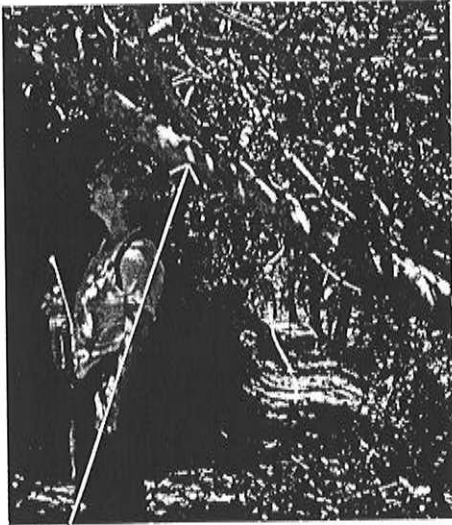
Remove overhanging branches to provide adequate clearance.
