# City of Palo Alto Tree Protection - It's Part of the Plan!

**PROPERTY ADDRESS:** 486 HAMILTON AVE.

486 HAMILTON AVENUE  
PALO ALTO, CA  
PRELIMINARY PLANTING PLAN

# NEW MIXED USE BUILDING 482-486 HAMILTON AVENUE PALO ALTO, CALIFORNIA

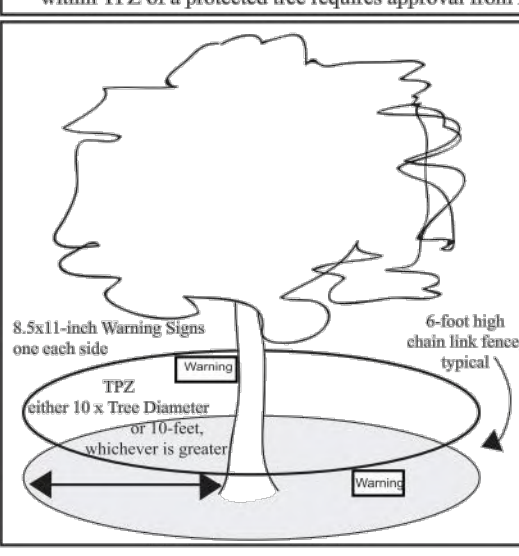
**Type I Tree Protection**  
For all Ordinance Protected and Designated trees, as detailed in the site specific tree preservation report (TPR) prepared by the applicant's project arborist as diagrammed on the plans.

Note: Ordinance Protected & Designated Trees. Issuance of a permit requires applicant's project arborist written verification Type I is installed correctly according to the plans and Tree Preservation Report.

8.5x11-inch Warning Signs one each side  
TPZ: other 10 x Tree Diameter or 10-foot, whichever is greater  
6-foot high chain link fence, typical  
Warning  
Any inoperative sidewalk or curb replacement or trenching requires approval  
Fence distance to outer fence or TPZ  
Sidewalk  
Yard  
Fencing must provide public passage while protecting all other land in TPZ

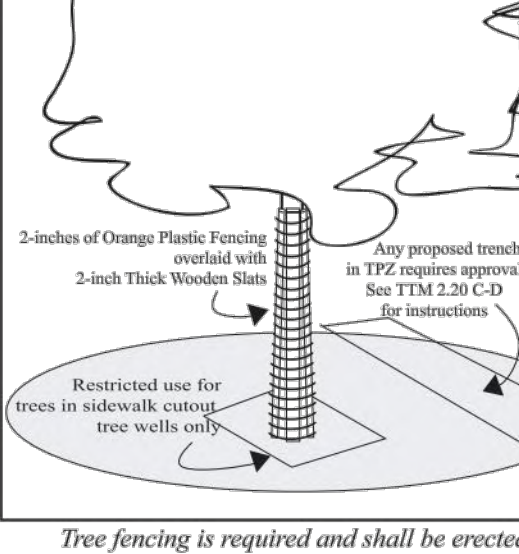
**Type II Tree Protection**  
2-inches of Orange Plastic Fencing overlaid with 2-inch Thick Wooden Slat  
Any proposed trench in TPZ requires approval See TTM 2.20 C-D for instructions  
Restricted use for trees in sidewalk canopy tree wells only

**Type III Tree Protection**  
(to be used only with approval of Public Works Operations)

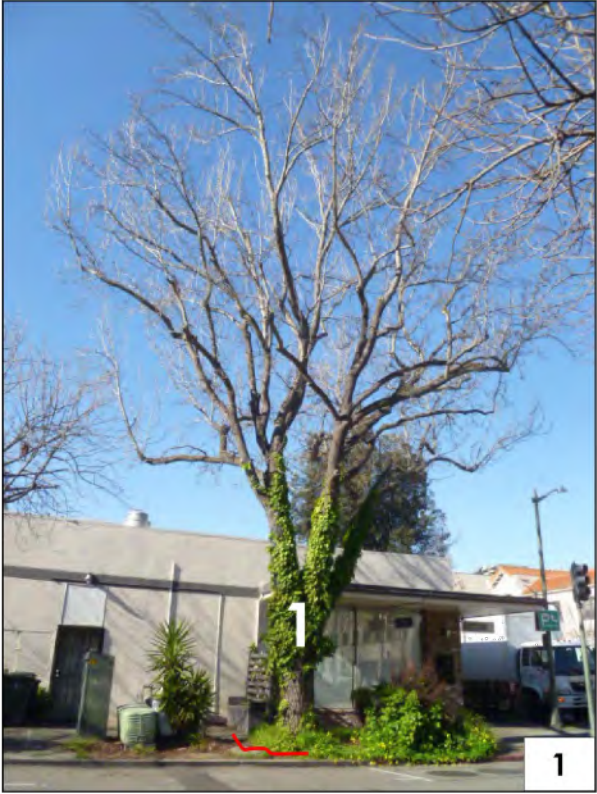
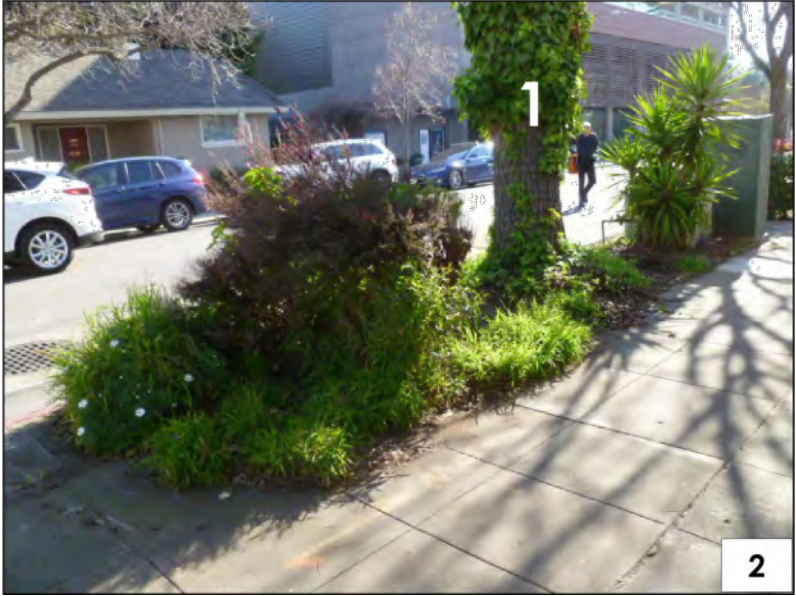
<p>1</p>

<p>2</p> <p>Photo 1. Tree 1 is located on the Cowper side of the property and is now dormant. Red line is approximate location of proposed curb cut.</p> <p>Photo 2. The approximate area of the planter strip is 4.5 feet by 23.5 feet. Vegetation and debris prevented an accurate measurement.</p> <p>Fujiitrees Consulting, LLC</p> <p>FTC   11 of 26</p>	<p>Appendix 1 v2 Photograph Exhibit 482 – 486 Hamilton Avenue Palo Alto, California</p>

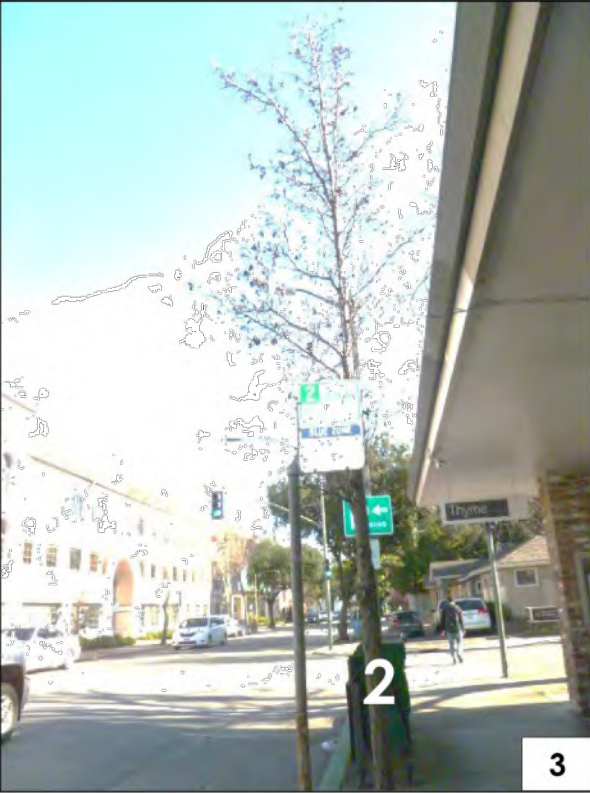
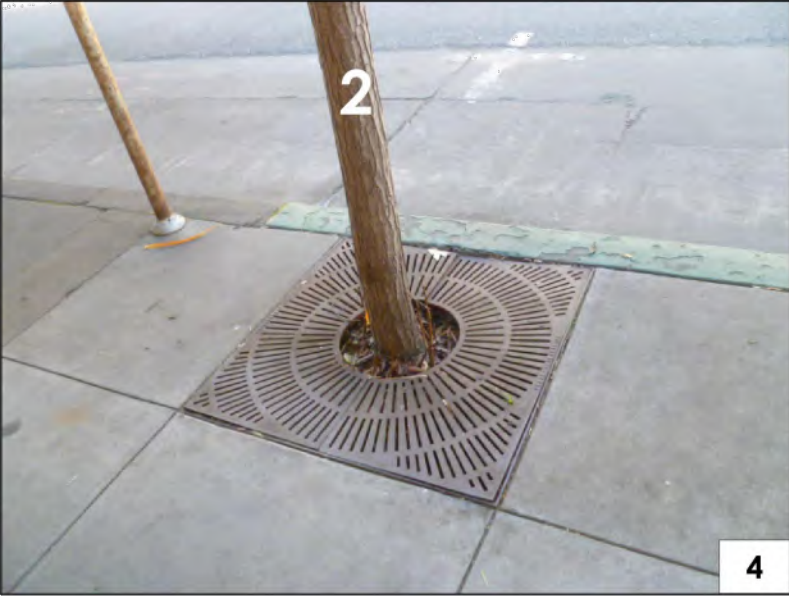
<p>3</p>

<p>4</p> <p>Photo 3. Tree 2 is located at the corner of Hamilton and Cowper. Like Tree 1, it is now dormant.</p> <p>Photo 4. The approximate area of the tree well is 3 feet by 3 feet.</p> <p>Fujiitrees Consulting, LLC</p> <p>FTC   12 of 26</p>	<p>Appendix 1 Photograph Exhibit 482 – 486 Hamilton Avenue Palo Alto, California</p>

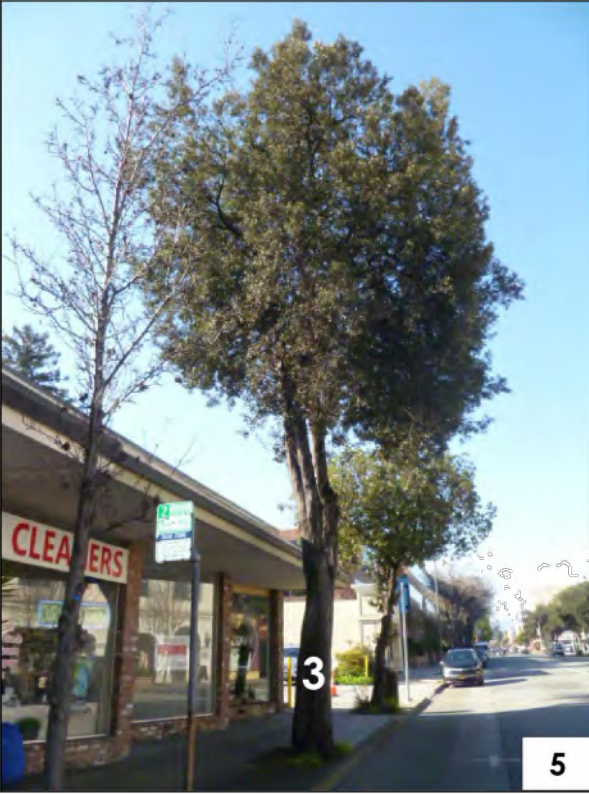
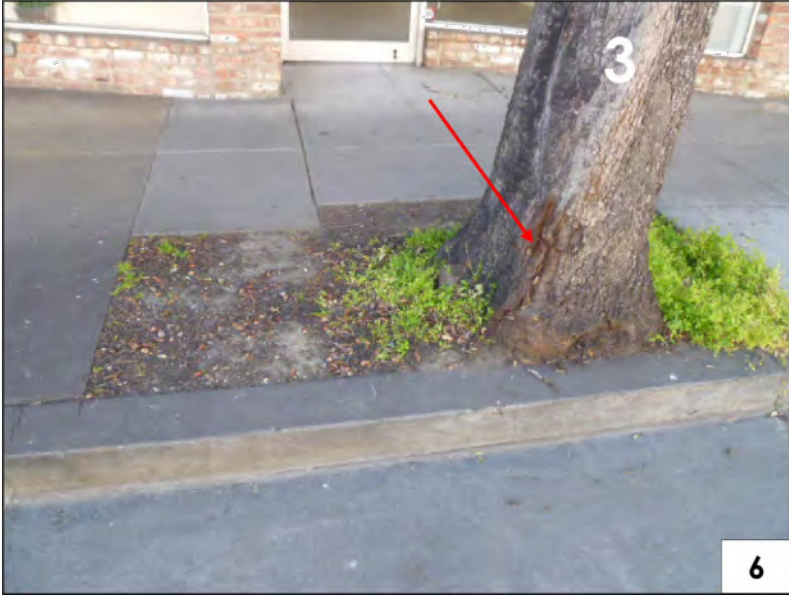
<p>5</p>

<p>6</p> <p>Photo 5. Tree 3 is located on Hamilton side of the property. An arrow points to past trunk damage.</p> <p>Photo 6. The approximate area of the planter strip is 3 feet 11 inches by 7.5 feet. This tree well narrows to 2 feet 11 inches.</p> <p>Fujiitrees Consulting, LLC</p> <p>FTC   13 of 26</p>

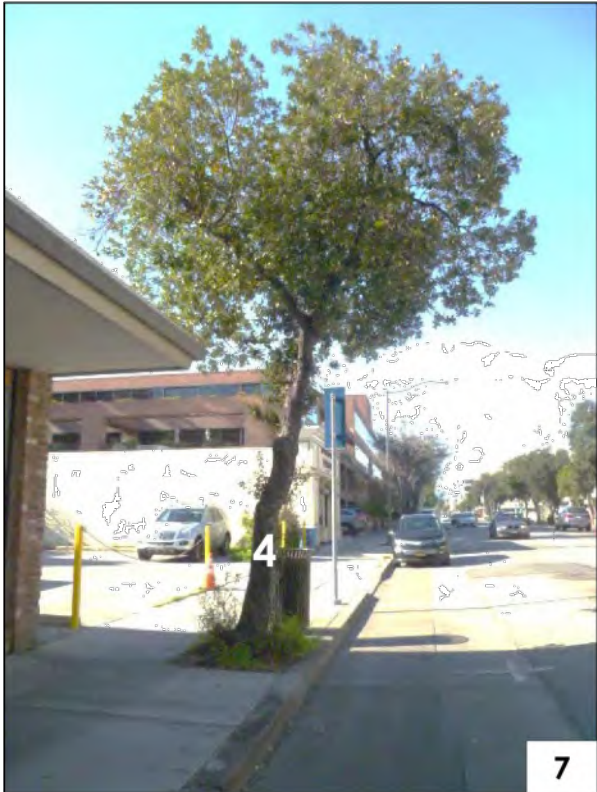
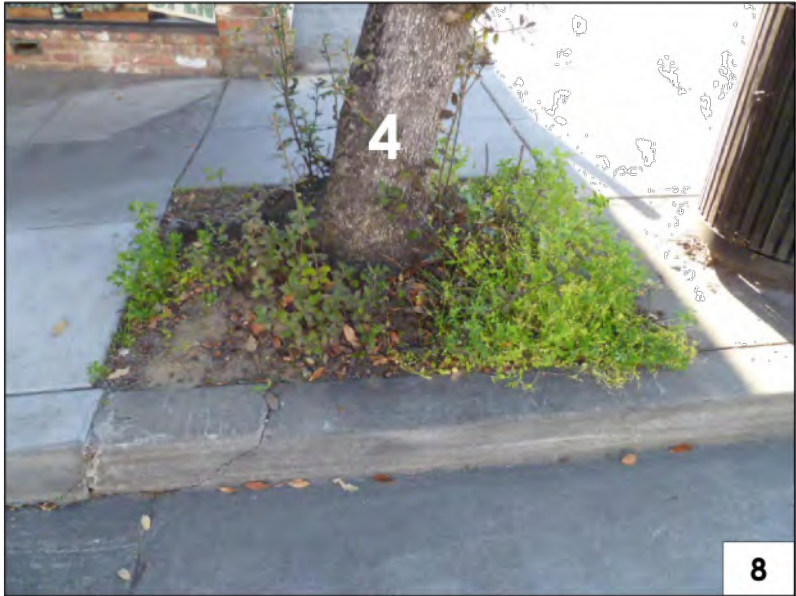
<p>7</p>

<p>8</p> <p>Photo 7. Tree 4 is located on the Hamilton side of the property.</p> <p>Photo 8. The approximate area of the planter strip is 3 feet 11 inches by 5 feet 3 inches.</p> <p>Fujiitrees Consulting, LLC</p> <p>FTC   14 of 26</p>	<p>Appendix 1 Photograph Exhibit 482 – 486 Hamilton Avenue Palo Alto, California</p>

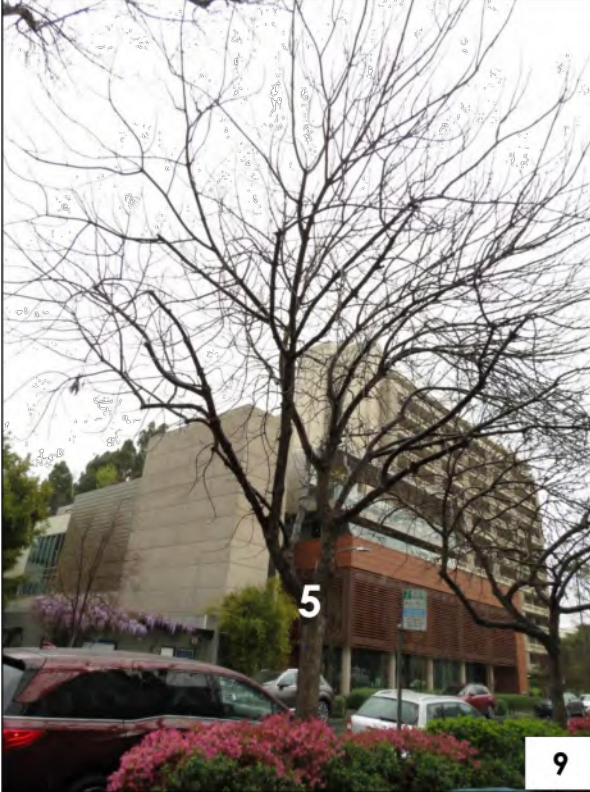
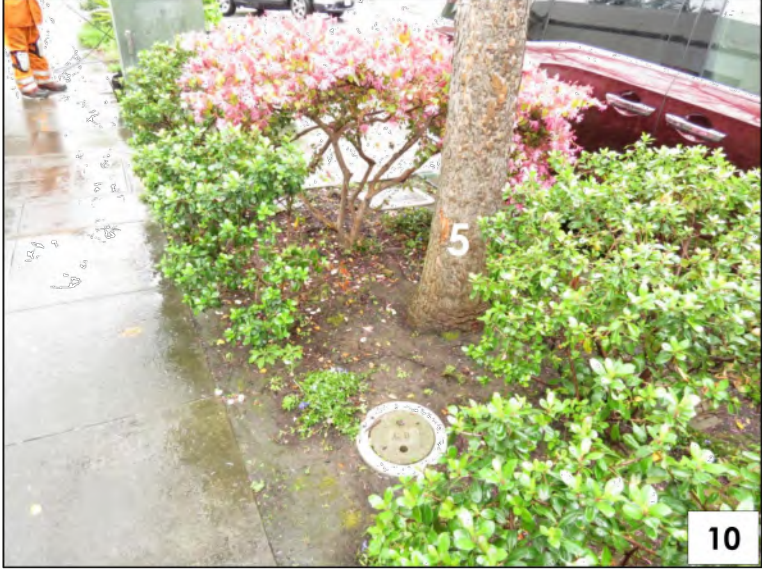
<p>9</p>

<p>10</p> <p>Photo 9. Tree 5, a dormant off-site tree, is located on Cowper Street and its canopy overhangs the property.</p> <p>Photo 10. The planter strip was observed to be off-site and not measured.</p> <p>Fujiitrees Consulting, LLC</p> <p>FTC   15 of 26</p>	<p>Appendix 1 Photograph Exhibit 482 – 486 Hamilton Avenue Palo Alto, California</p>

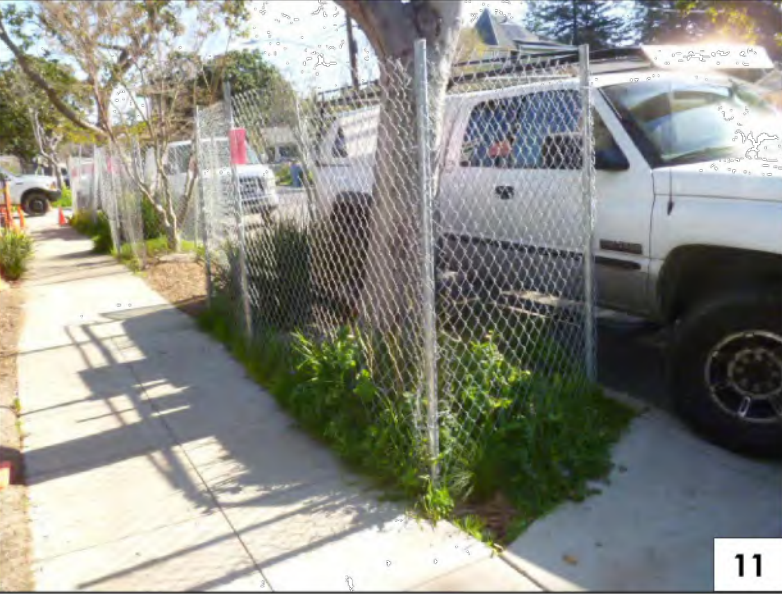
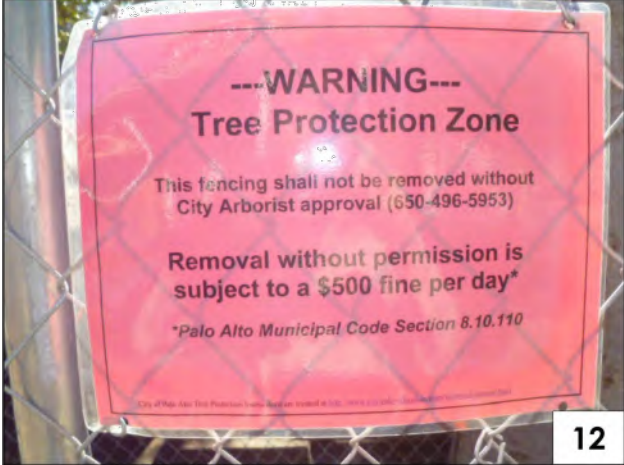
<p>11</p>

<p>12</p> <p>Photo 9. An example of Type 2 tree protection when a tree or trees are located between a sidewalk and the curb.</p> <p>Photo 10. Pictured is an example of a typical warning sign to be posted on the tree protection fencing.</p> <p>---WARNING--- Tree Protection Zone This fencing shall not be removed without City Arborist approval (530.496.5853) Removal without permission is subject to a \$500 fine per day Palo Alto Municipal Code Section 8.16.110</p> <p>Fujiitrees Consulting, LLC</p> <p>FTC   16 of 26</p>
