CHILDREN'S HEALTH COUNCIL SAN FRANCISQUITO CREEK BANK STABILIZATION PROJECT – PHASE II

AIR QUALITY ASSESSMENT

Palo Alto, California

September 29, 2020

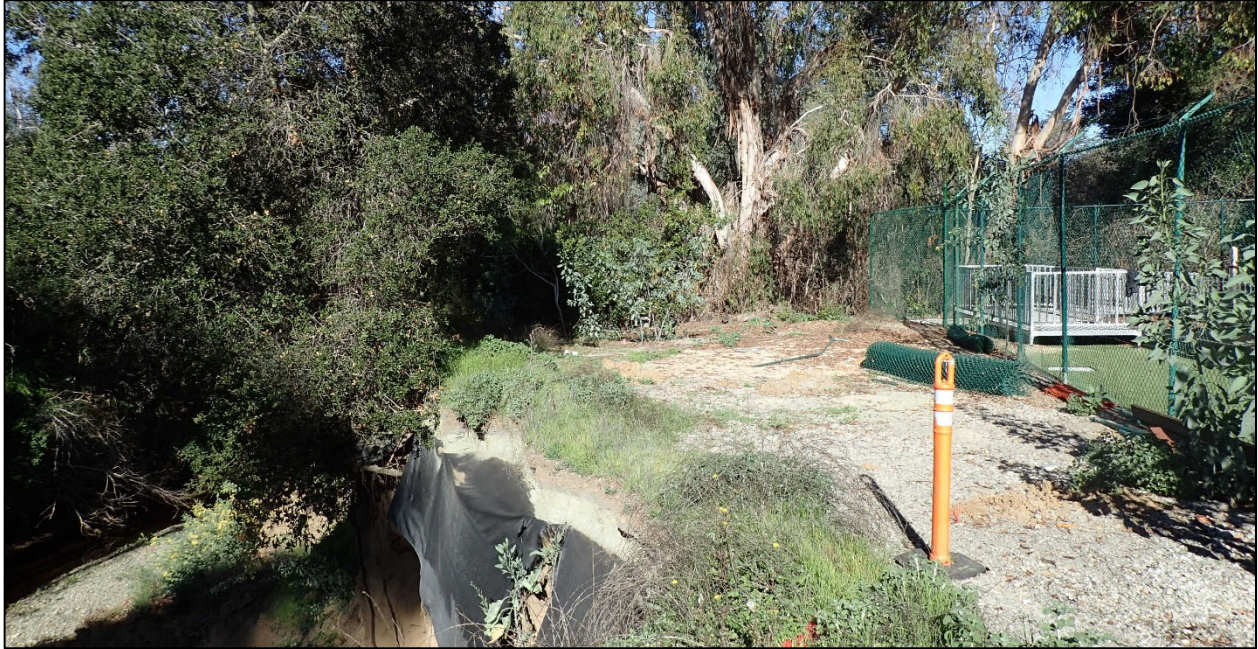
Photograph 1. Photograph depicting protected coast live oak tree (tree #742), which is proposed for removal. The eroding creek bank, exposed roots, and slight lean can be seen at left.

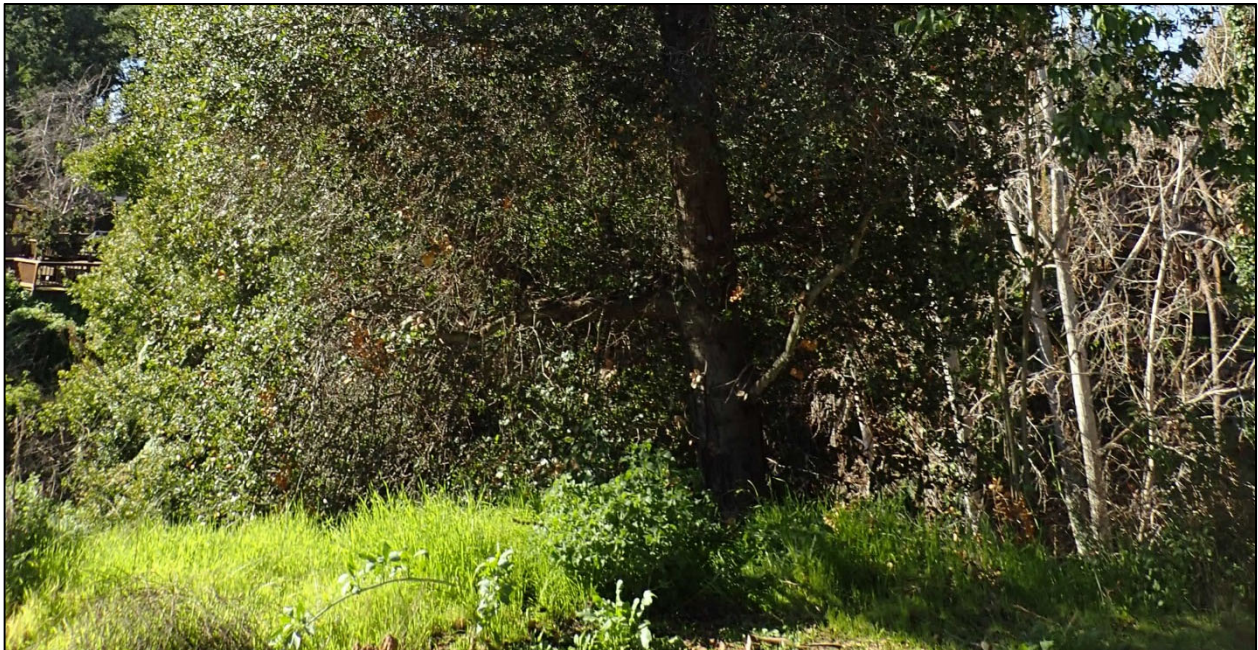
Photograph 2. Photograph depicting tree #742, which is proposed for removal. The tree is outwardly asymptomatic of pests or disease, but is severely undercut by the eroding creek bank, making preservation infeasible.

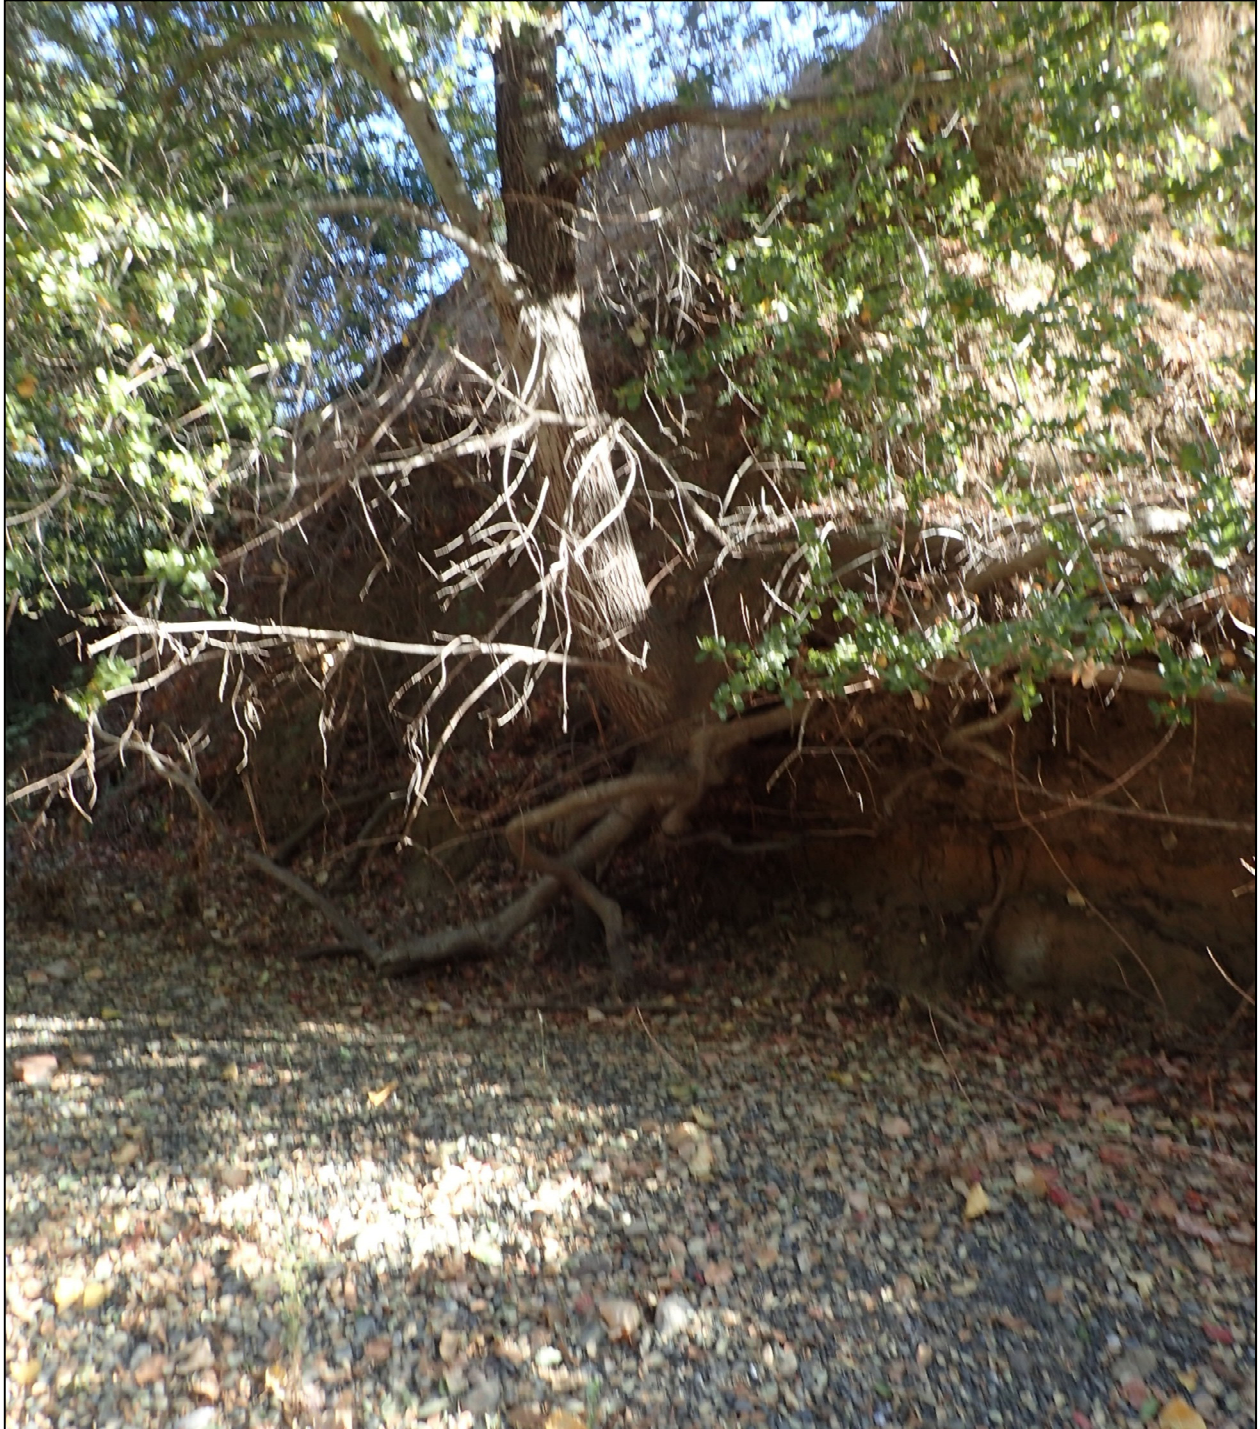
Photograph 4. Tree #996, a protected coast live oak tree, which is significantly undercut by the eroding creek bank. Tree #998 is proposed for removal, as it is within the limit of grade, and is not feasible to preserve.

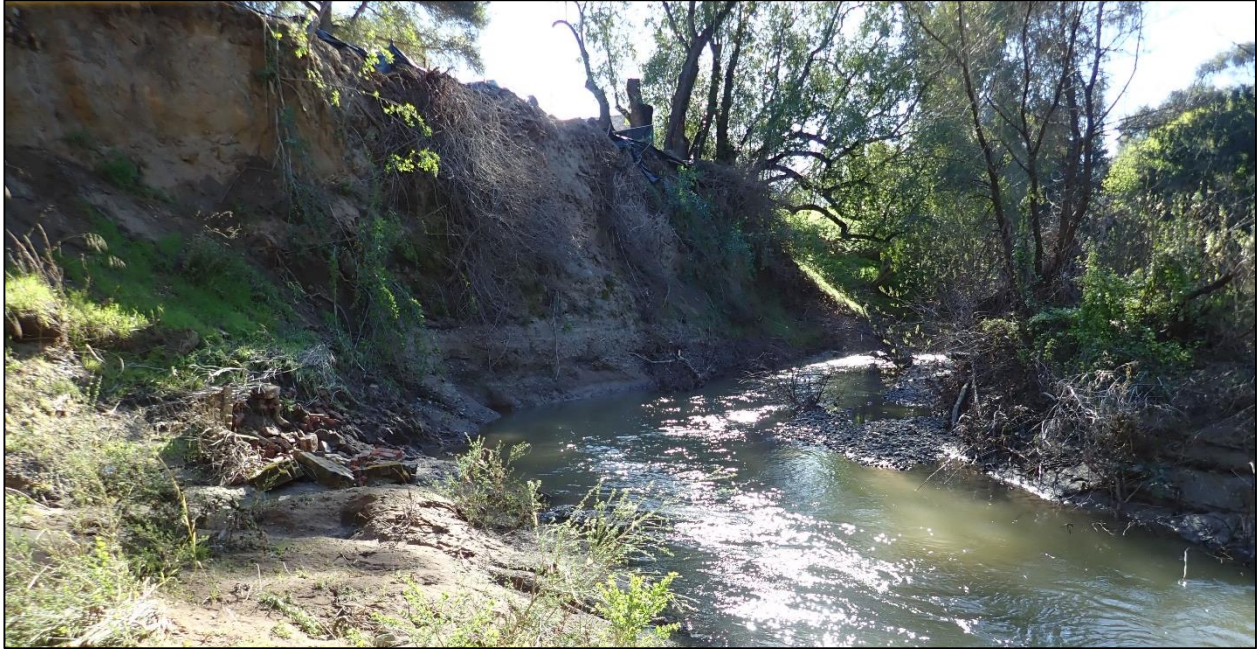
Photograph 1. Photo depicts the approximately 30-foot tall near vertical bank failure along San Francisquito Creek. Evidence of slumped debris and matted or destroyed vegetation can be seen on the east bank. The crib wall will be installed along the east bank to protect against future erosion and provide long-term stabilization. Photograph taken February 22, 2019.

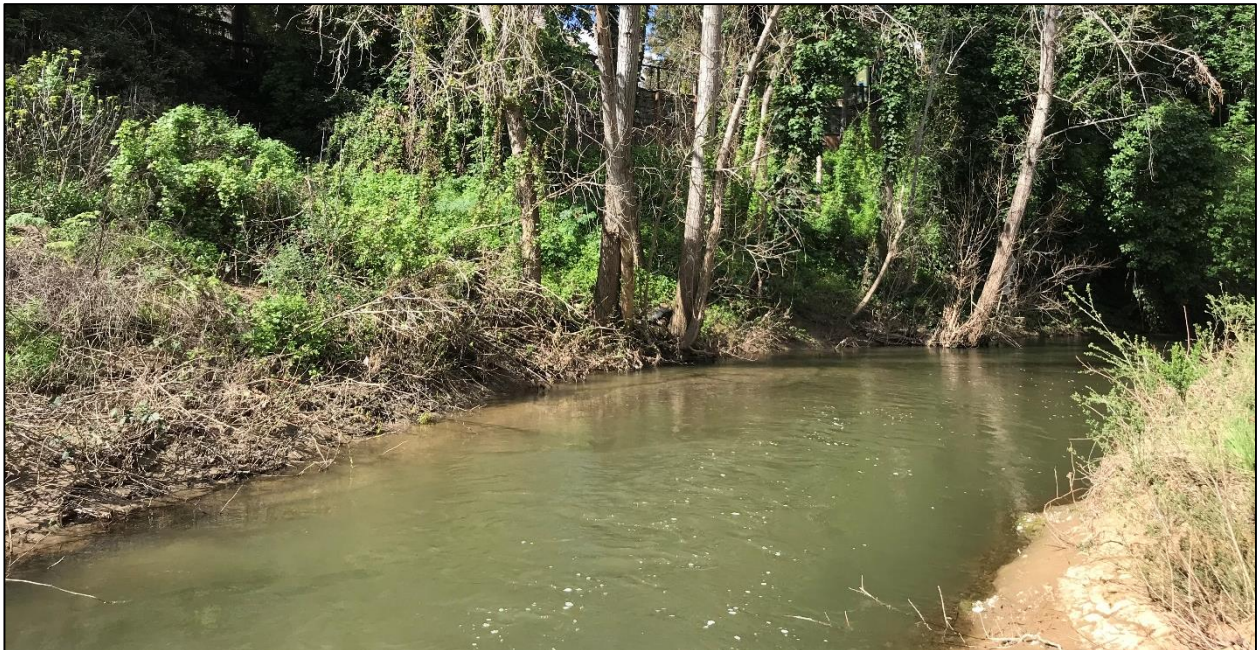
Photograph 2. Photo depicts flow of stream immediately downstream of Project Area. Photograph taken March 21, 2019.

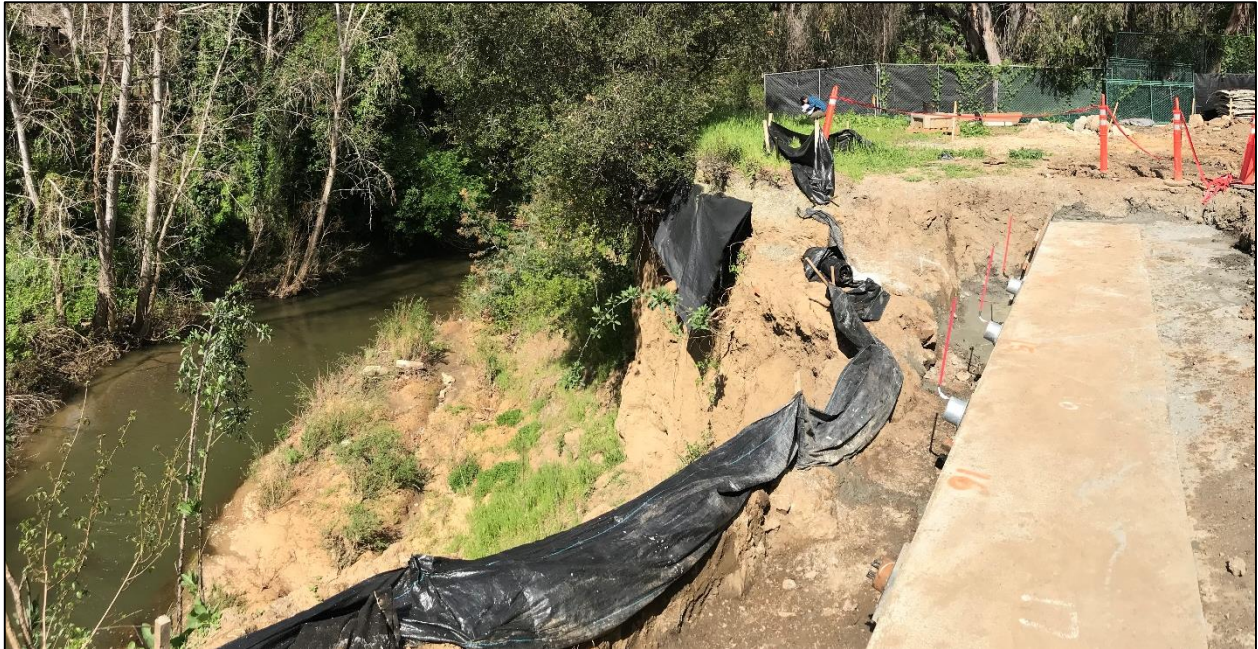
Photograph 3. View looking northwest along top of bank of creek. Photo depicts installation of concrete shear pin wall and set back from the top of bank. Cribwall work would occur along the lower sections of bank depicted here. Photograph taken March 21, 2019.

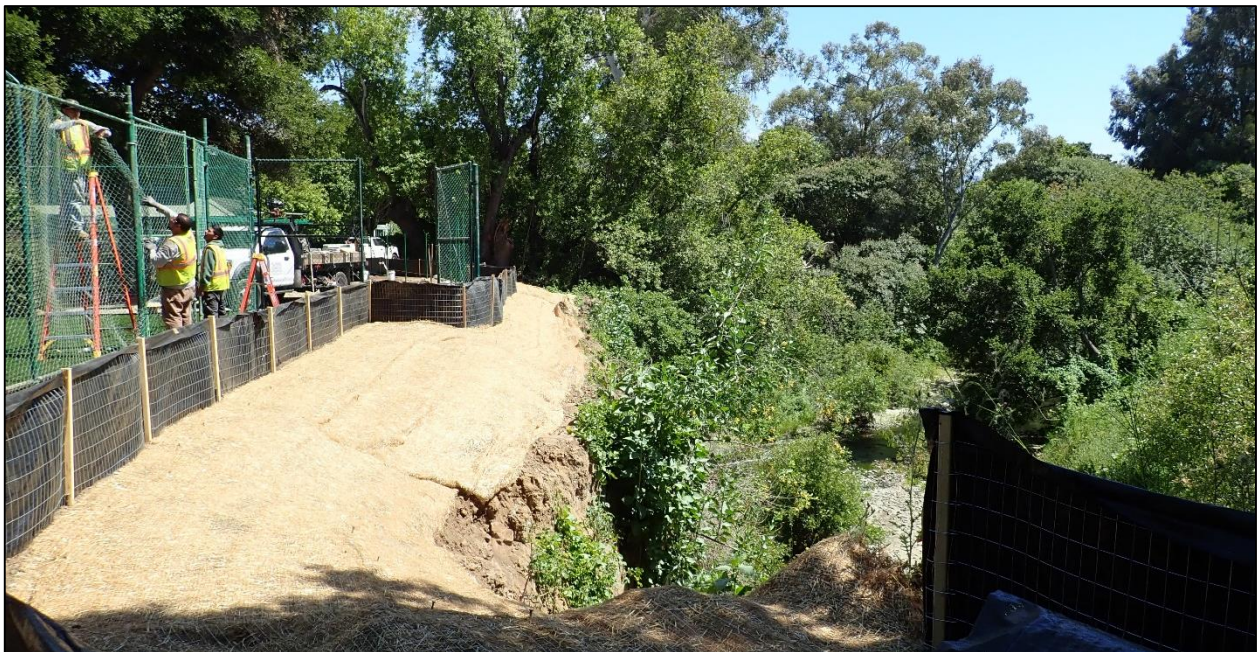
Photograph 4. View looking southeast along top of bank of the creek within the Project Area. Photo depicts completed Phase I shear pin wall construction. Photograph taken May 13, 2019.

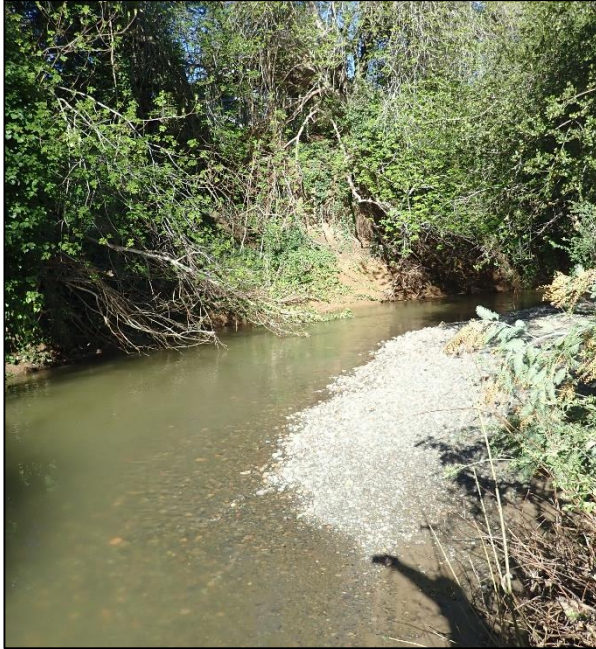
Photograph 5. Photo depicting point bar stream feature immediately downstream of bank failure. Photograph taken February 22, 2019.

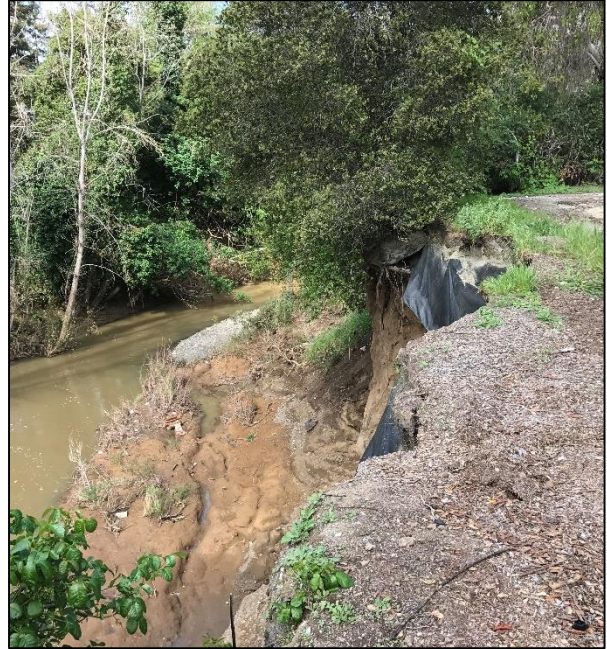
Photograph 6. Photograph looking downstream depicting acceleration of bank failure during 2016-2017 rainy season. Photograph taken March 23, 2017.

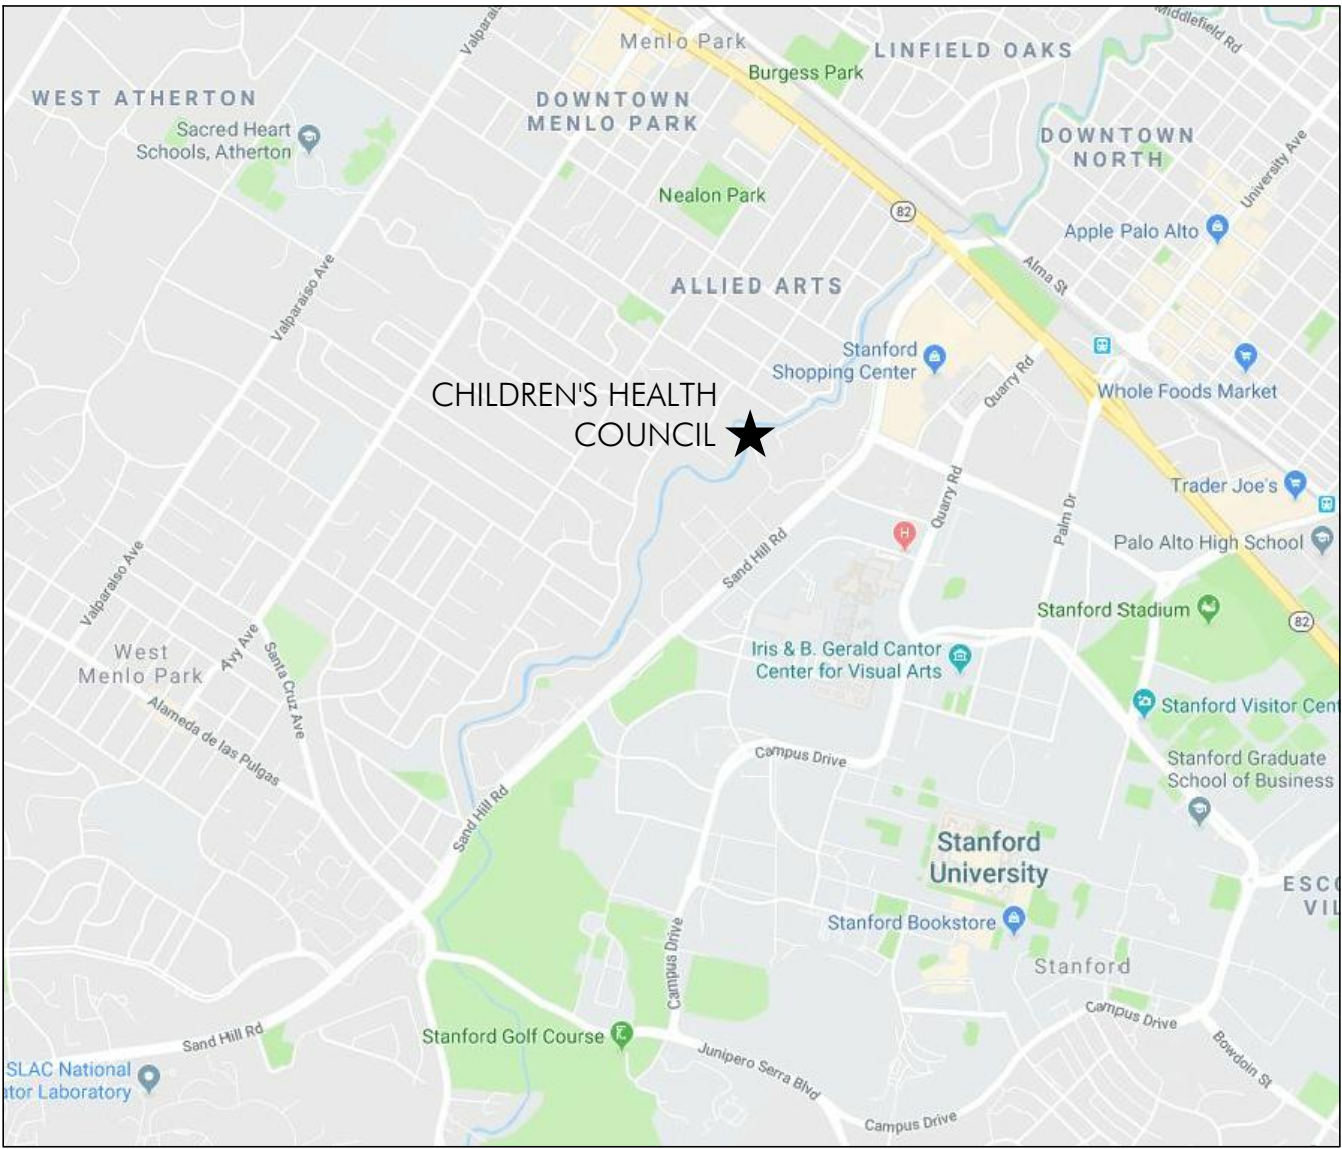
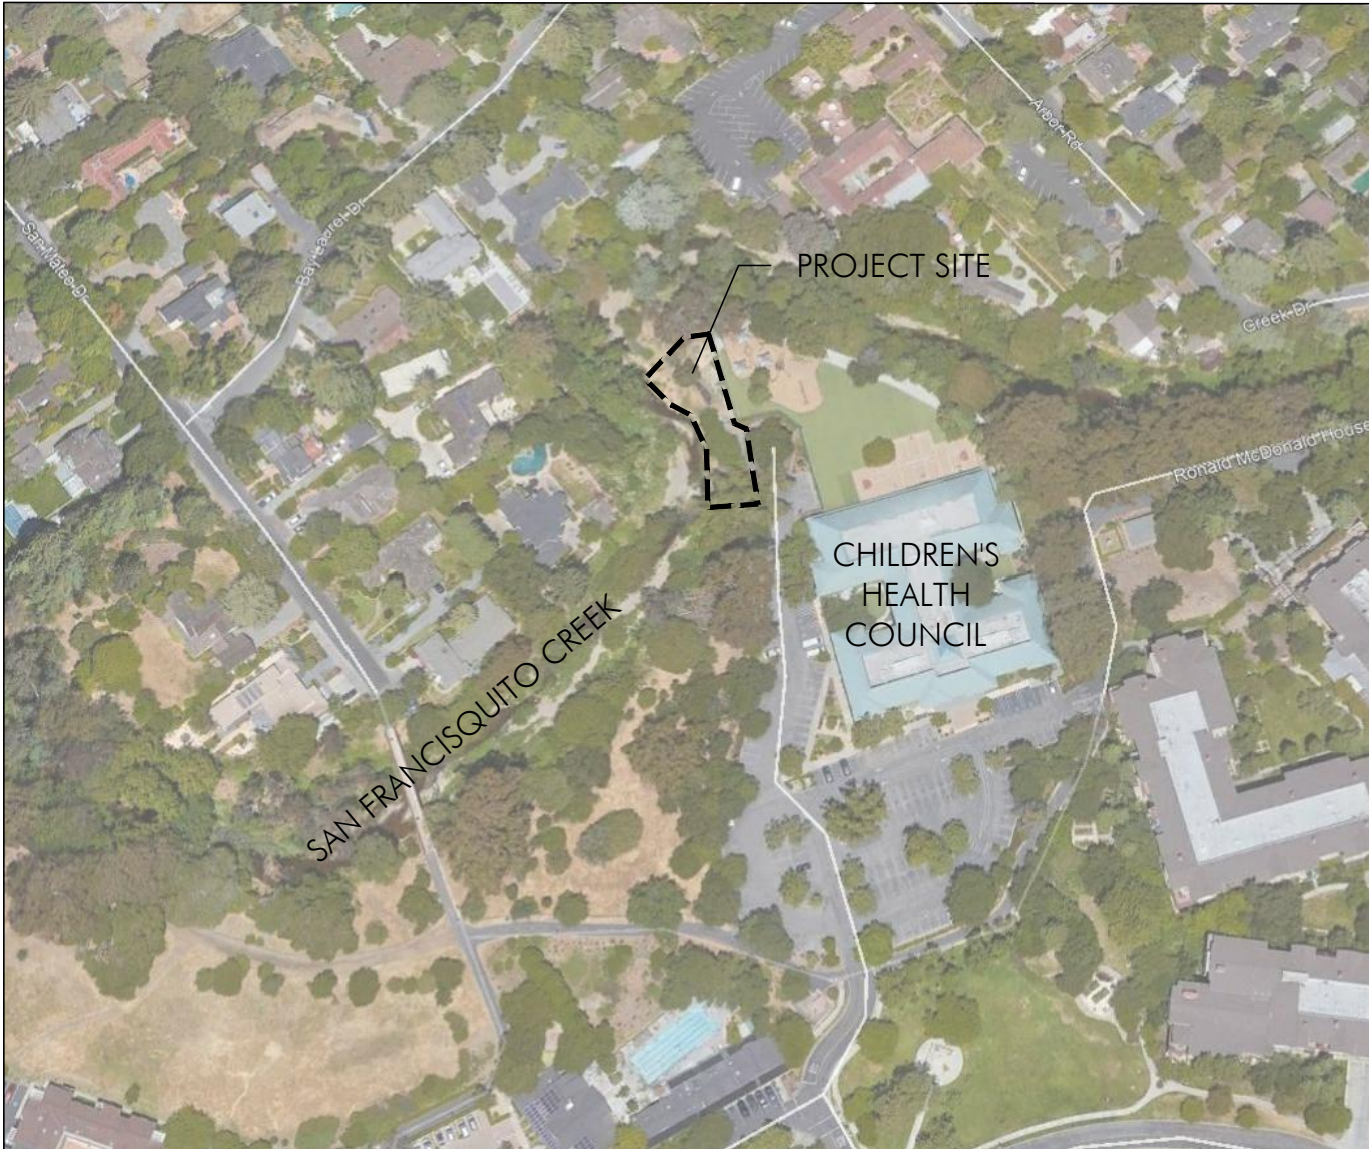
THE PROJECT INVOLVES THE EXCAVATION OF LANDSLIDE DEPOSITION OF ARTIFICIAL FILL MATERIAL, ALLUVIUM SILTY SAND, AND ALLUVIUM GRAVELLY SAND WHICH WILL BE HAULED OFF THE PROJECT SITE. LARGER ALLUVIUM ROCK SUCH AS BOULDERS AND COBBLES SHALL BE PURCHASED AND DELIVERED TO THE PROJECT SITE. ENGINEERED FILL MATERIAL SHALL CONSIST OF ALLUVIUM COBBLE AND GRAVEL AND SHALL BE PURCHASED AND DELIVERED TO THE SITE.

- CUT = 1370 CU. YDS. (HAUL OFF SITE)
- IMPORT BOULDERS = 330 CU. YDS.
- IMPORT COBBLES = 220 CU. YDS.
- IMPORT ENGINEERED FILL = 1780 CU. YDS.

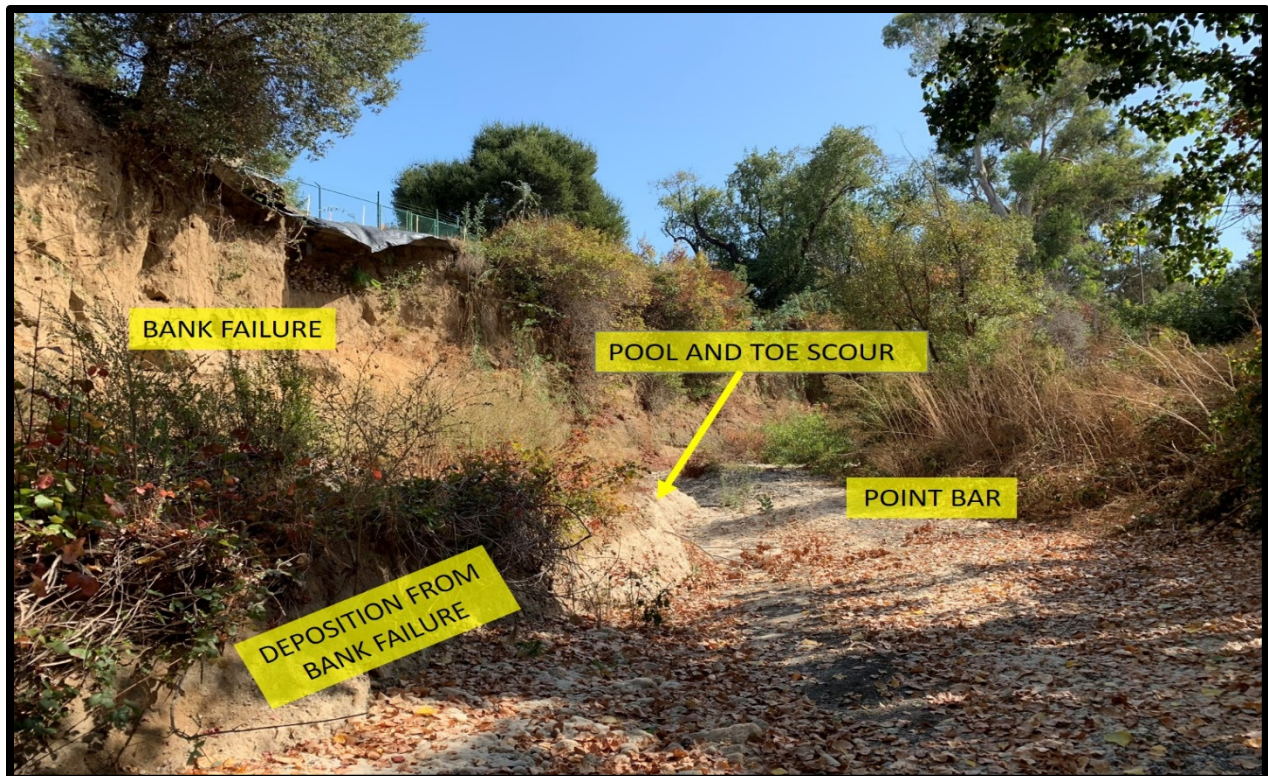
Figure 2. Oblique view of project area as viewed from San Francisquito Creek, looking upstream

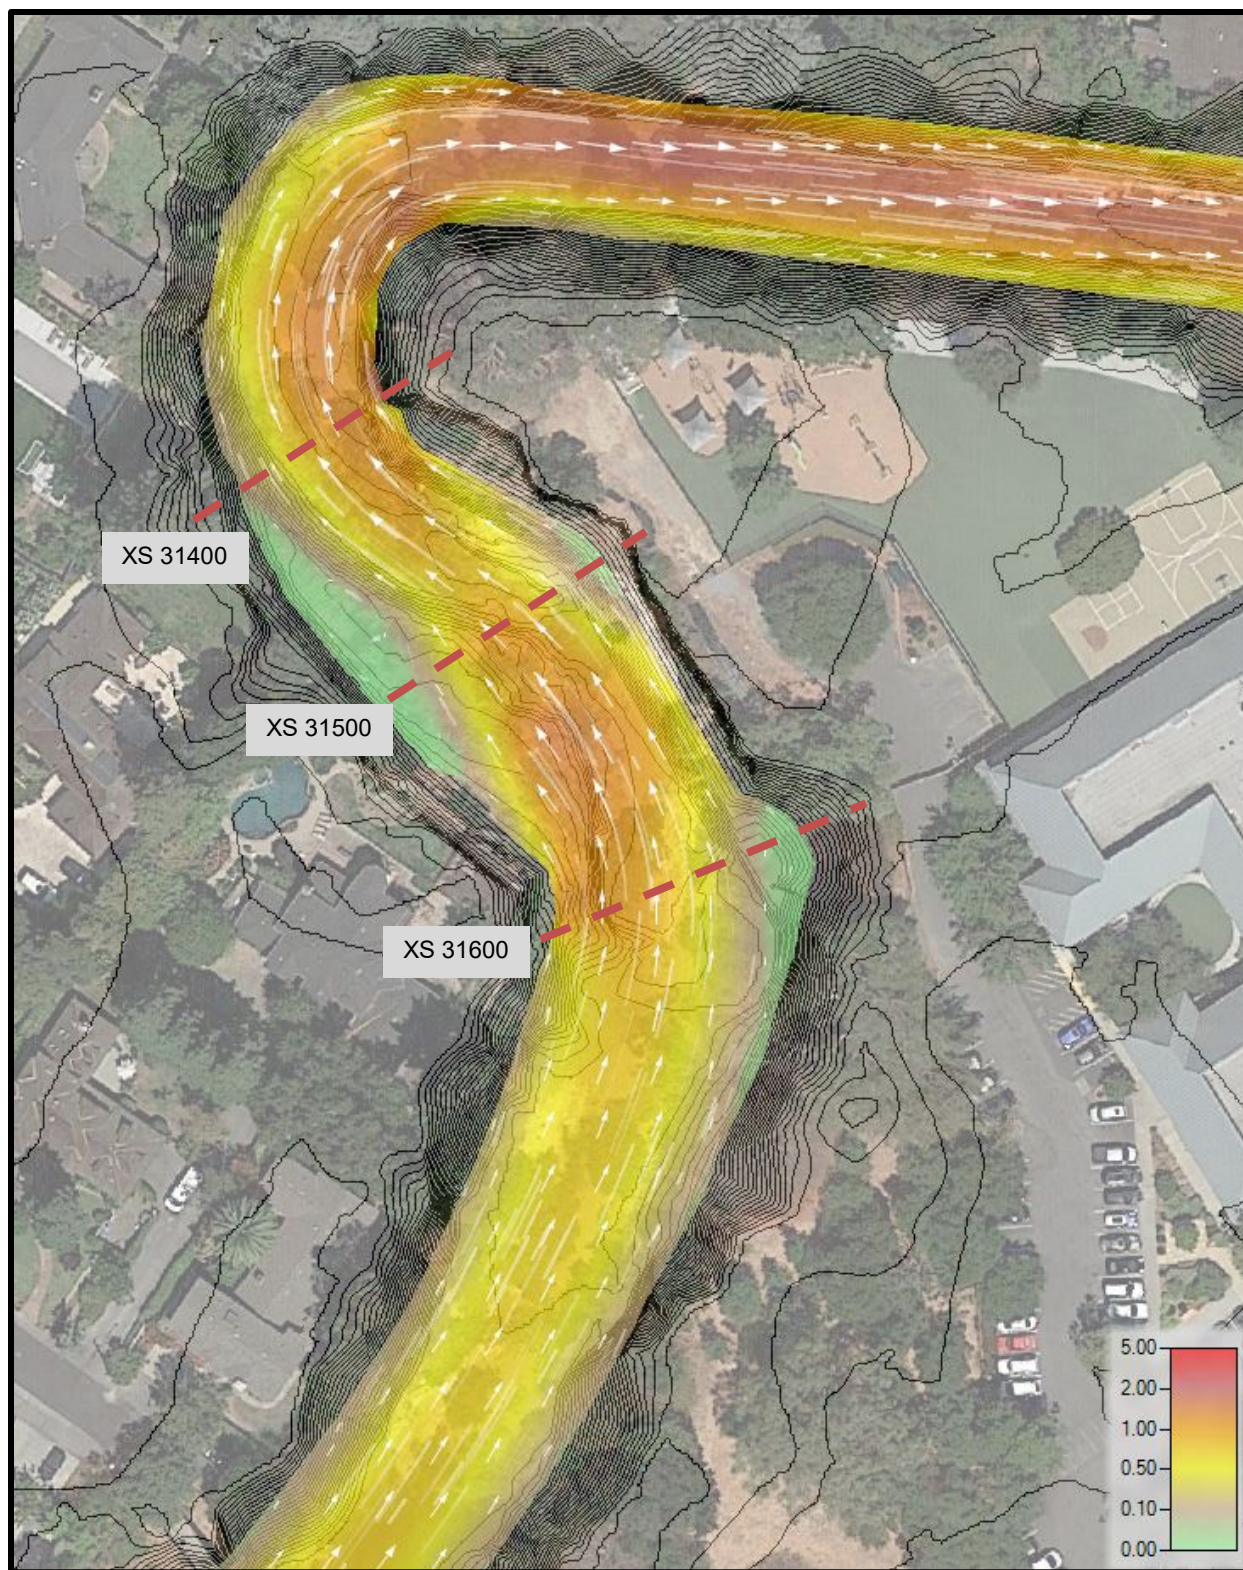
Figure 7 . Proposed Conditions model of shear (lb/sf) for 10-year event

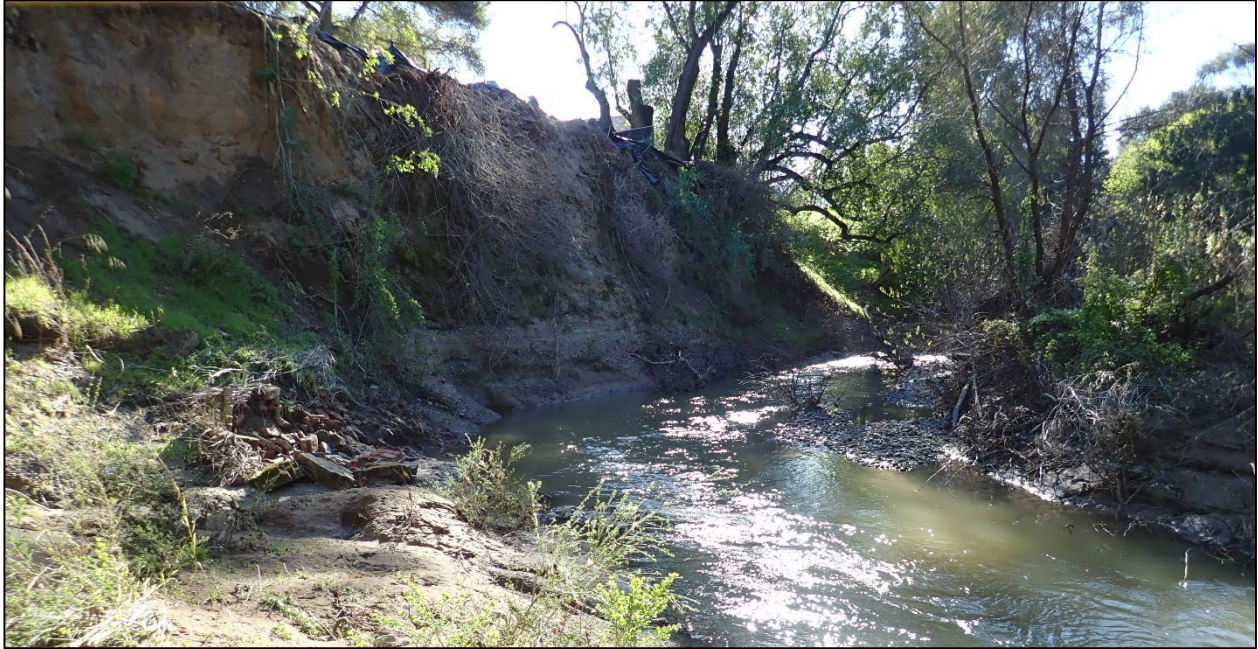
Photograph 1. Photograph looking upstream at the approximately 30-foot tall near vertical bank failure along San Francisquito Creek. Evidence of slumped debris and matted or destroyed vegetation can be seen on the east bank. The crib wall will be installed along the east bank to protect against future erosion and provide long-term stabilization. Photograph taken February 22, 2019.

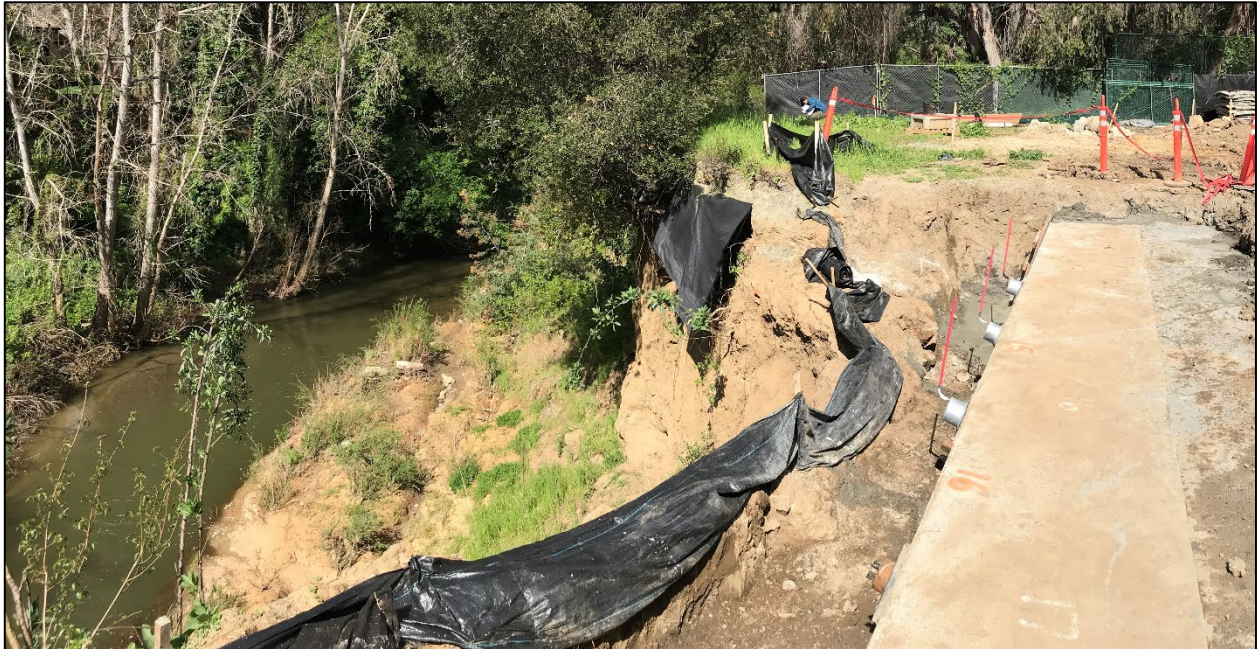
Photograph 3. View looking downstream, northwest, along top of bank of creek. Photograph depicts installation of Phase I concrete shear pin wall set back from the top of bank. Photograph taken March 21, 2019.

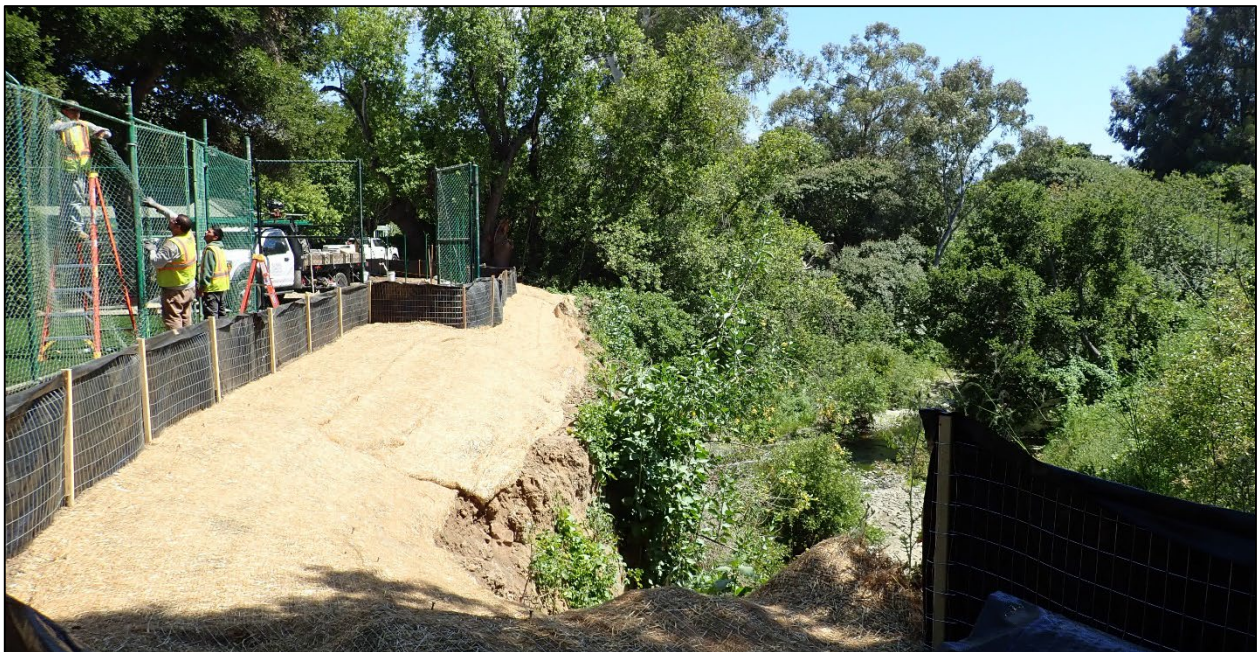
Photograph 4. View looking upstream, southeast, along top of bank of the creek within the Project Area. Photograph depicts completed Phase I shear pin wall construction. Photograph taken May 13, 2019.

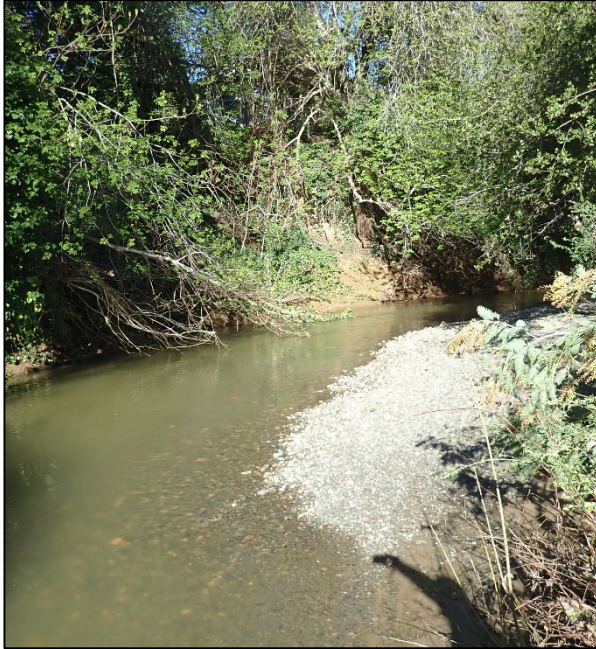
Photograph 5. Photograph of point bar stream feature immediately downstream of bank failure. Photograph taken February 22, 2019.

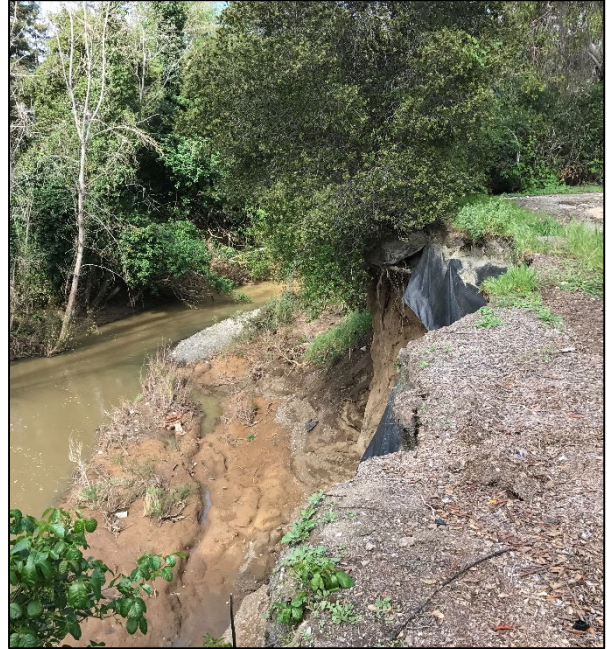
Photograph 6. Photograph looking downstream depicting acceleration of bank failure during 2016-2017 rainy season. Photograph taken March 23, 2017.

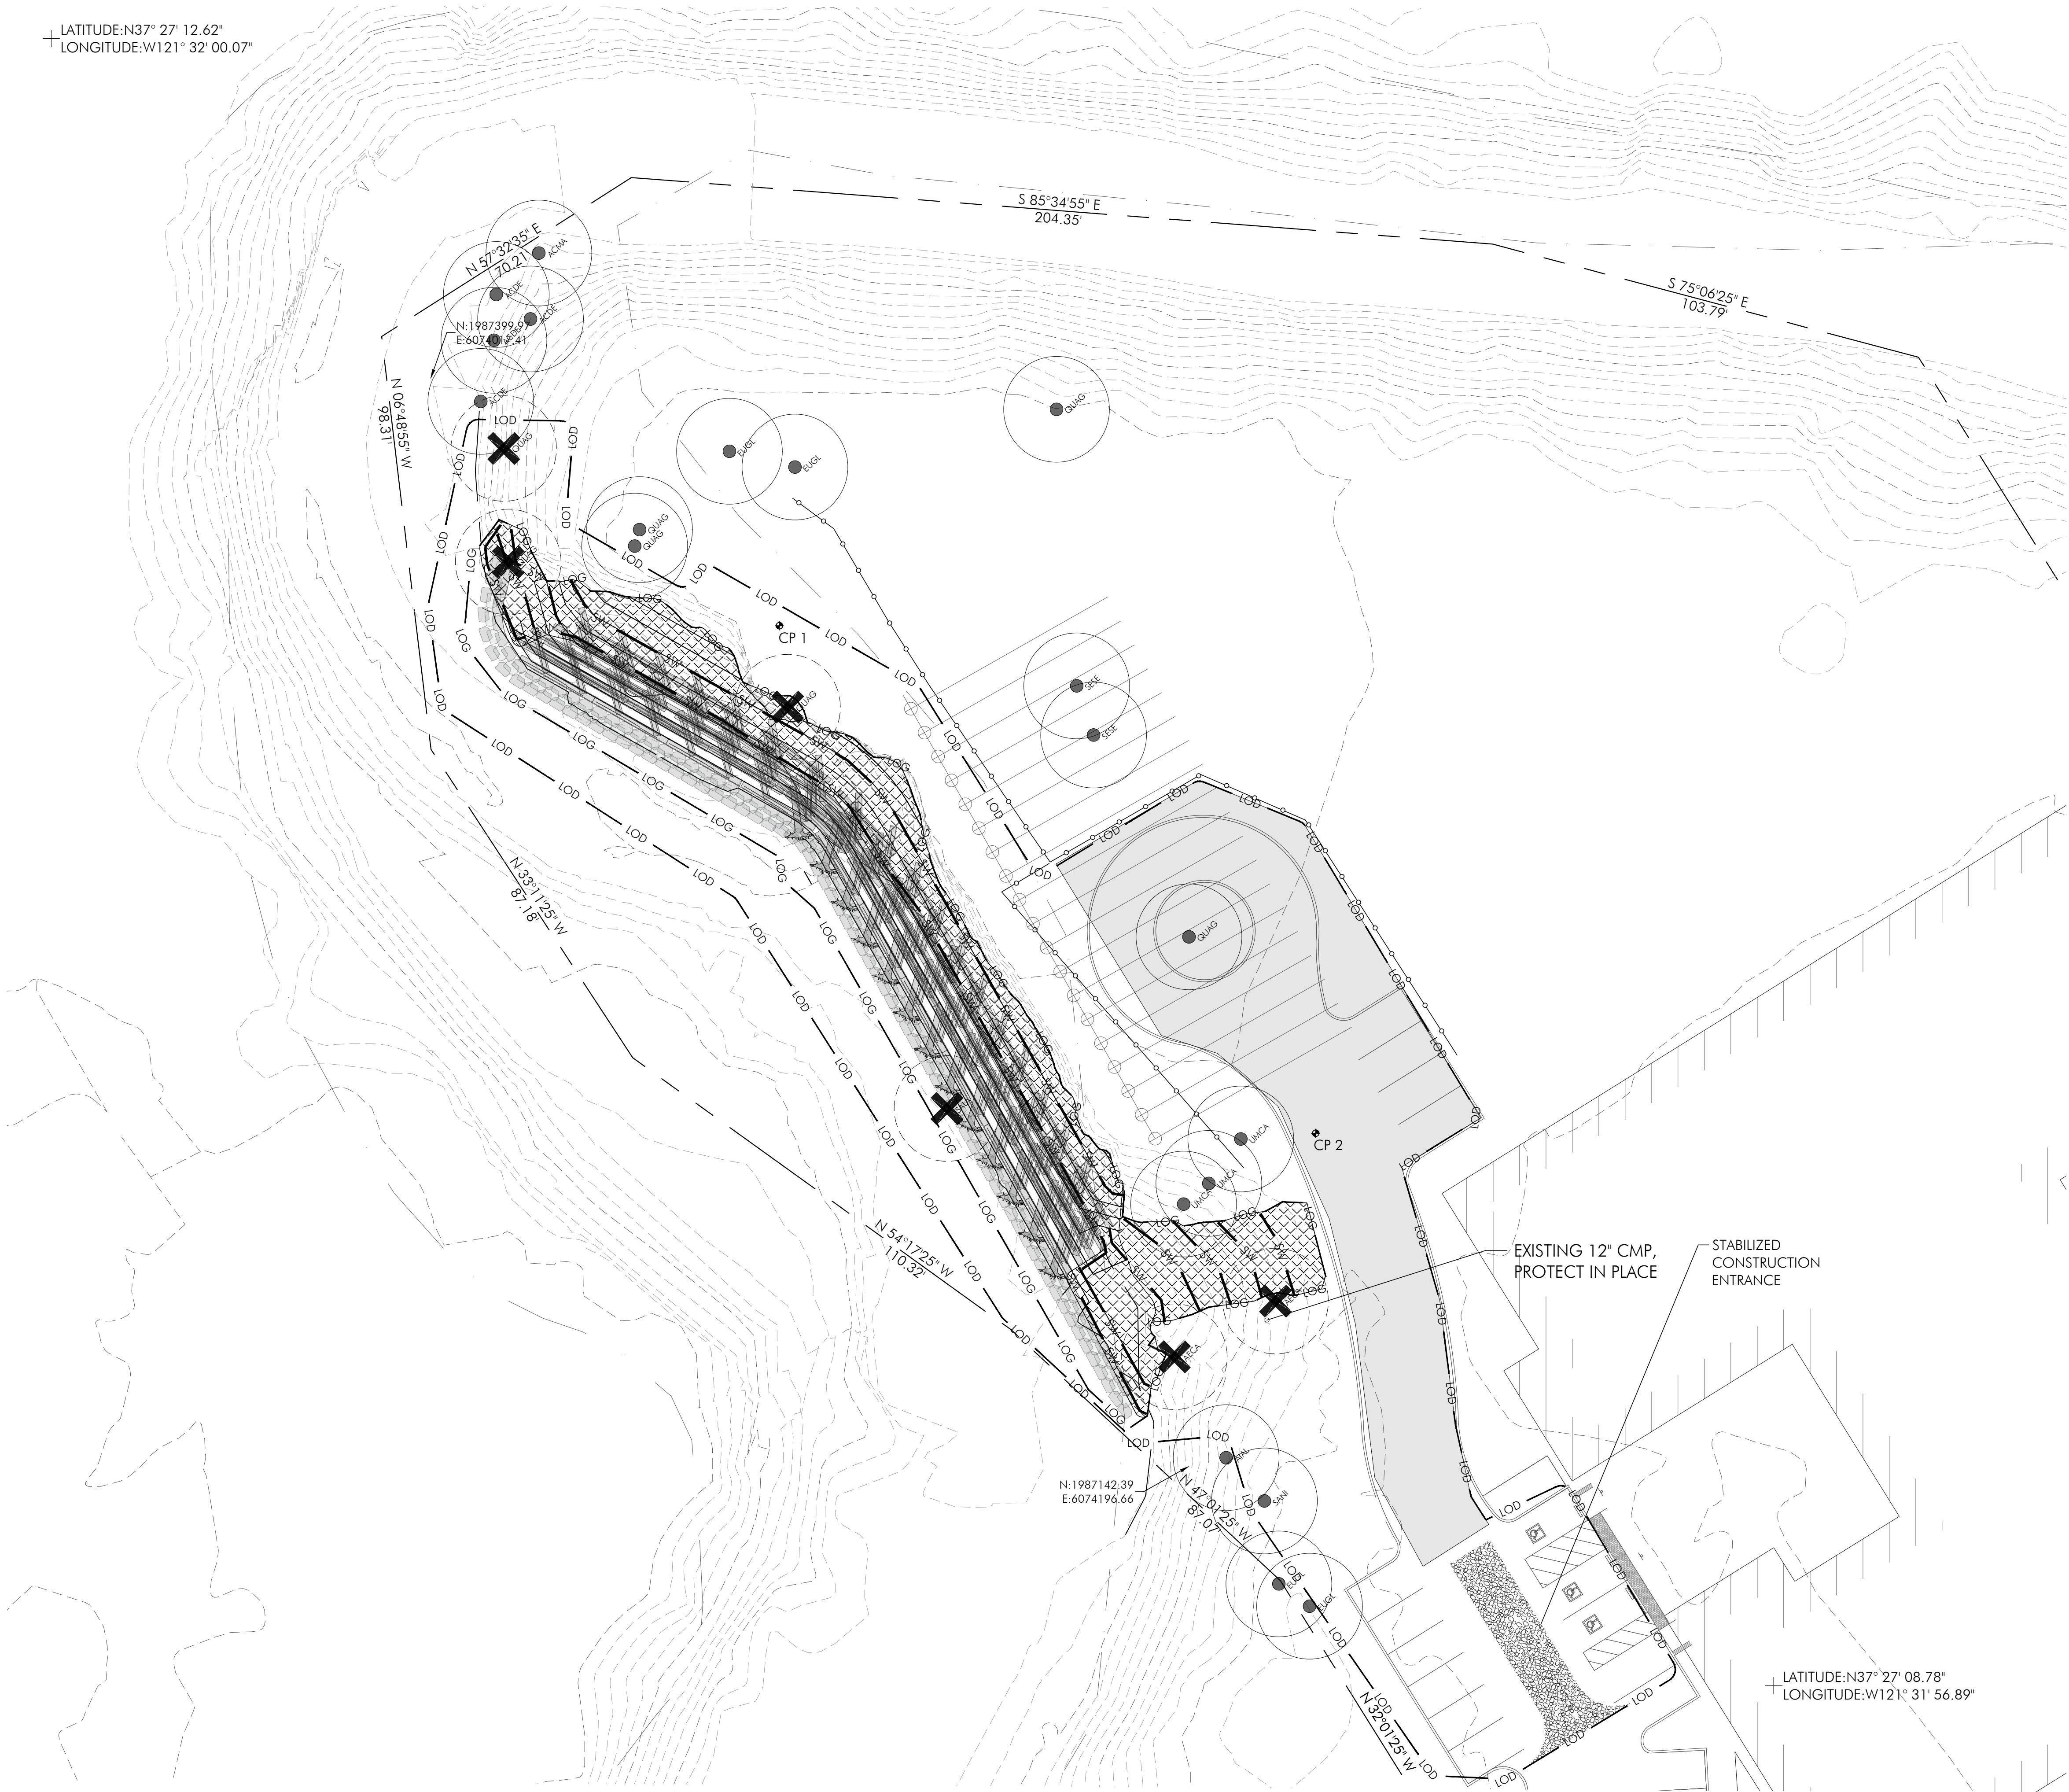
- NOTES:
- CONTRACTOR SHALL COMPLY WITH NPDES CONSTRUCTION GENERAL PERMIT.
 - CONTRACTOR SHALL COMPLY WITH CAL TRANS FIBER ROLL (TYPE 2) STANDARDS. SEE SHEET C-6.1.
 - CONTRACTOR SHALL COMPLY WITH CAL TRANS ROLLED EROSION CONTROL PRODUCTS MODIFIED TO USE WOOD STAKES. SEE SHEET C-6.2.
 - ALL MATERIALS SHALL BE BIODEGRADABLE
