**THE OAKS SUBDIVISION**  
 BY STEEL BRIDGE HOMES PALO ALTO, LP  
 4103 Old Trace Road, City of Palo Alto, CA  
 Assessor Parcel Number : 175 - 020 - 178

**THE OAKS SUBDIVISION**  
**Project By Steel Bridge Homes Palo Alto, LP**  
**Data 4103 Old Trace Road, City of Palo Alto, CA**  
**APN: 175-020-178**

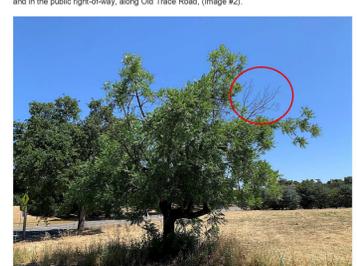
Image #2 - Tree T1 - walnut, grows on the boundary between the subject property and the right-of-way, along Old Trace Road. Note the tie-dieback in canopy. (circled).

The walnut has a 16" trunk diameter, and two codominant trunks, which form a union at 5-feet above grade. The single lower trunk has a 15-degree lean. I noted lip dieback over 25-35% of the canopy. The tree needs pruning including crown clearing, and weight reduction, and selected removal of some crowded branches.

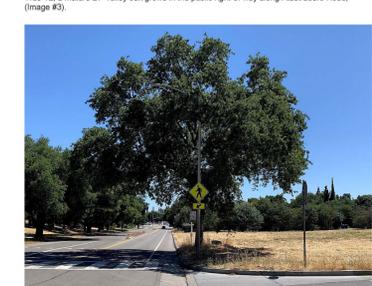
Image #3 - Tree T2, valley oak, grows in the public right-of-way, along Atastradero Road.

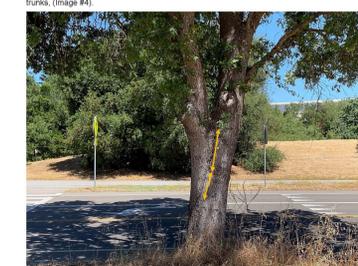
Image #4 - Tree T2 valley oak. Note vertical seam on trunk beginning at codominant union, (I to left of arrow).

Because of the seams location at the codominant attachment point, I recommend a more detailed inspection of the seam to determine if it affects the structural integrity of the attachment.

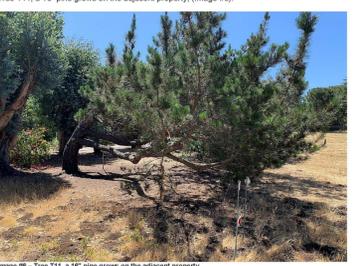
Image #6 - Tree T11, a 16" pine grows on the adjacent property.

The trunk has several structural defects including a trunk bow, an unbalanced canopy, and overextended limbs. All growth is on one side of the trunk creating an unbalanced canopy with a weight bias towards the subject property. However, the tree appears stable.

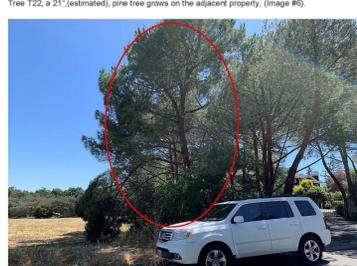
Image #6 - Tree T22, a 21" pine, (circled), growing on the adjacent property. Note the overhanging lower limbs.

The trunk has a 15 degree lean towards the subject property. One 4" and one 7" diameter limb overhangs the property and grows to the ground. I noted a minor infestation of Sequoia pitch moth. Overall, the pine is in fair condition.

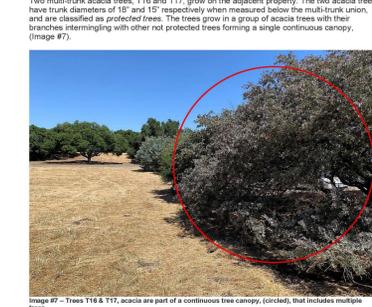
Image #7 - Trees T16 & T17, acacia are part of a continuous tree canopy, (circled), that includes multiple trees.

The trees show normal amounts of canopy growth and are in fair health. Both trees have multiple structural defects including trunk leans, unbalanced canopies and overextended limbs. Because of these defects I rate their structure as poor. Overall, the trees are in fair condition.

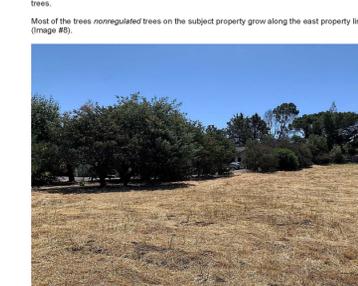
Image #8 - The trees growing along the east property line. Most are purple-leaf acacia, mixed with two oaks and an olive.

The trees are mostly purple-leaf acacia. The acacia have multiple structural defects, are in fair to poor condition, and are not suitable for incorporation into the project.

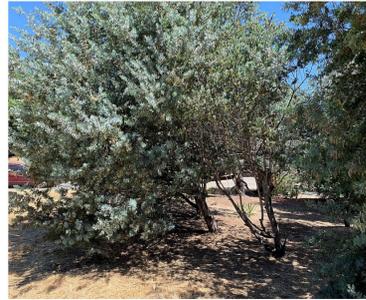
The trees contain one or more structural defects including unbalanced canopies, trunk leans, and some have minimal live growth in their canopies. (Image #9).

Image #9 - Trees T3 - T5 acacia. Note the trunk leans and unbalanced canopies with a weight bias towards the west.

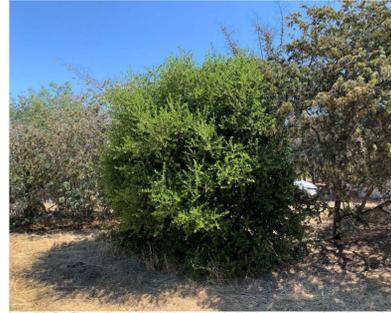
Image #10 - Tree T5; coast live oak. Note the vigorous growth with a dense canopy growing to the south.

Tree T6, a multi-trunk oak, is 11' in diameter below the trunk union. The coast live oak is in good health. The tree canopy is unbalanced and grows with a weight bias to the west. The oak is in good condition.

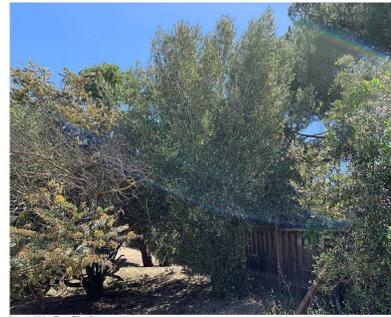
Image #11 - Tree T9; olive.

The olive is in good health. Structurally, I rate the tree as fair due to the three codominant trunks.

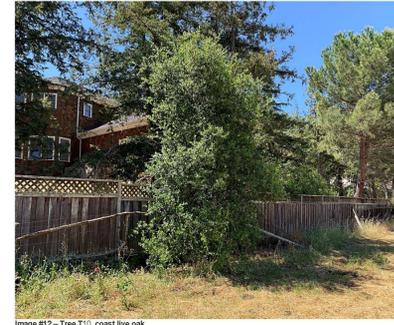
Image #12 - Tree T10; coast live oak.

The tree is likely a volunteer that sprouted at the base of the fence. This location has affected the tree growth pattern. The trunk leans 5 degrees away from the fence. All of the canopy growth is on one side of the trunk. The tree has good health, but poor structure and overall is in fair condition.

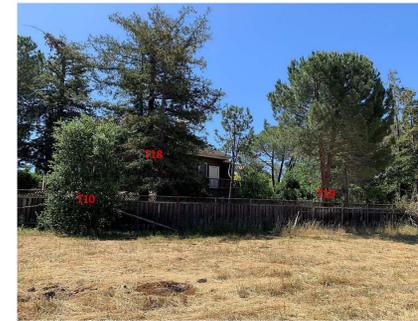
Image #13 - Trees T10, coast live oak, T18 coast redwood, and T19, pine.

Tree T18, a 15' (estimated), coast redwood is in fair condition. The redwood has limbs that overhang the property line by 10 feet.

Tree T19, a 14' pine has two codominant trunks at 10 feet above grade. The trees lowest limb is 10 feet above grade and overhangs the property by 13 feet. The pine is in fair condition.
