TREE PROTECTION REPORT

660 UNIVERSITY AVENUE

PALO ALTO, CALIFORNIA (511 BYRON ST., 660 & 680 UNIVERSITY AVE.)

David L. Babby Registered Consulting Arborist[®] #399 Board-Certified Master Arborist[®] #WE-4001B

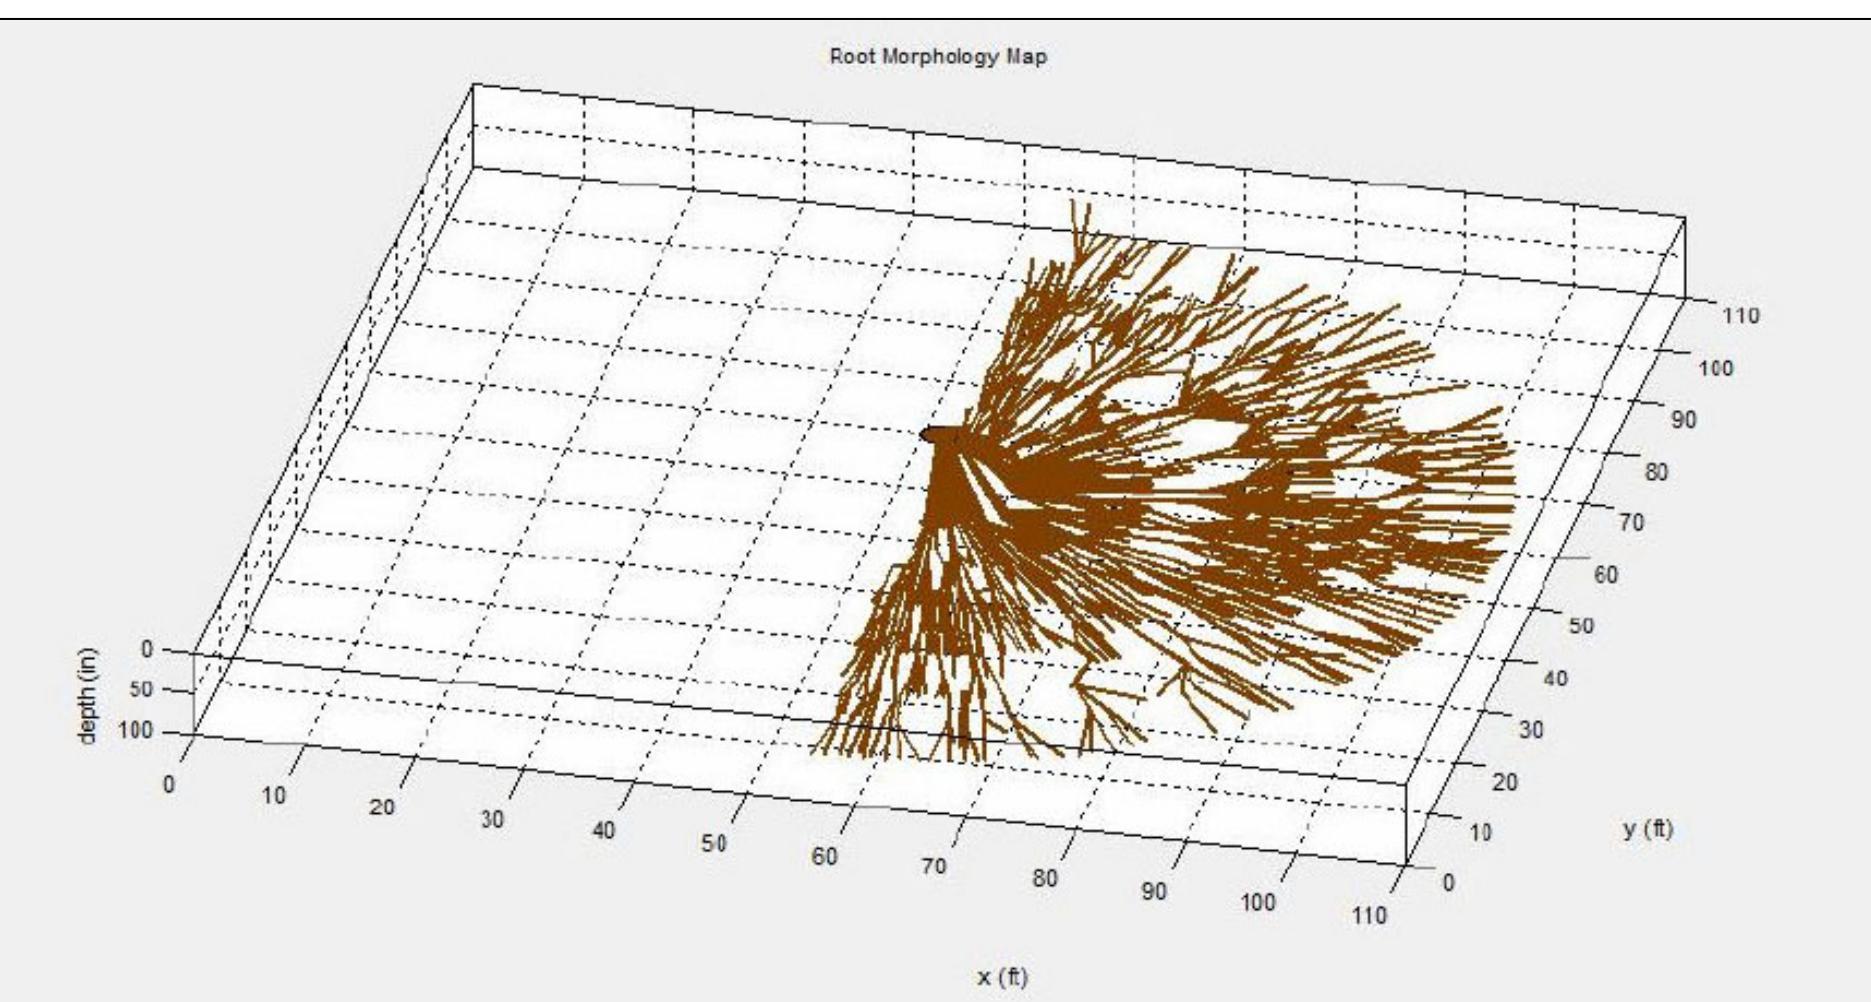
This is a conceptual 3D Top-Down diagram of what the root structure may look like below the ground of Oak Tree #1572 on University Avenue. It is obtained from the root data collected from the 12 half circle scans performed over the asphalt parking lot.

The software uses the results of the predicted root locations from the 12 half circle scans generated from the virtual trench data on the following pages and connects the predicted root hits, creating what you see on this page. This provides a visualization concept of what the root structure may look like below ground. The scan begins from a distance of 7ft. from the tree and ends at a distance of 51ft. The scanning depth was set to penetrate to 7 feet, in an effort to compensate for the 3 foot difference of the lower grade the tree is actually growing in.

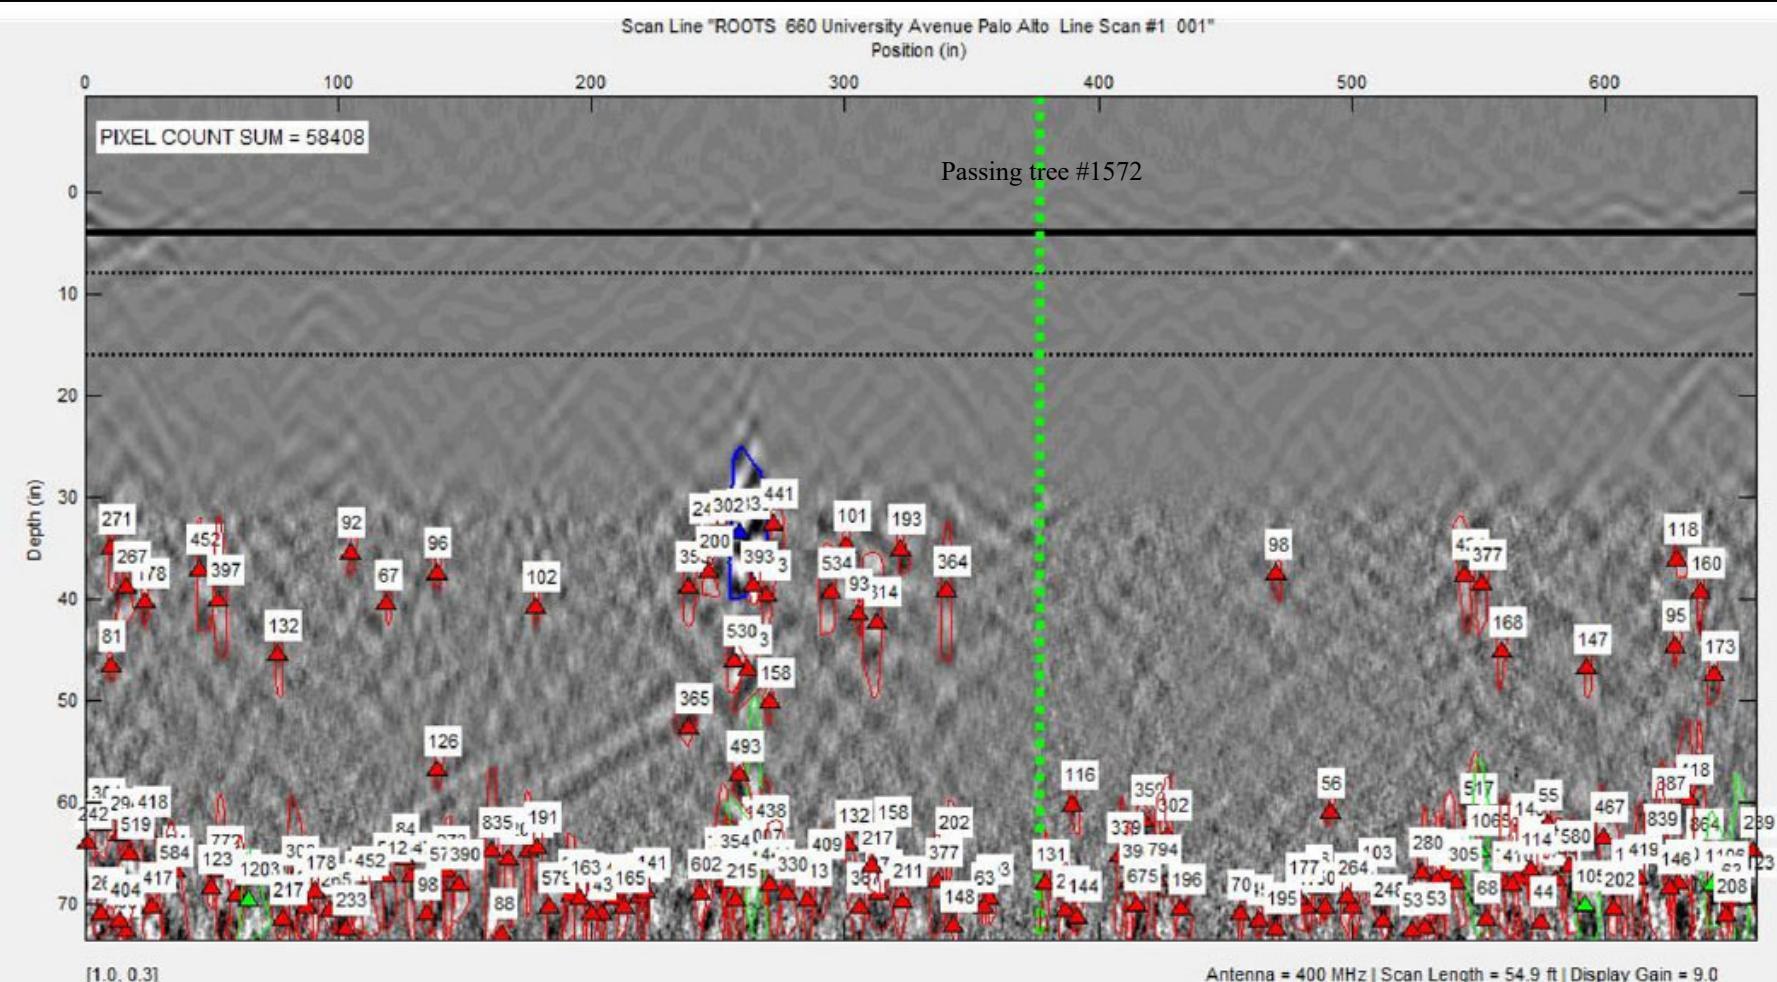
Scan #1 Root size estimate, Pixel count. The area inside each Area Shape Polygon reflection field, is determined by the number of pixels (related to root size) printed inside each white box. This will provide more insight as to individual root size estimates within each of the 3 size categories below.

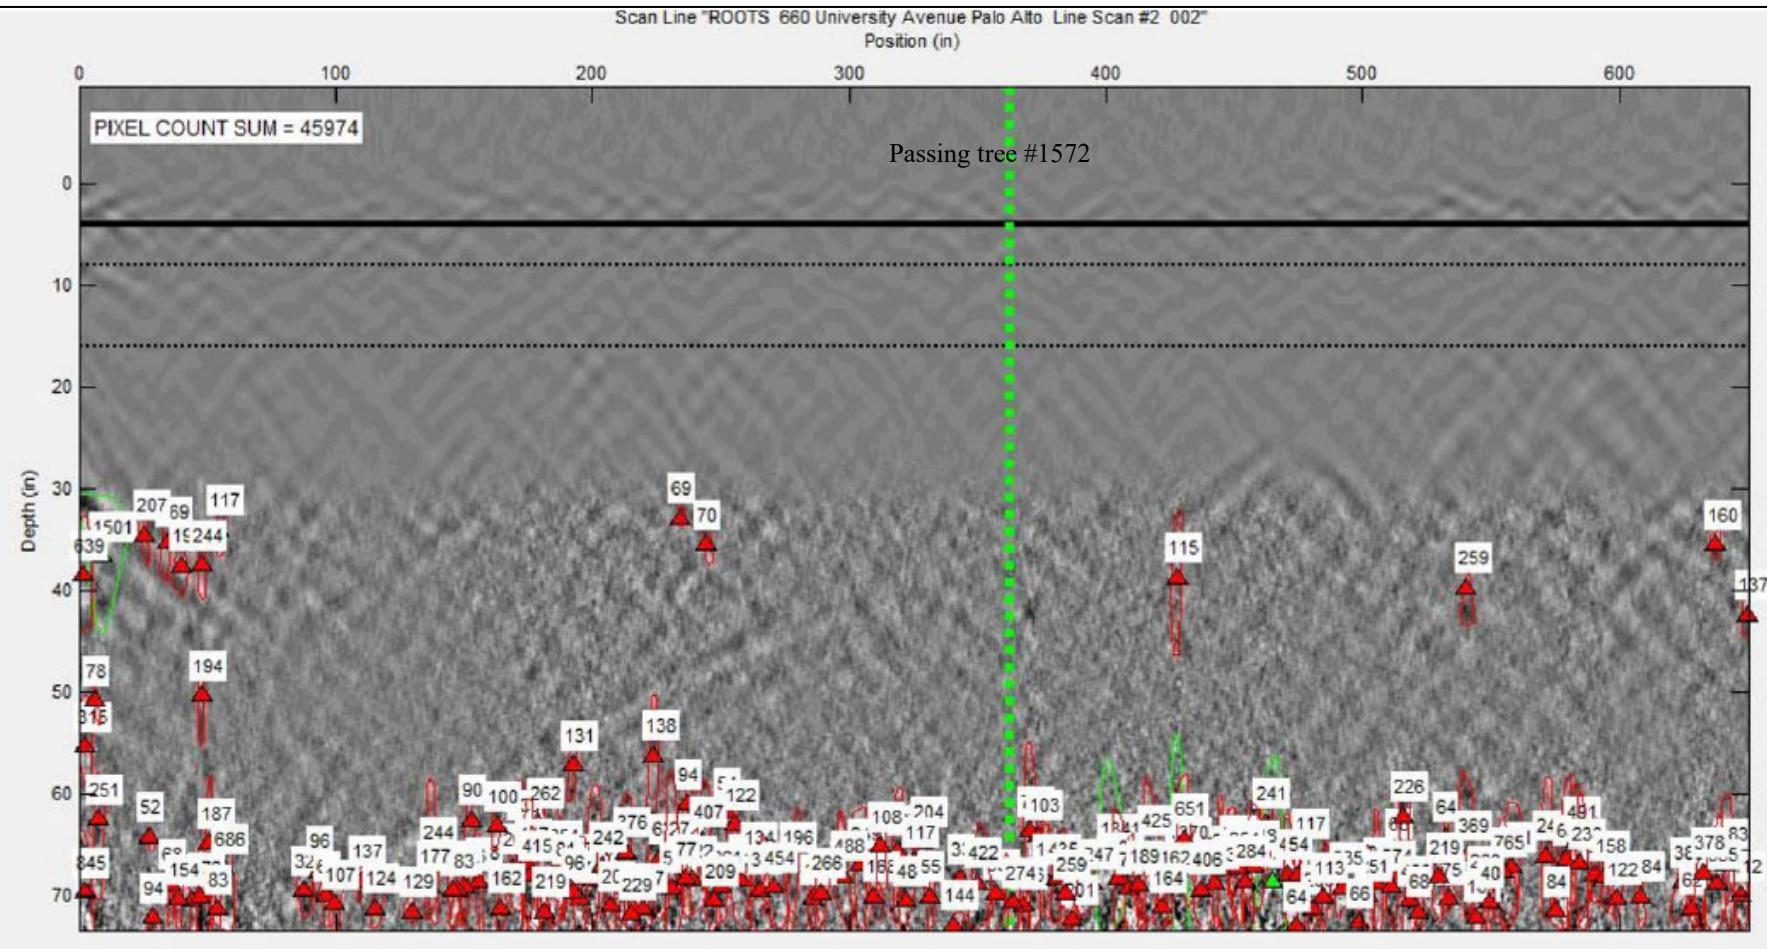
Scan #2 Root size estimate, Pixel count. The area inside each Area Shape Polygon reflection field, is determined by the number of pixels (related to root size) printed inside each white box. This will provide more insight as to individual root size estimates within each of the 3 size categories below.

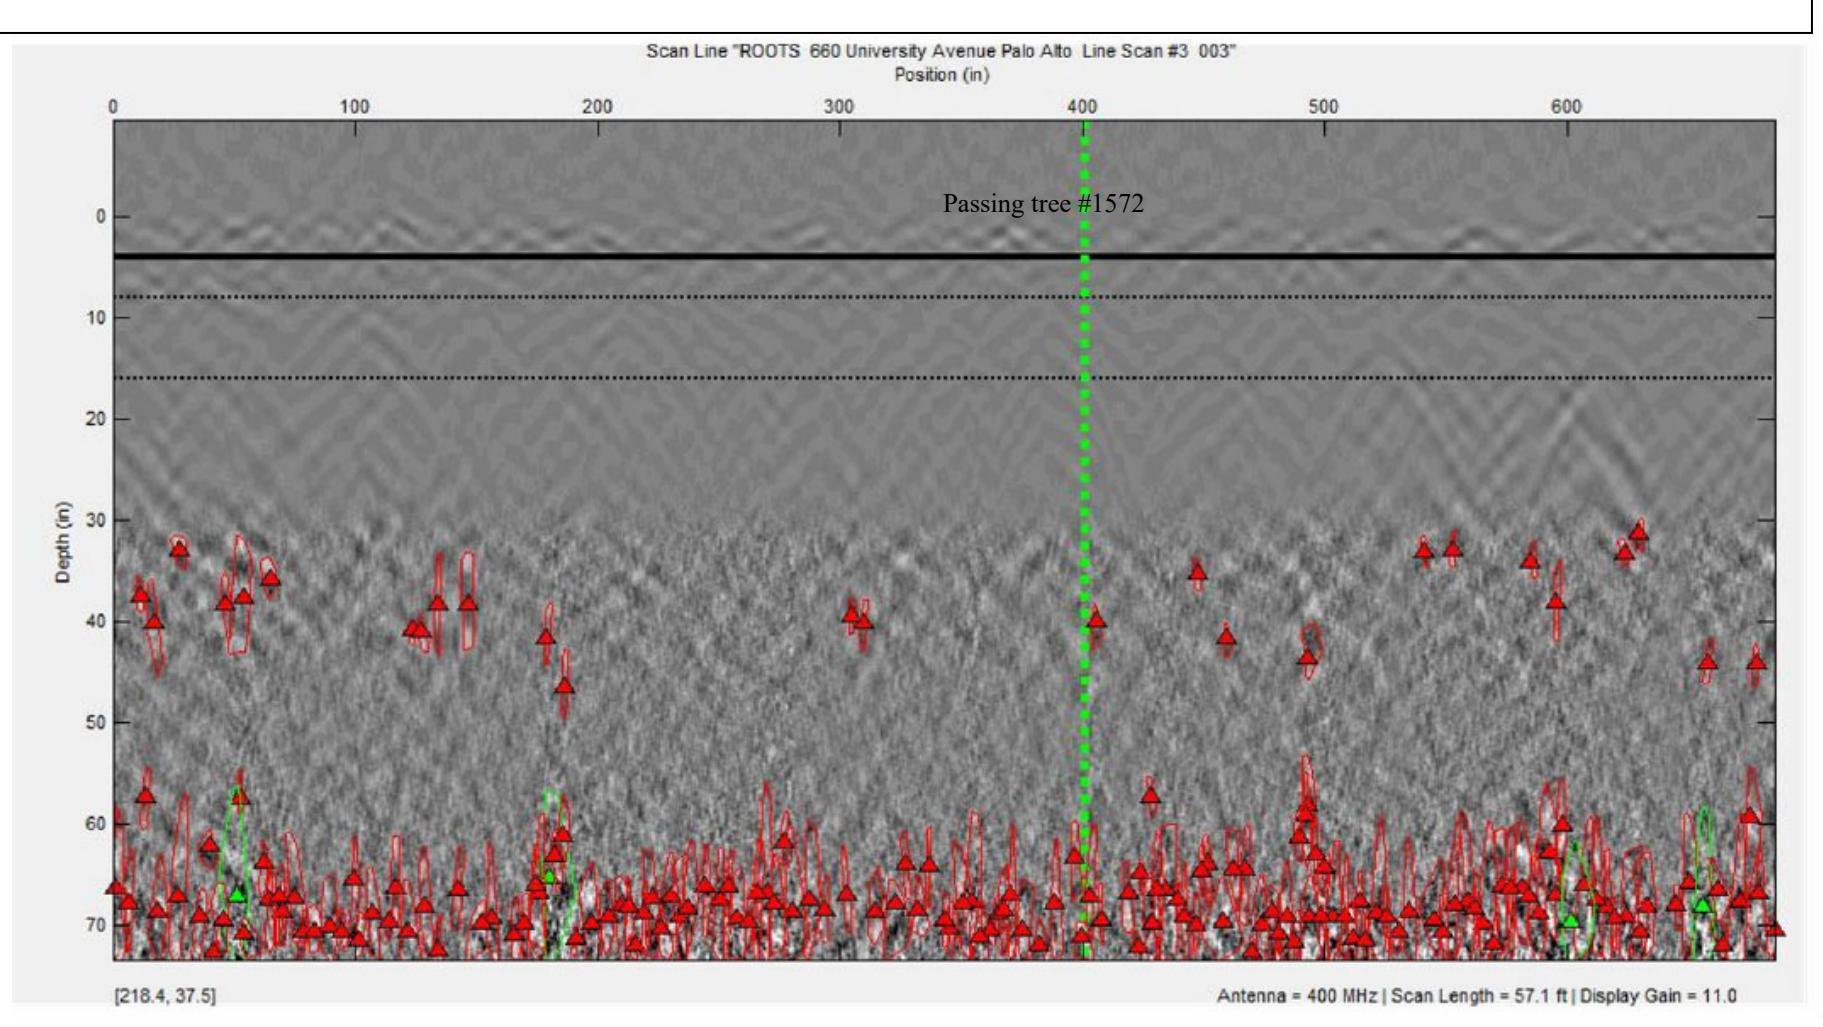
Scan #3 Root size estimate using Polygon region, reflection field size around root. Small Red 2.5 inches or less Medium Green 2.5 – 5 inches. Large Blue 5 inches and larger.

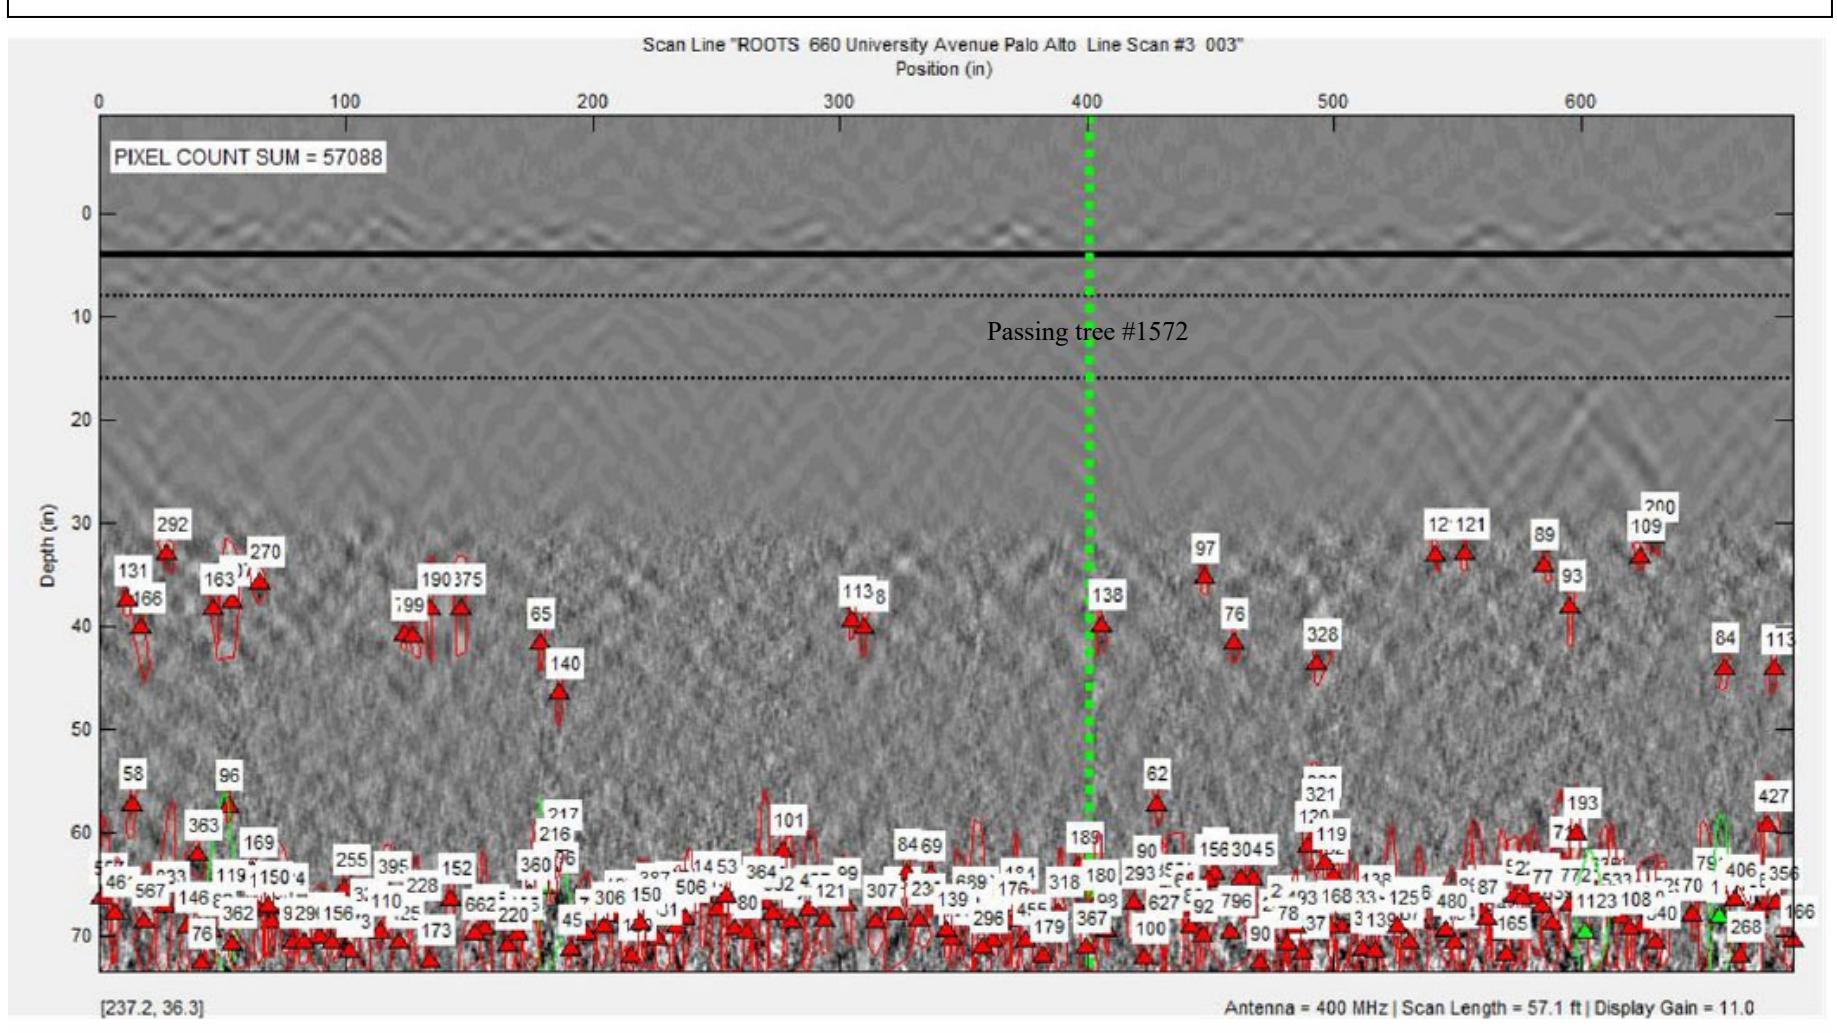
Scan #3 Root size estimate, Pixel count. The area inside each Area Shape Polygon reflection field, is determined by the number of pixels (related to root size) printed inside each white box. This will provide more insight as to individual root size estimates within each of the 3 size categories below.

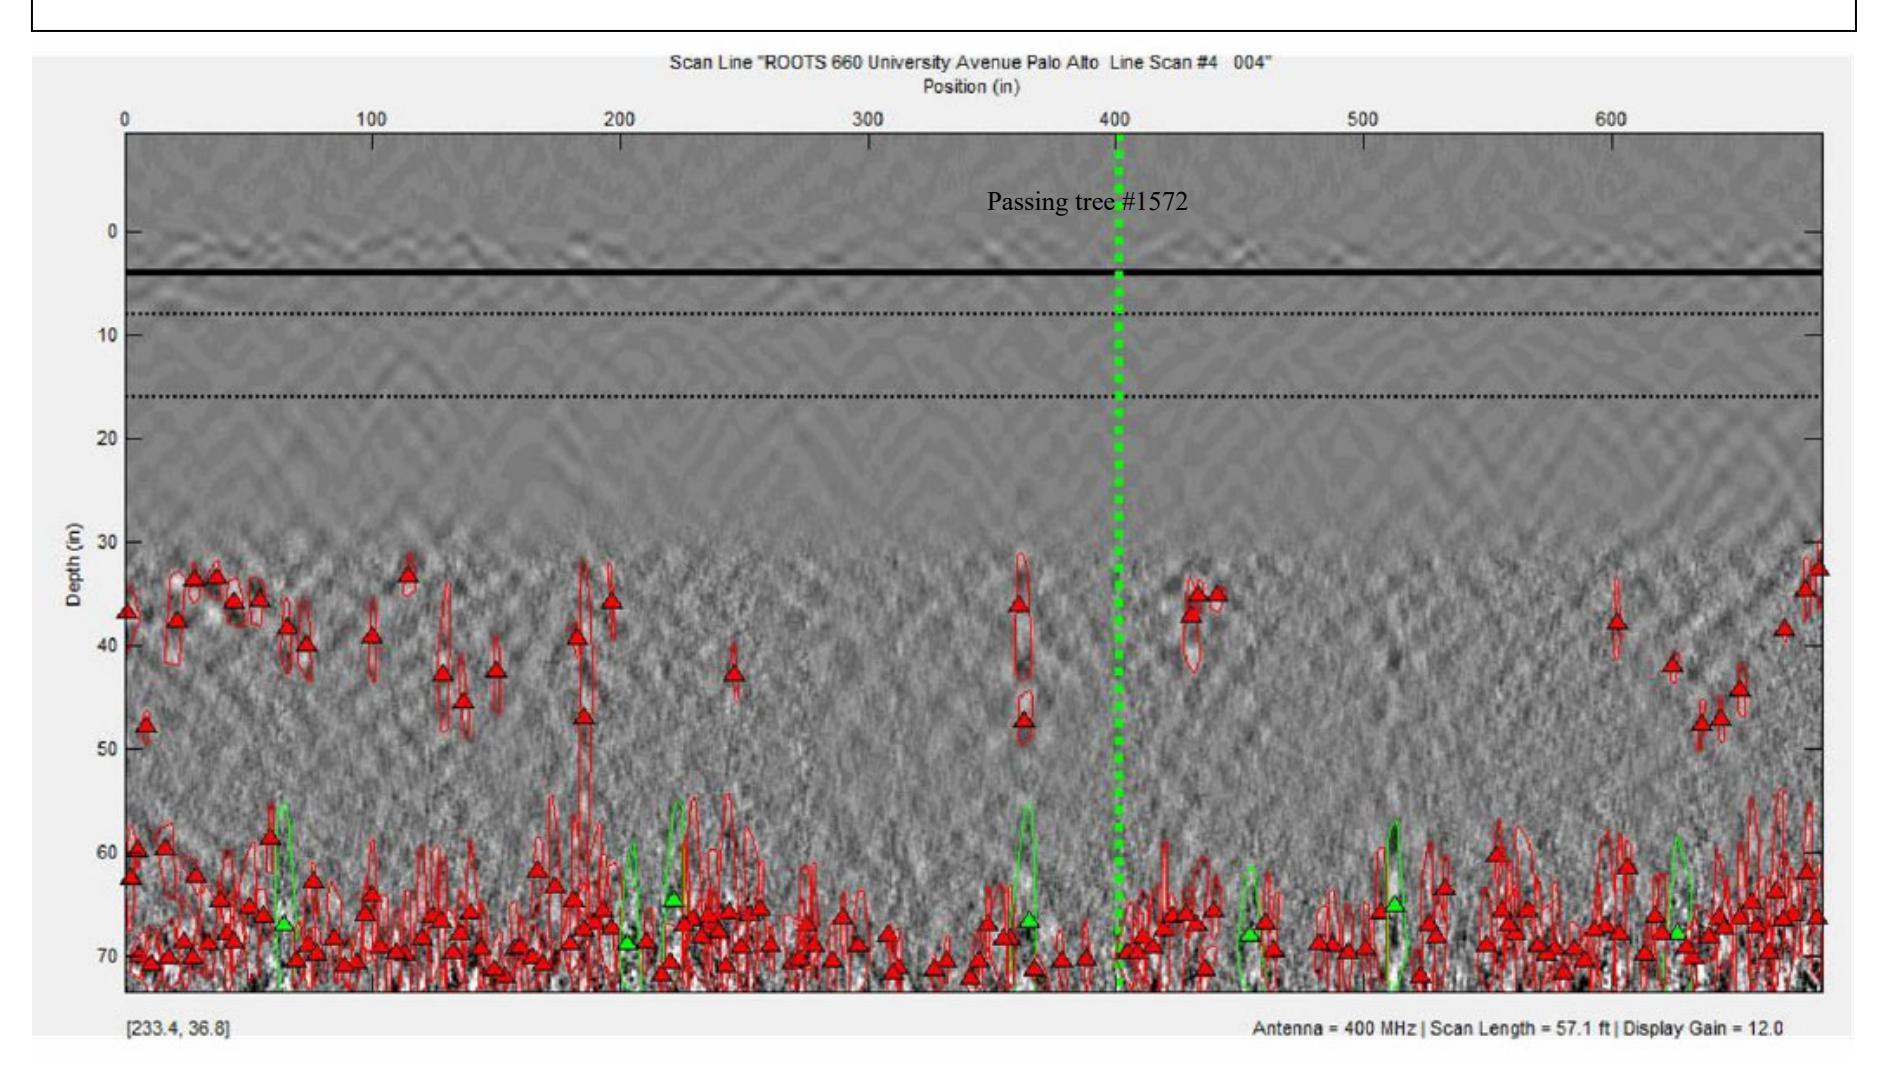
Scan #4 Root size estimate using Polygon region, reflection field size around root. Small Red 2.5 inches or less Medium Green 2.5 – 5 inches. Large Blue 5 inches and larger.

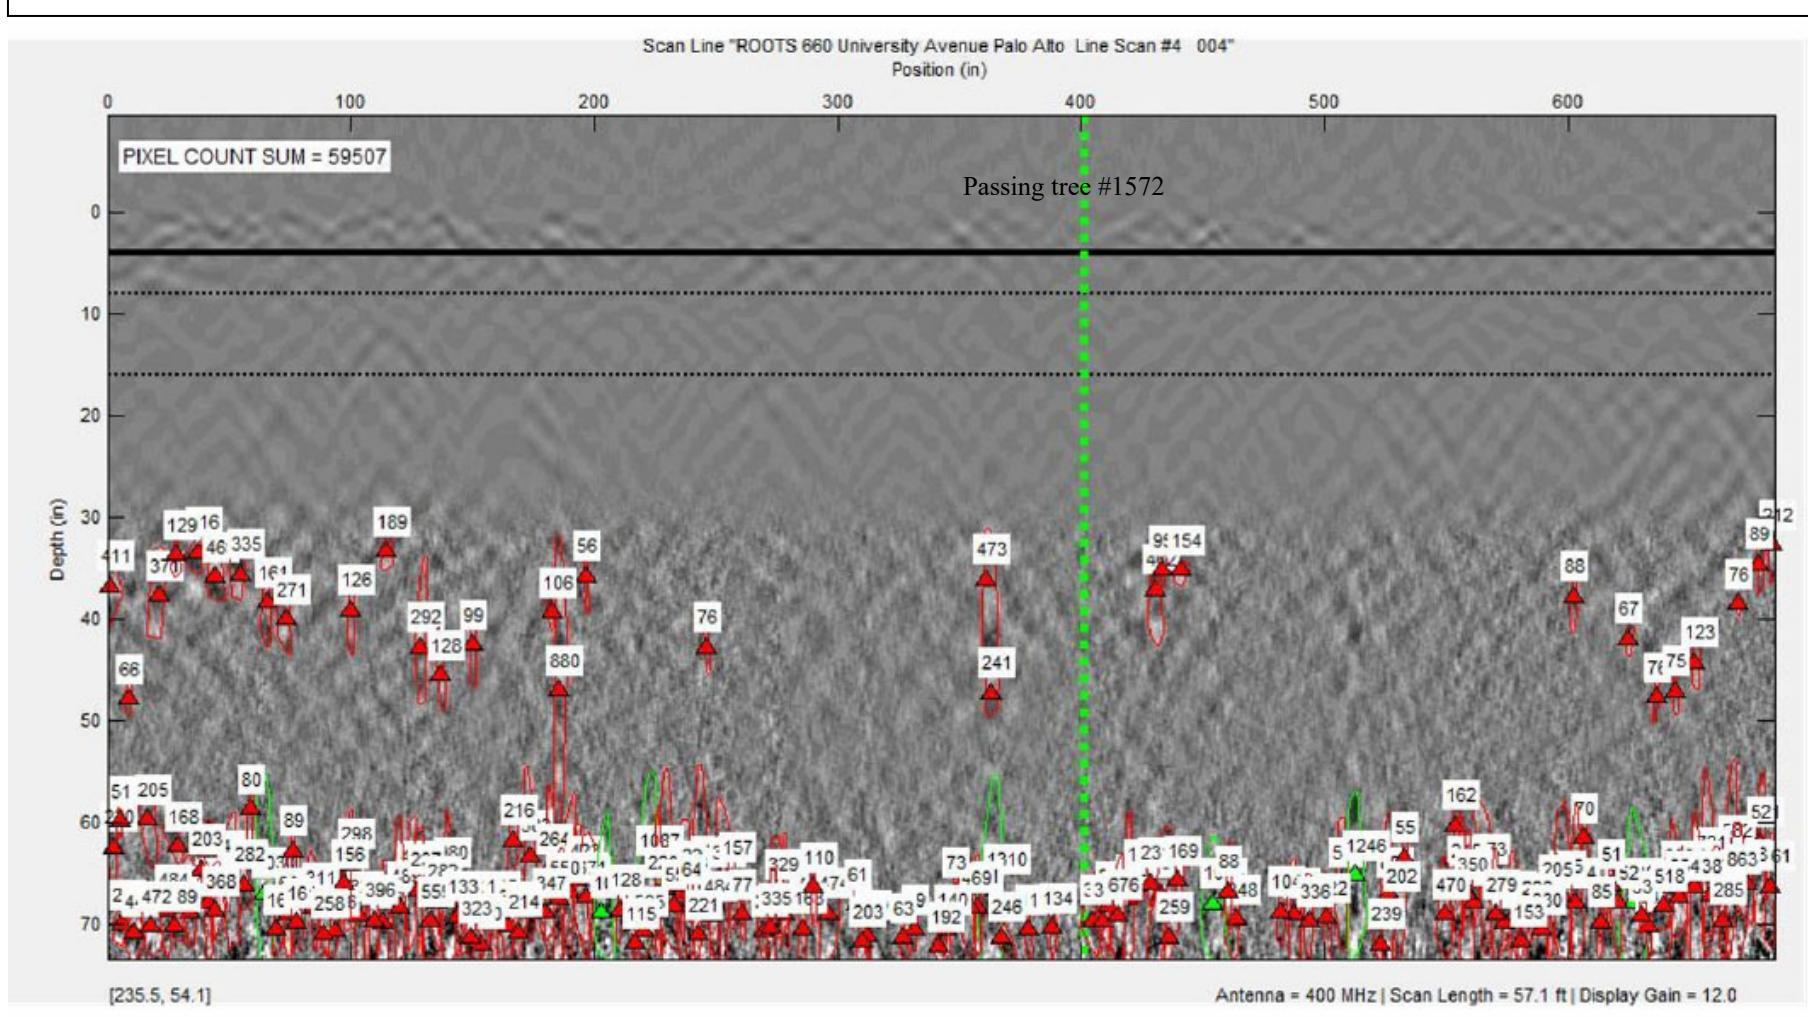
Scan #4 Root size estimate, Pixel count. The area inside each Area Shape Polygon reflection field, is determined by the number of pixels (related to root size) printed inside each white box. This will provide more insight as to individual root size estimates within each of the 3 size categories below.

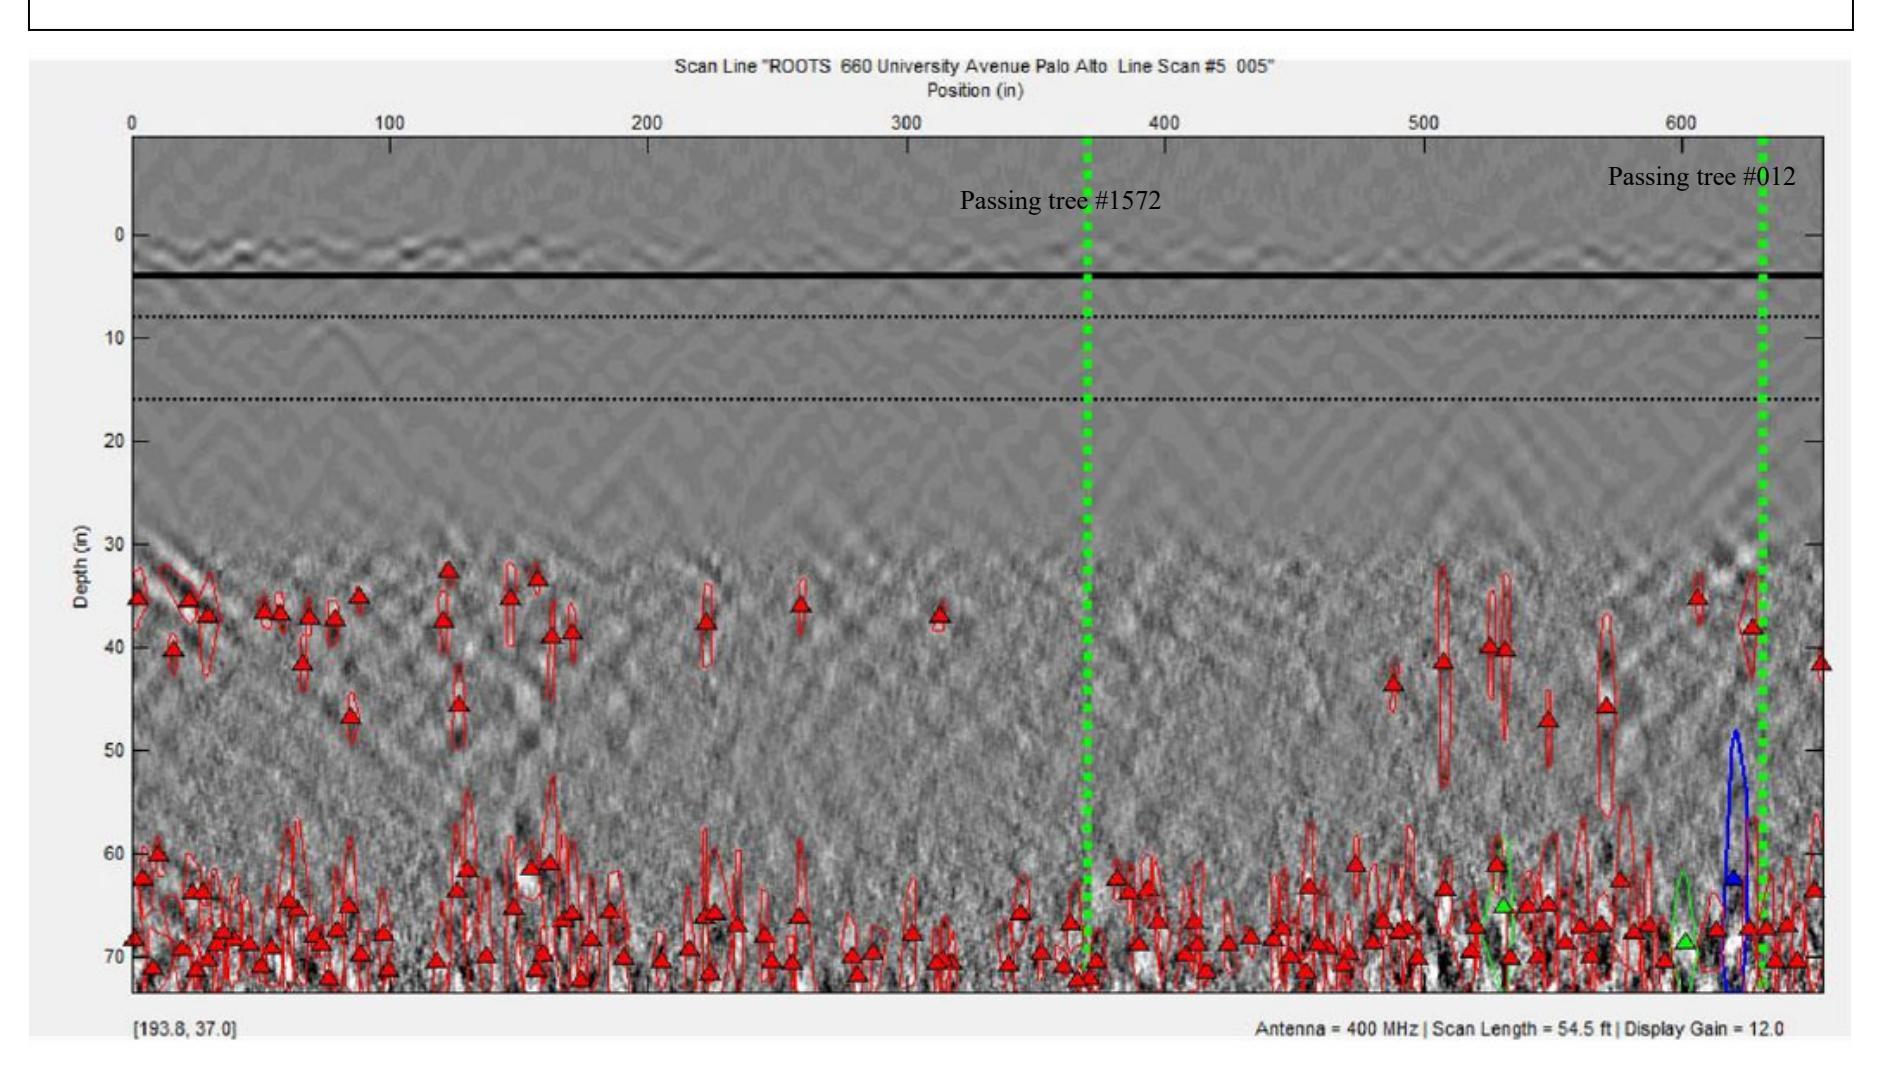
Scan #5 Root size estimate using Polygon region, reflection field size around root. Small Red 2.5 inches or less Medium Green 2.5 – 5 inches. Large Blue 5 inches and larger.

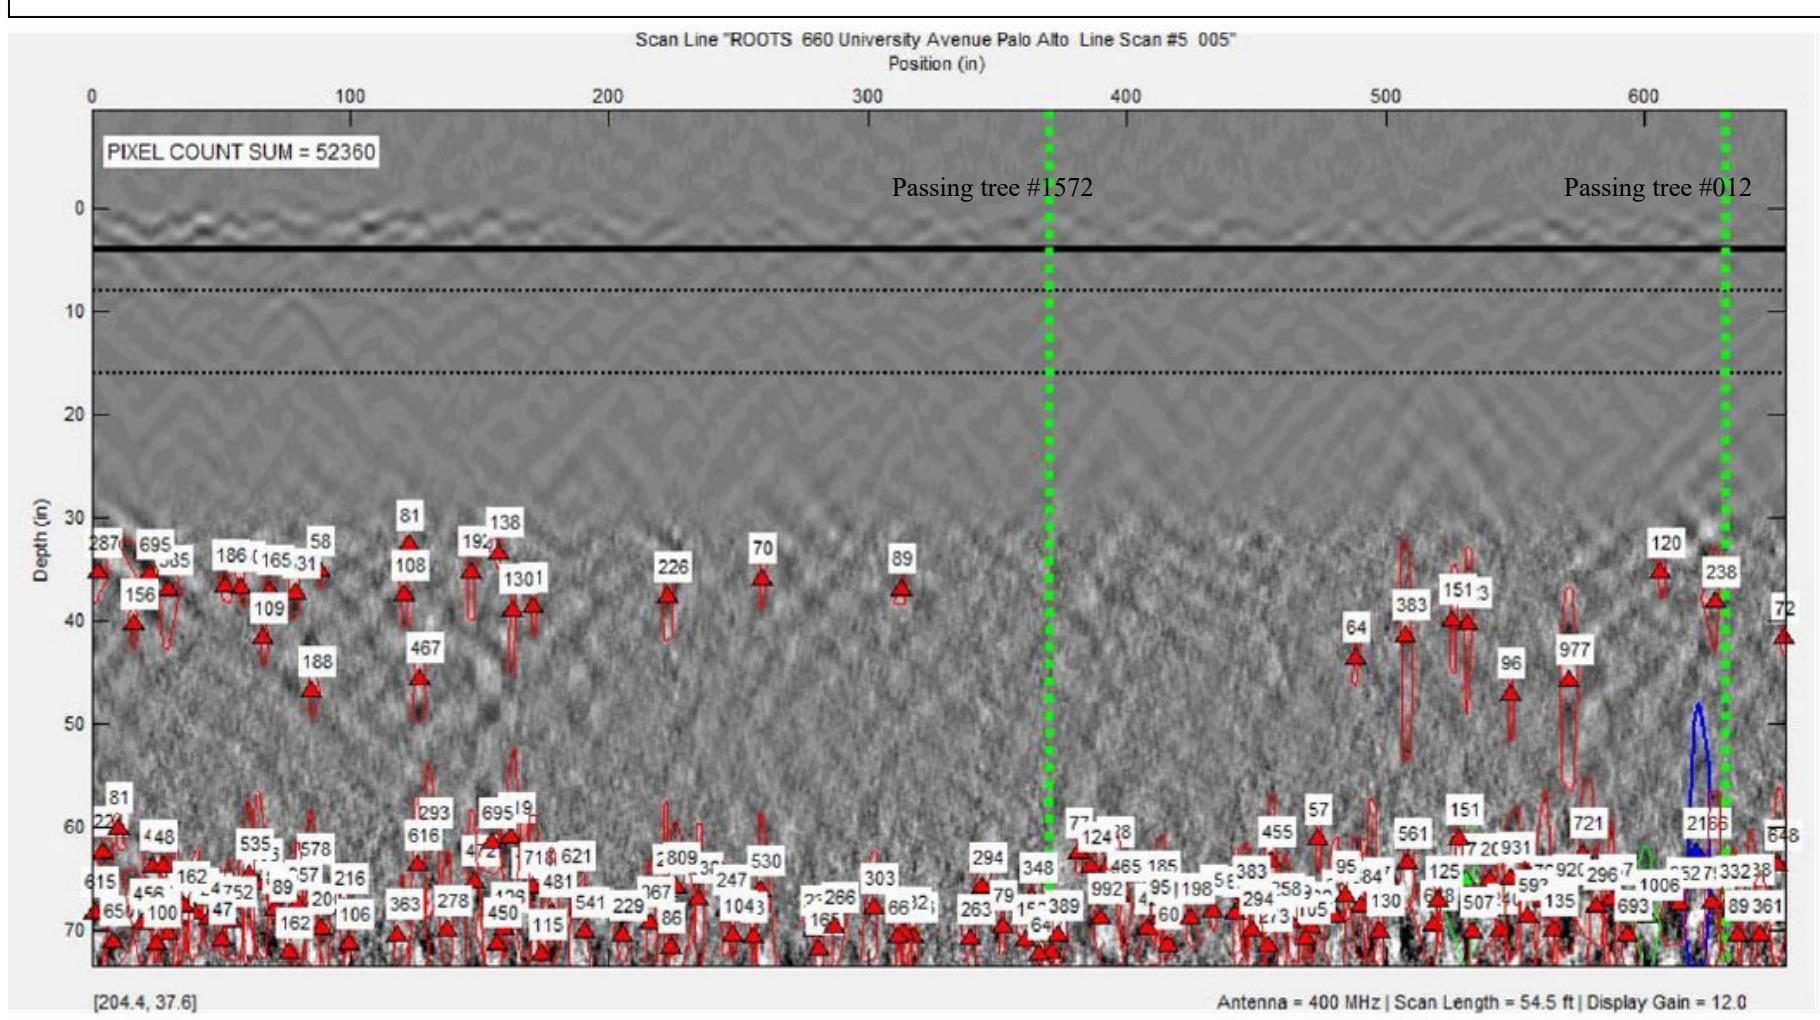
Scan #5 Root size estimate, Pixel count. The area inside each Area Shape Polygon reflection field, is determined by the number of pixels (related to root size) printed inside each white box. This will provide more insight as to individual root size estimates within each of the 3 size categories below.

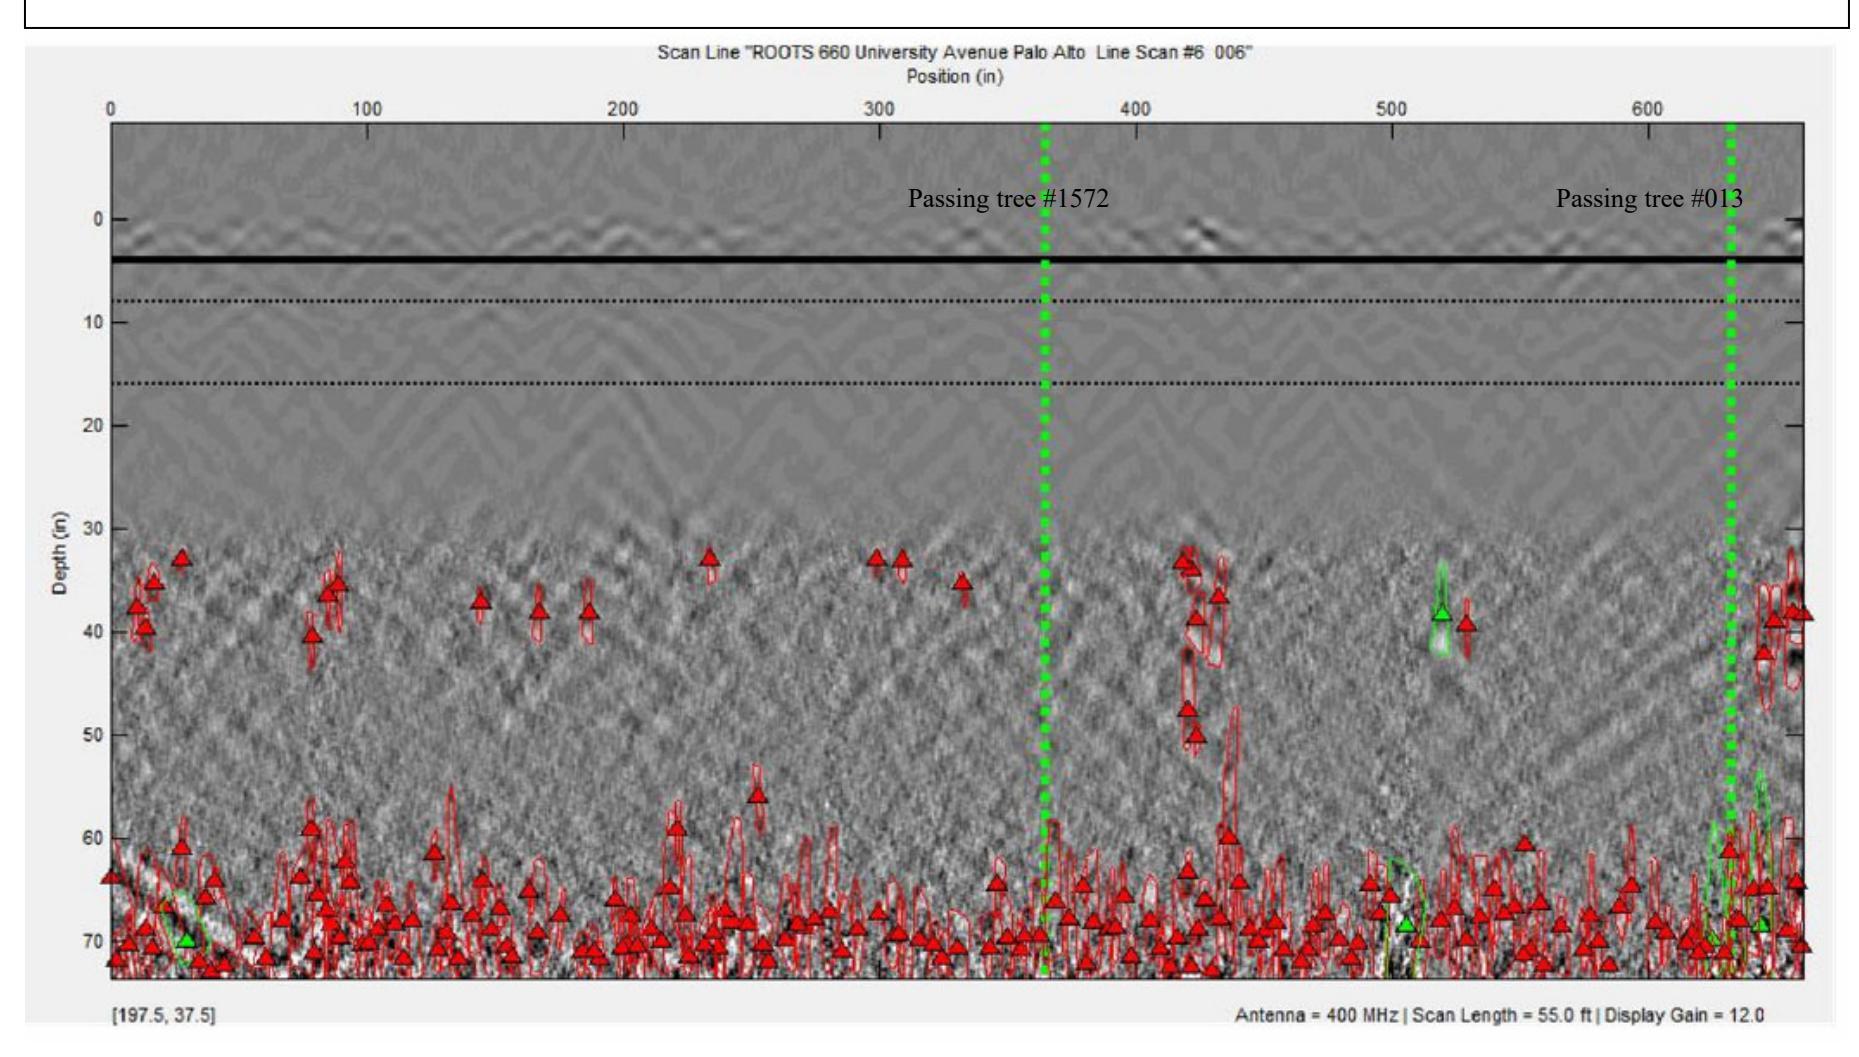
Scan #6 Root size estimate using Polygon region, reflection field size around root. Small Red 2.5 inches or less Medium Green 2.5 – 5 inches. Large Blue 5 inches and larger.
