GEOTECHNICAL INVESTIGATION

CUBBERLEY COMMUNITY CENTER
RESTROOM BUILDING
4000 MIDDLEFIELD ROAD
PALO ALTO, CALIFORNIA 94303

Prepared for
City of Palo Alto
Public Works Department
250 Hamilton Avenue
Palo Alto, California 94301

May 2018

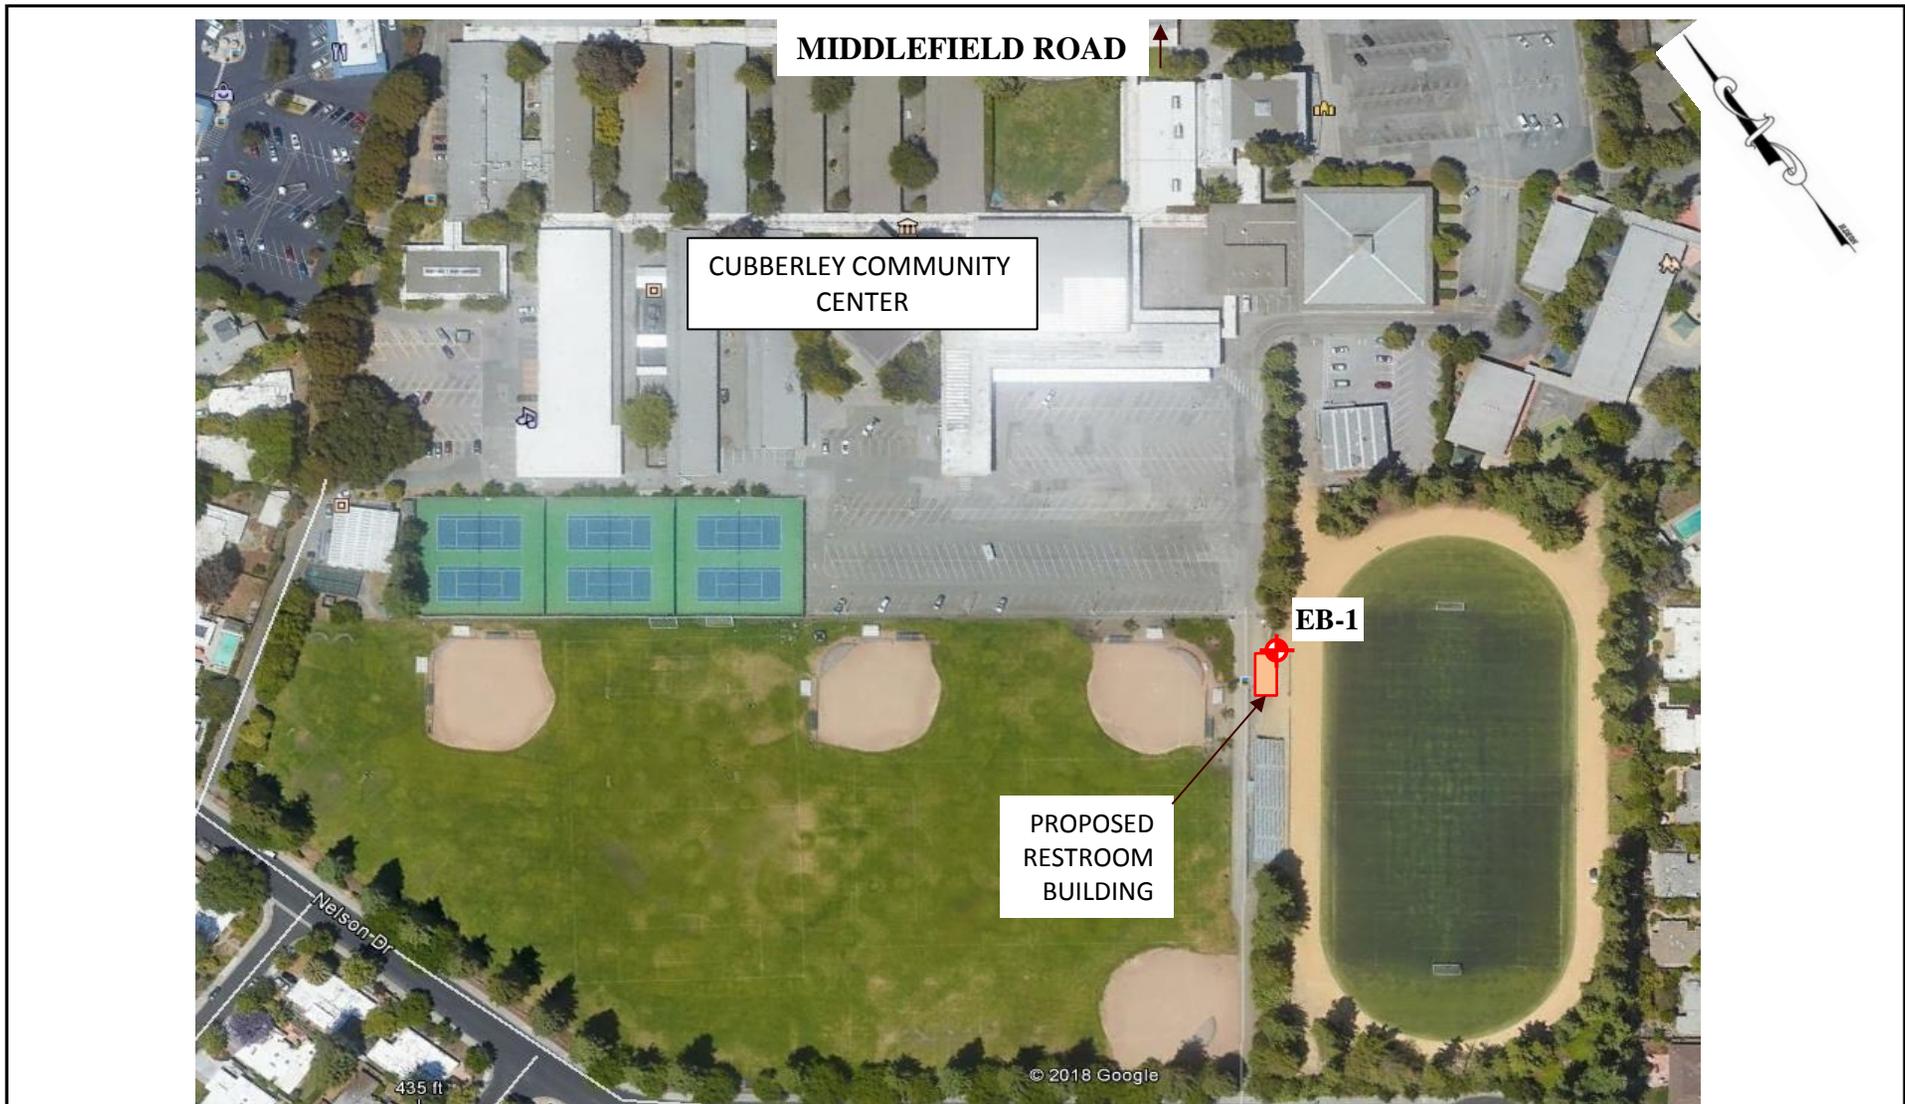
FIGURE 2
MAY 2018
PROJECT NO. 2520-3

EB-1

Site reconnaissance and subsurface exploration were performed on April 27, 2018, using hand-auger and sampling equipment. A sample of near surface soil was collected from a shallow boring at the approximate location of the building. One soil sample was collected from a depth of 1.5 to 2 feet below existing grade. The location of hand-sampled boring is shown on the Site Plan, Figure 2. The boring log and the results of our laboratory tests are attached in Appendices A and B, respectively.

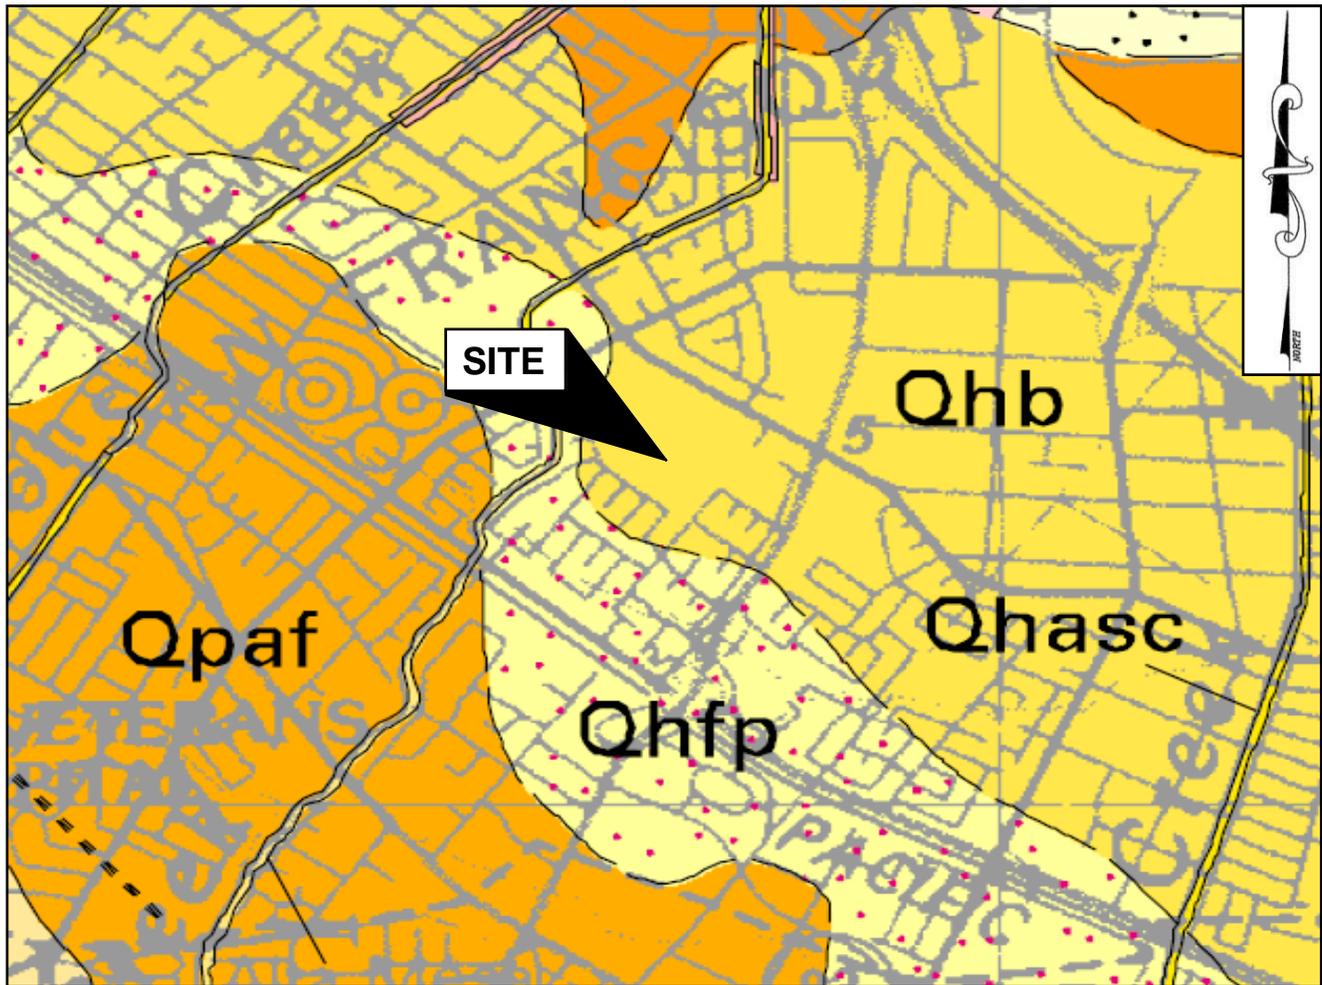
FIGURE 3
MAY 2018
PROJECT NO. 2520-3

VICINITY GEOLOGIC MAP
CUBBERLEY COMMUNITY CENTER RESTROOM BUILDING
PALO ALTO, CALIFORNIA

We have briefly reviewed our local experience and geologic literature pertinent to the area of the site. The information that we reviewed for this study indicates the site is underlain by Holocene-age basin deposits, Qhb (Brabb, Graymer and Jones, 2000). These deposits are generally expected to consist of firm to stiff, fine silty clay to clay with interbeds of medium dense sand at the edge of alluvial fans between floodplain deposits and soft Bay Mud. The geology of the site vicinity is shown on the Vicinity Geologic Map, Figure 3.

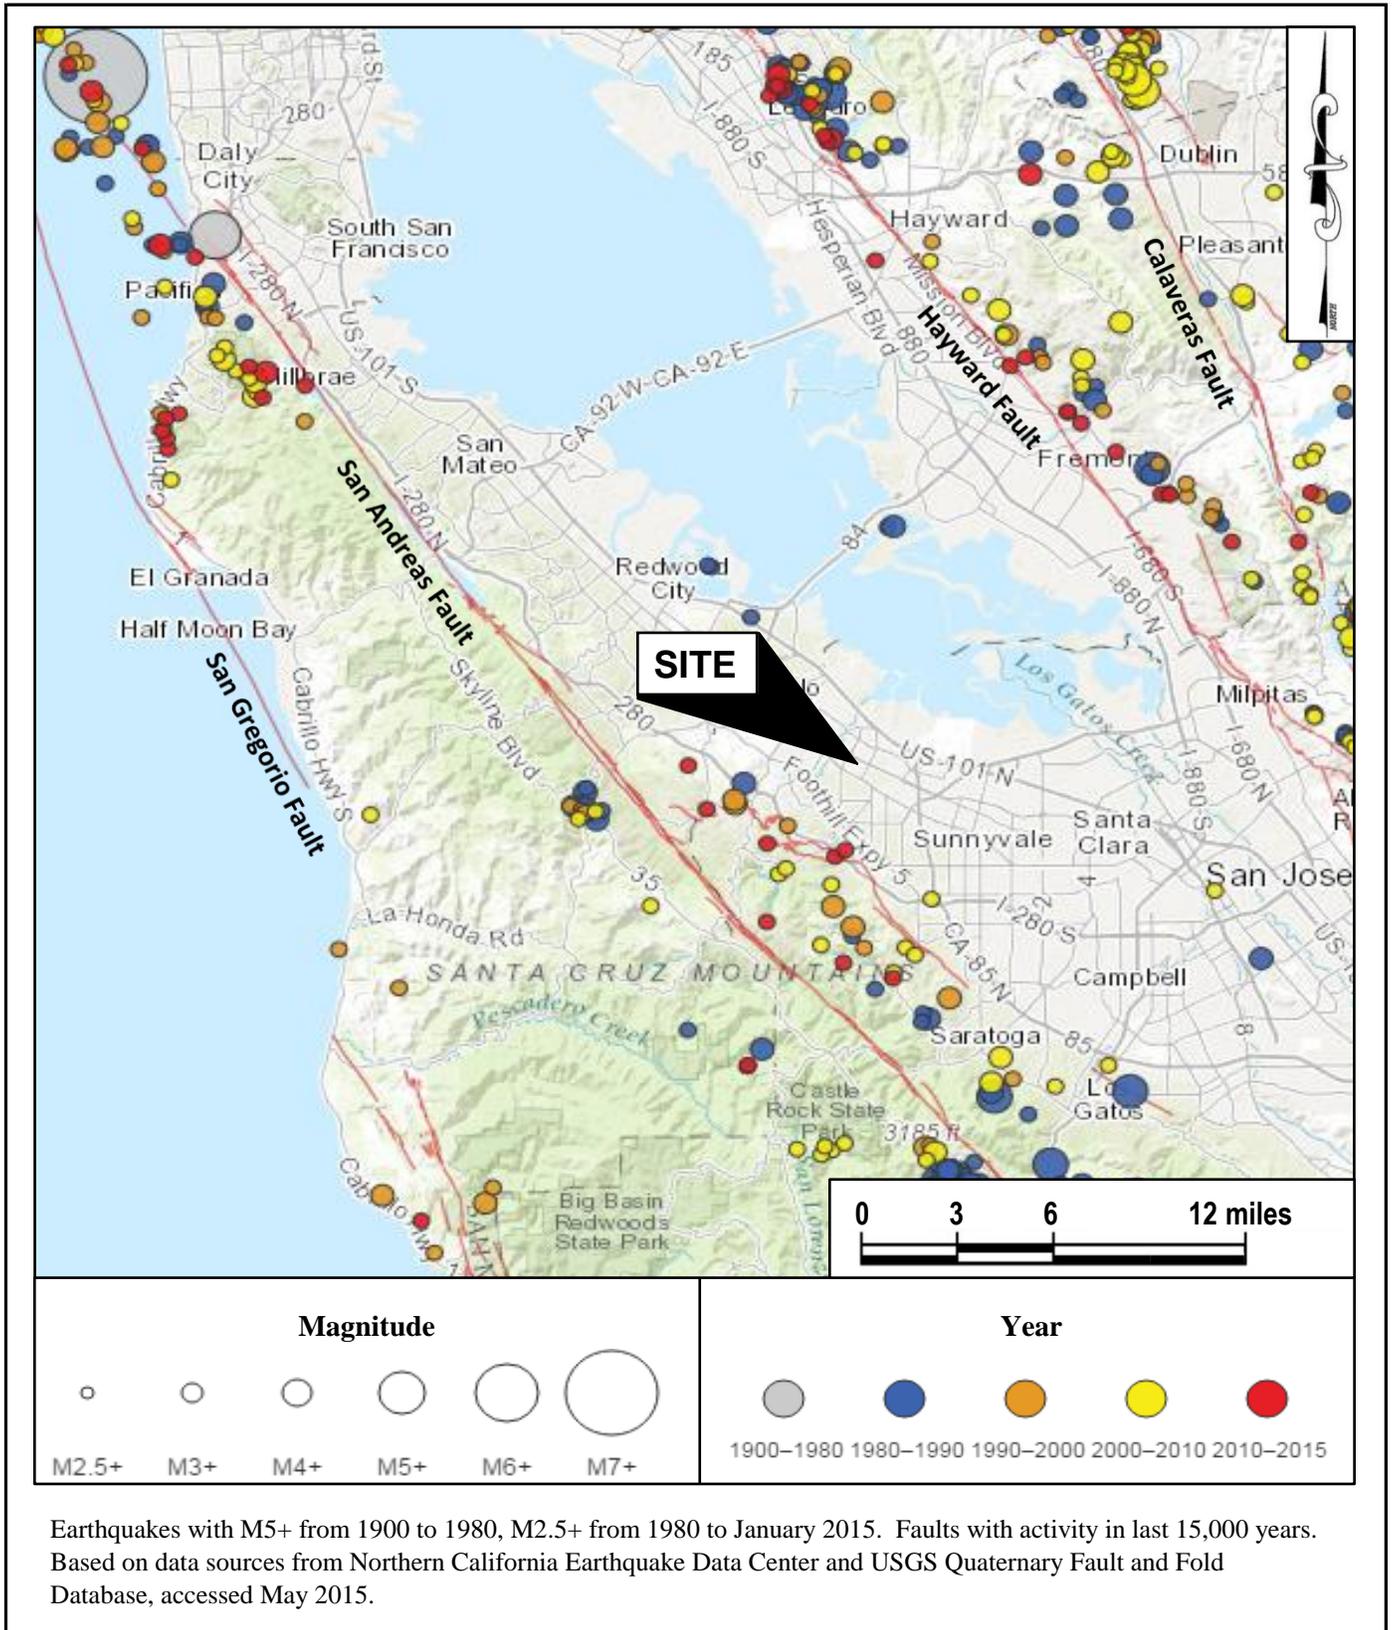
FIGURE 4
MAY 2018
PROJECT NO. 2520-3

REGIONAL FAULT AND SEISMICITY MAP
CUBBERLEY COMMUNITY CENTER RESTROOM BUILDING
PALO ALTO, CALIFORNIA

The San Francisco Bay Area is, however, an active seismic region. Earthquakes in the region result from strain energy constantly accumulating because of the northwestward movement of the Pacific Plate relative to the North American Plate. On average about 1.6-inches of movement occur per year. Historically, the Bay Area has experienced large, destructive earthquakes in 1838, 1868, 1906 and 1989. The faults considered most likely to produce large earthquakes in the area include the San Andreas, San Gregorio, Hayward, and Calaveras faults. The San Gregorio fault is located approximately 18 miles southwest of the site. The Hayward and Calaveras faults are located approximately 12 and 17 miles northeast of the site, respectively. These faults and significant earthquakes that have been documented in the Bay Area are listed in Table 1 on the following page and are shown on the Regional Fault and Seismicity Map, Figure 4.

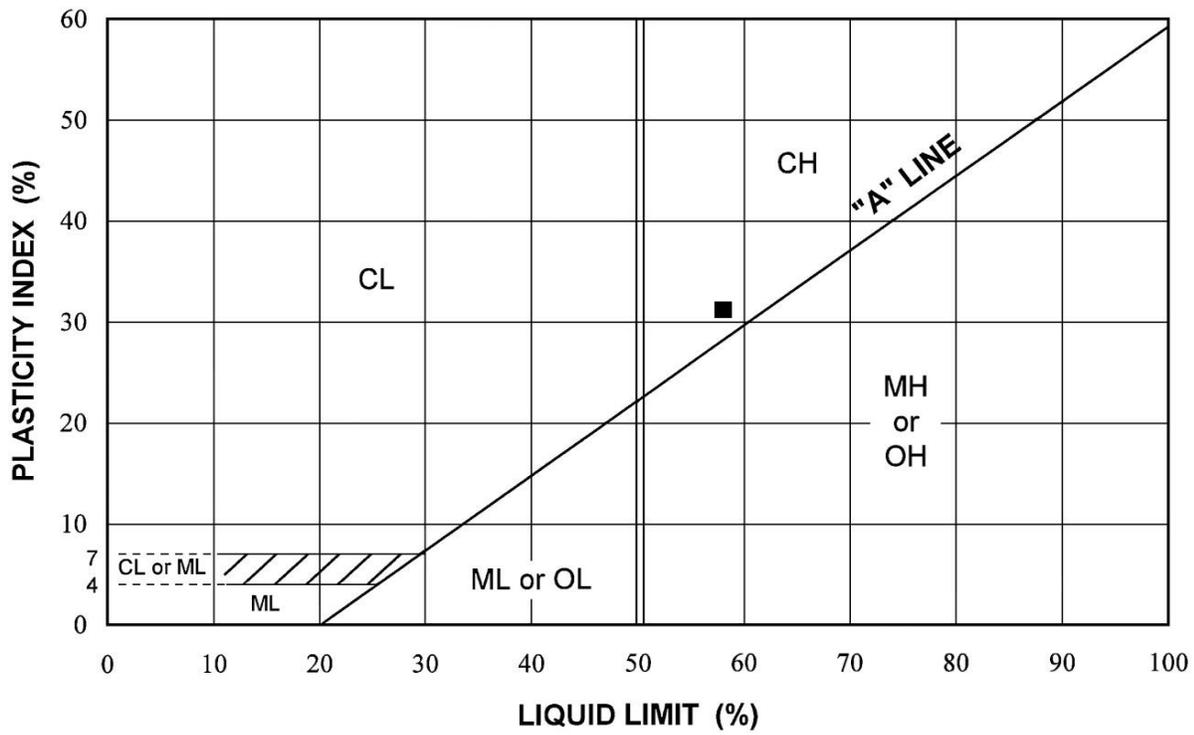
Chart Symbol	Boring Number	Sample Depth (feet)	Water Content (percent)	Liquid Limit (percent)	Plasticity Index (percent)	Liquidity Index (percent)	Passing No. 200 Sieve (percent)	USCS Soil Classification
■	EB-1	0-1	16	58	31		-35	CH

PLASTICITY CHART
 CUBBERLEY COMMUNITY CENTER RESTROOM BUILDING
 PALO ALTO, CALIFORNIA

The Atterberg Limits were determined on one sample of soil in accordance with ASTM D4318. The Atterberg limits are the moisture content within which the soil is workable or plastic. The results of this test are presented in Figure B-1 and on the boring log at the appropriate sample depth.
