# City of Palo Alto

## City Council Staff Report

**Summary Title: Appeal of a Director's Interpretation Regarding Seismic Rehabilitation**

**Title: Consideration of an Appeal of a Director's Interpretation Made Pursuant to Palo Alto Municipal Code Section 18.01.025 and Related to Seismic Rehabilitation. The Project is Exempt from the California Environmental Quality Act (CEQA) in Accordance With CEQA Guidelines 15061(b)(3).**

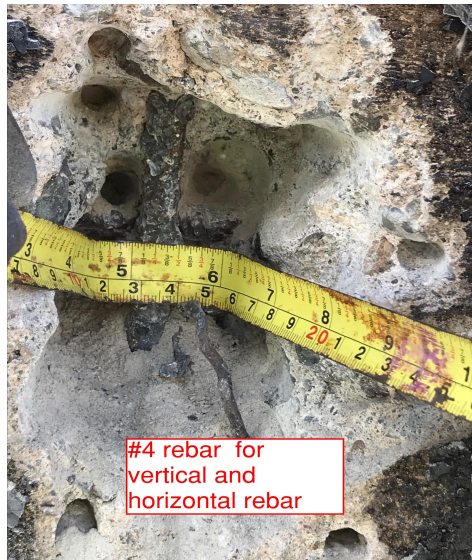
*Rebar size for S1 location*
