GEOTECHNICAL INVESTIGATION PROPOSED BUENA VISTA MOBILE HOME PARK REDEVELOPMENT 3980 EL CAMINO REAL Palo Alto, California

May 22, 2023 Project No. 23-2398

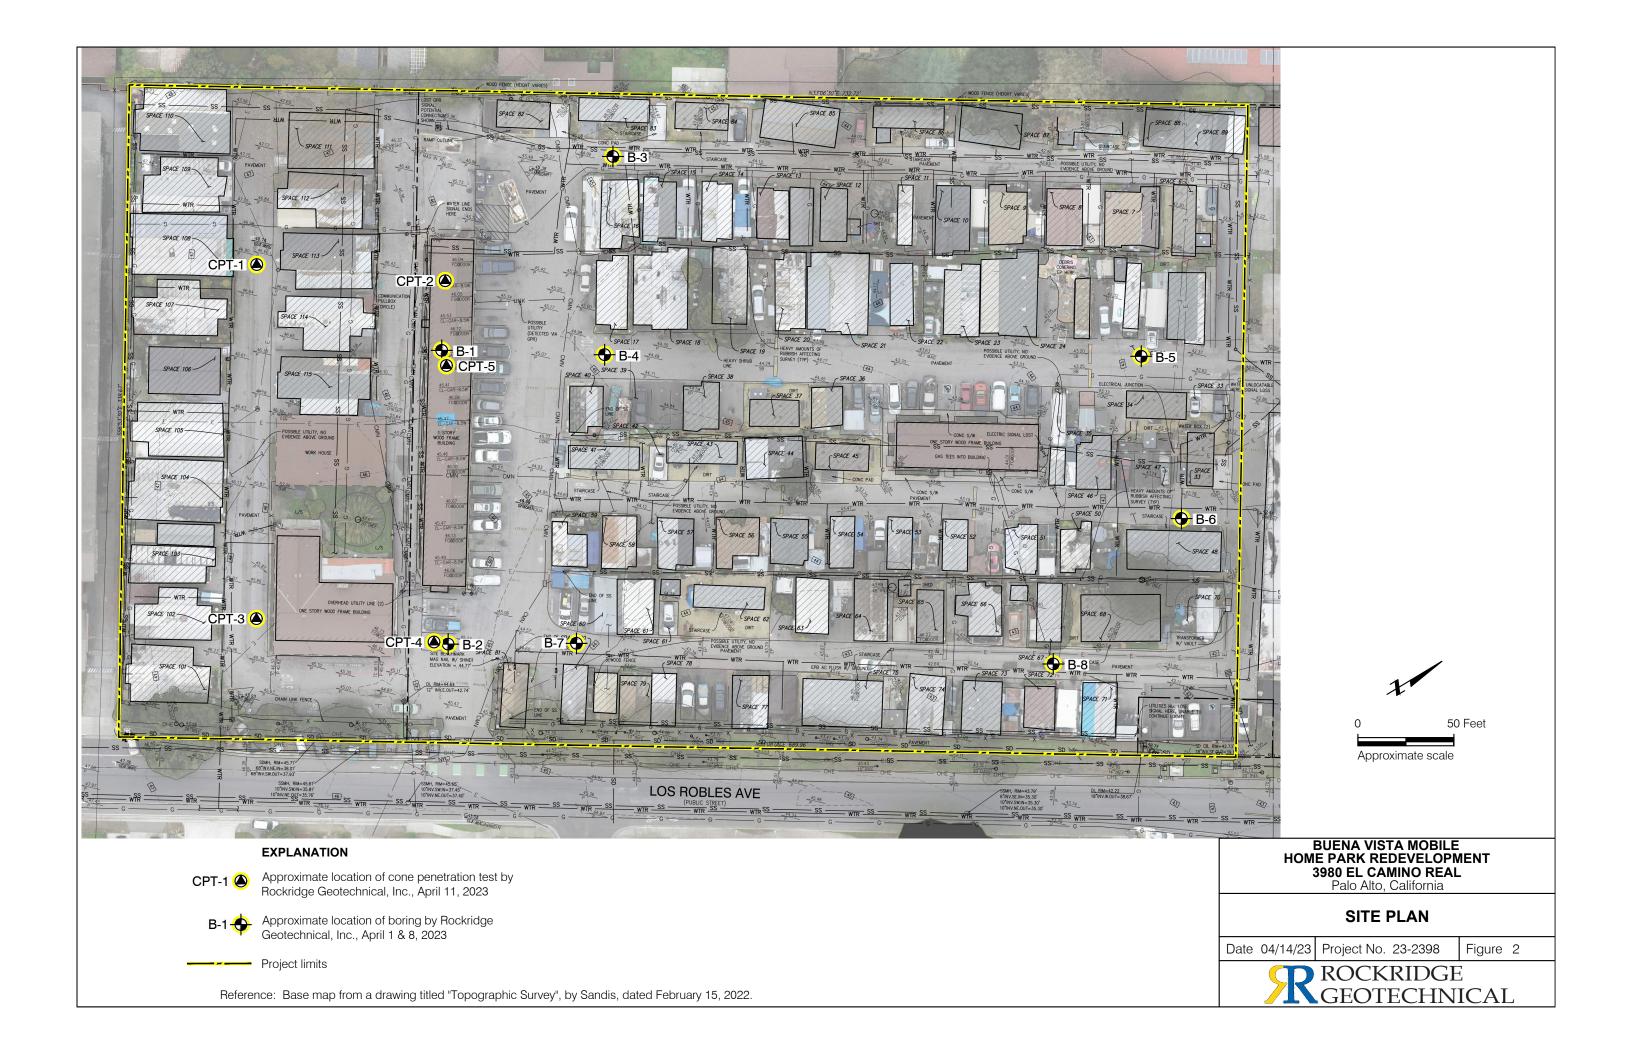
The project site is a relatively level, rectangular-shaped lot with plan dimensions of approximately 350 feet by 720 feet, as shown on the Site Plan (Figure 2). It is bordered by commercial buildings to the northeast, Los Robles Avenue to the southeast, and single-family residences to the northwest and southwest. The site is currently occupied by the Buena Vista Mobile Home Park, which consists of at least 117 mobile home spaces, as well as various RVs and a single-family home. Other improvements at the site include internal streets and parking areas. A motel that previously occupied a portion of the property was recently demolished.

We investigated the subsurface conditions beneath the site by performing five CPTs, drilling eight test borings, and performing laboratory tests on selected soil samples. The approximate locations of the CPTs and borings are shown on Figure 2. Prior to our field investigation, we obtained a drilling permit from Santa Clara Valley Water District (SCVWD). We also contacted Underground Service Alert (USA) to notify them of our work, as required by law, and retained

Eight test borings, designated as Boring B-1 through B-8, were drilled on April 1 and 8, 2023, by Exploration Geoservices, Inc. of San Jose, California, at the approximate locations shown on Figure 2. The borings drilled on April 1 (B-1 and B-2) were drilled to depths of 40 feet bgs using a Mobile B-53 truck-mounted drill rig. The borings drilled on April 8 were drilled to depths of 15 to 20 feet bgs using a Mobile B-40 truck-mounted drill rig. Both drill rigs were equipped with 8-inch-outside-diameter hollow-stem flight augers. During drilling, our field engineer logged the

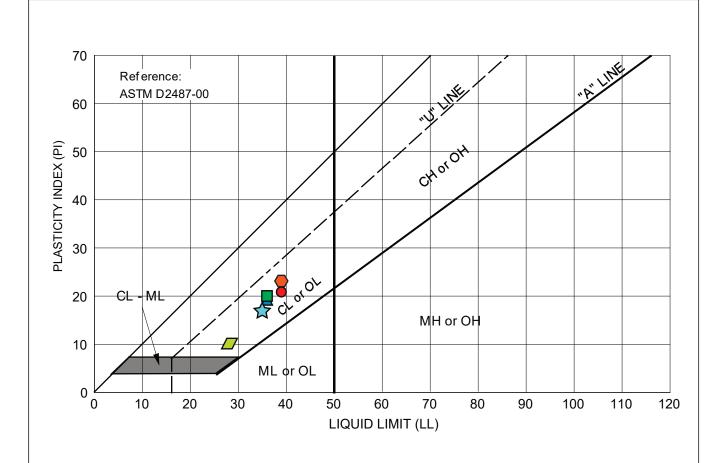
Date 05/02/23 Project No. 23-2398 Figure B-1

Symbol	Source	Description and Classification	Natural M.C. (%)	Liquid Limit (%)	Plasticity Index (%)	% Passing #200 Sieve
•	B-1 at 2.8 feet	SANDY CLAY (CL), brown to dark brown	14.2	39	21	
A	B-1 at 5.5 feet	SANDY CLAY (CL), brown	15.5	36	19	
	B-2 at 3.0 feet	SANDY CLAY (CL), dark brown	9.8	36	20	
•	B-2 at 14.5 feet	SANDY CLAY (CL), yellow-brown	21.1	39	23	
\Rightarrow	B-4 at 2.0 feet	SANDY CLAY (CL), dark brown with red	12.0	35	17	
	B-5 at 9.0 feet	CLAYEY SAND (SC), red-yellow	12.3	28	10	39

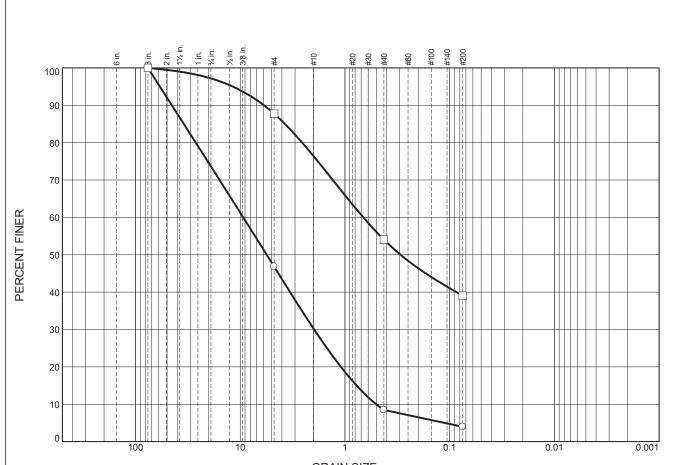
(<u> 3RAIN SIZE :</u>	· mm.		
	0/ 19!!	% G	ravel		% San	d	% Fines	
	% +3"	Coarse	Fine	Coarse	Medium	Fine	Silt	Clay
0	0.0	26.4	26.8	16.5	21.8	4.5	4.0	
	0.0	2.8	9.4	11.4	22.3	15.1	39.0

SOIL DATA	
SYMBOL	SOURCE	DEPTH (ft.)	Material Description	uscs
0	B-4	14.0'	GRAVEL with SAND, brown	GP
	B-5	9.0'	CLAYEY SAND, red-yellow	SC

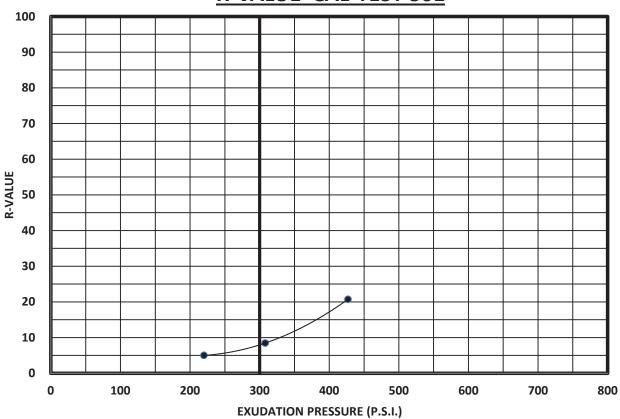
Sample Description: SANDY CLAY (CL) dark brown

R-VALUE CAL-TEST 301

Exudation (psi)	Compaction (psi)	Expansion (0.0001")	Expansion (psf)	Moisture %	Dry Density	Resistance Value
427	185	11	48	13.7	124.1	21
308	147	0	0	15.4	120.5	8
220	137	0	0	17.6	114.6	5

Resistance Value
7
