Storm Drain Master Plan Update

June 2015

Public Works Department/Engineering Services Division

Schaaf & Wheeler CONSULTING CIVIL ENGINEERS

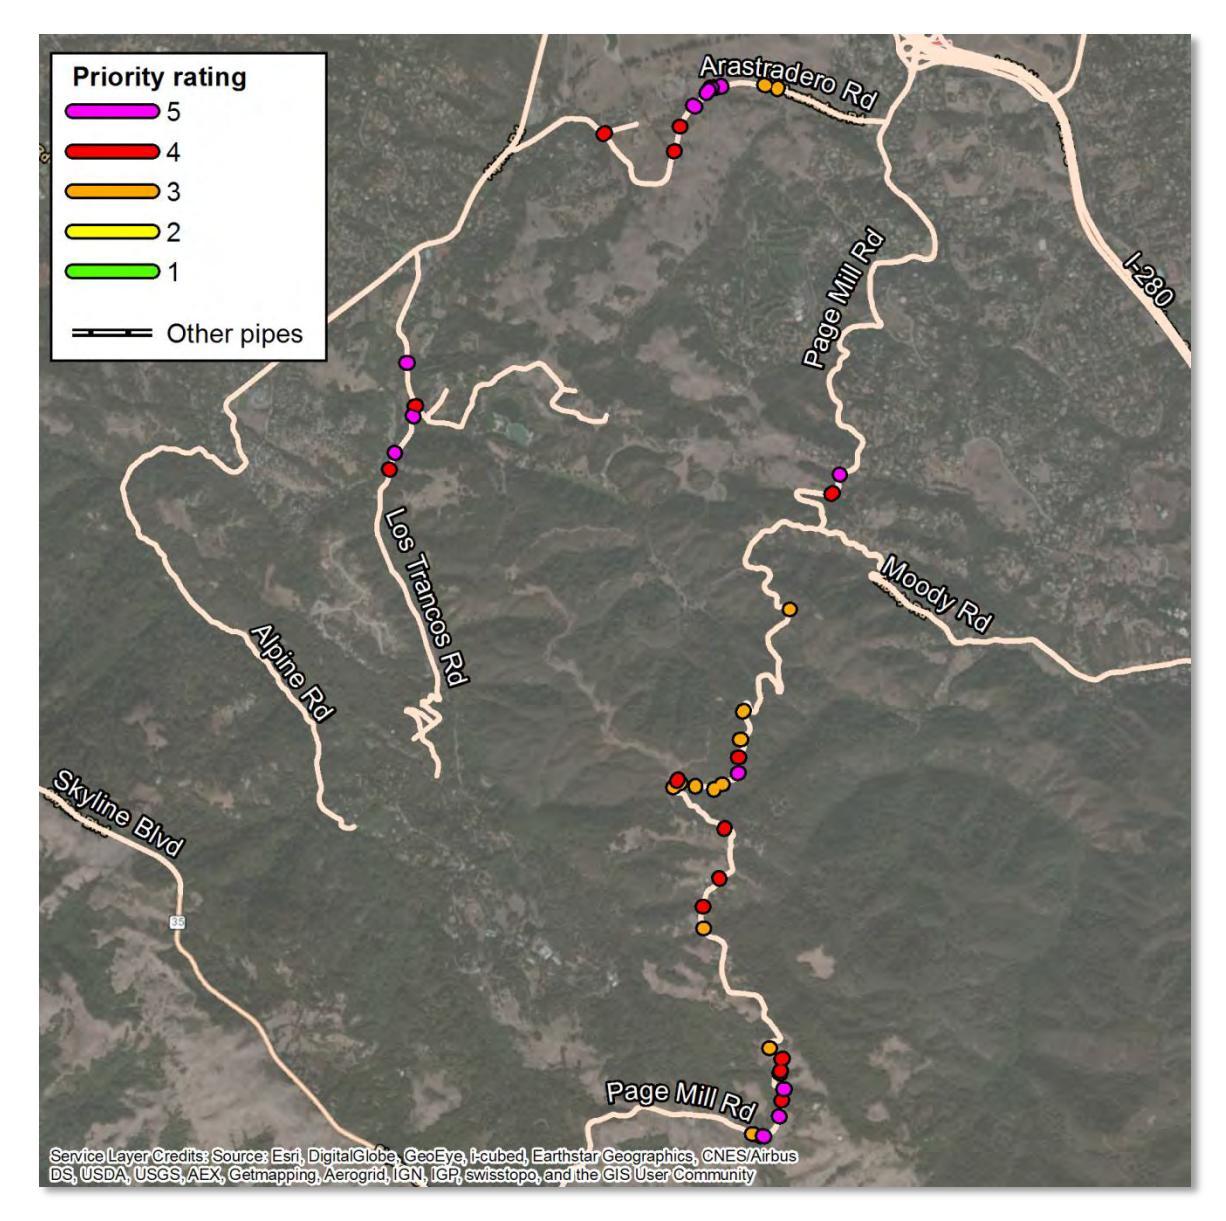
Figure 3-1. Overall Map – Prioritization Ratings

A total of 42 culverts were evaluated. The culverts were numbered A-1 through A-43. Culvert A-18 could not be found along Page Mill Rd. and is abandoned per City staff. Figure 3-1 through Figure **3-3** display the culverts that were assessed and their associated prioritization ratings.

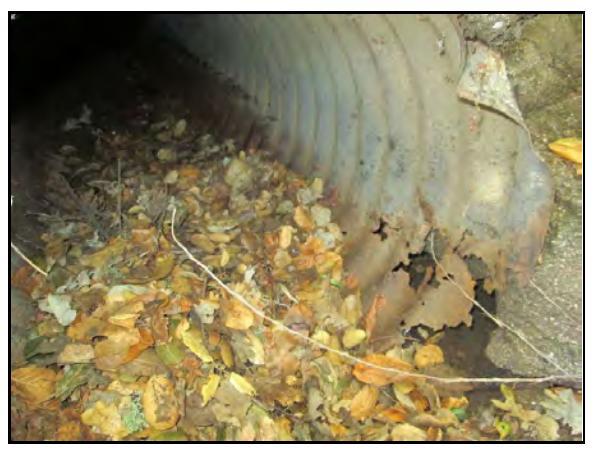
Pipe runs under the road. Lower half of CMP is severely corroded and perforated. Outlet is deflected.

Inlet with perforations in CMP.

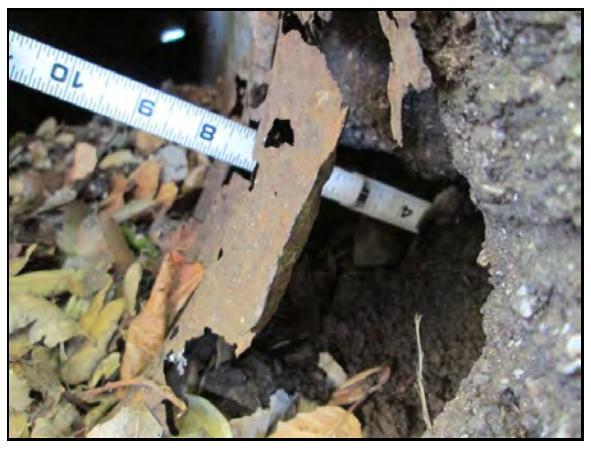
Perforations in CMP at inlet.

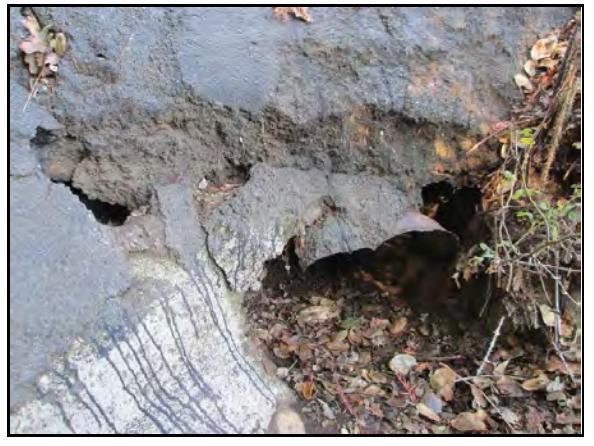
Outlet. CMP is deflected at outlet. Void in soil at left.

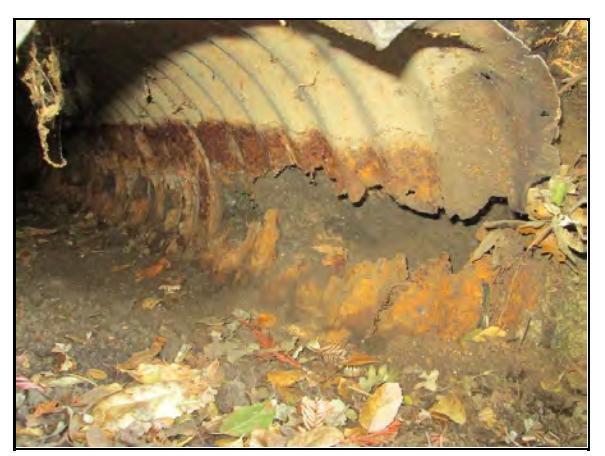
Perforated CMP at outlet.

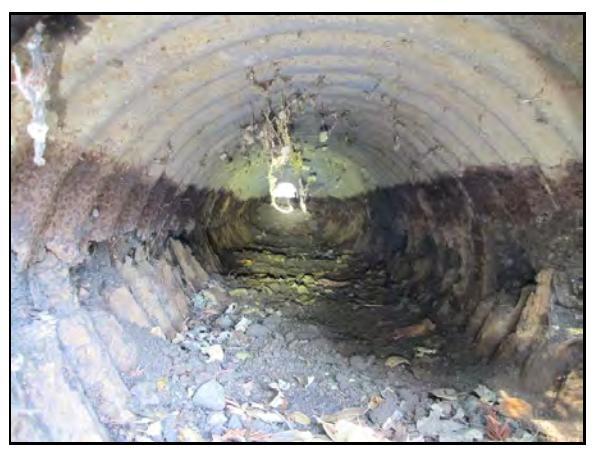
View inside outlet. Note perforations at spring lines.

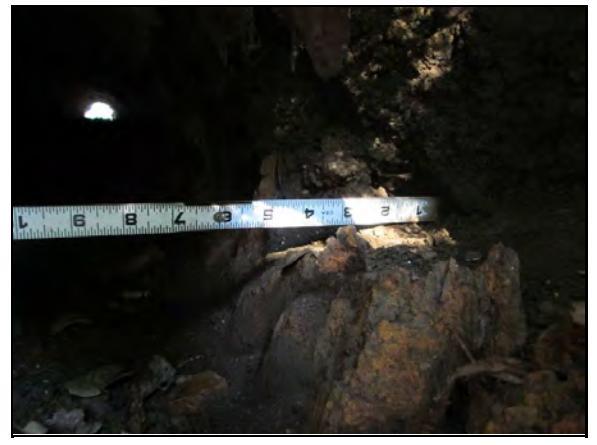
Perforated CMP at outlet.

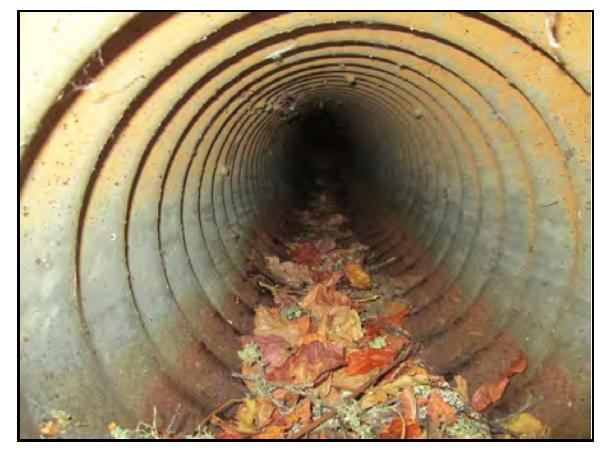
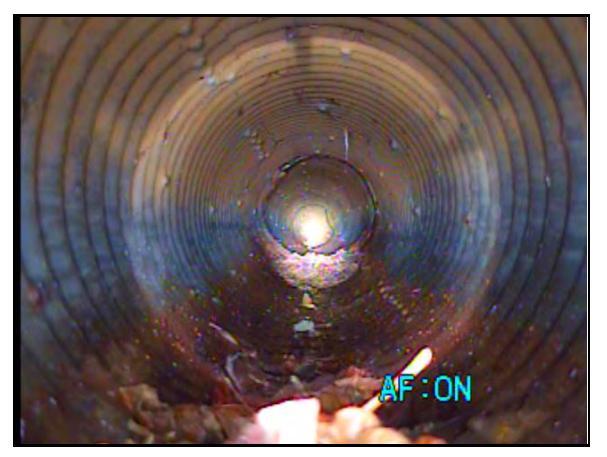
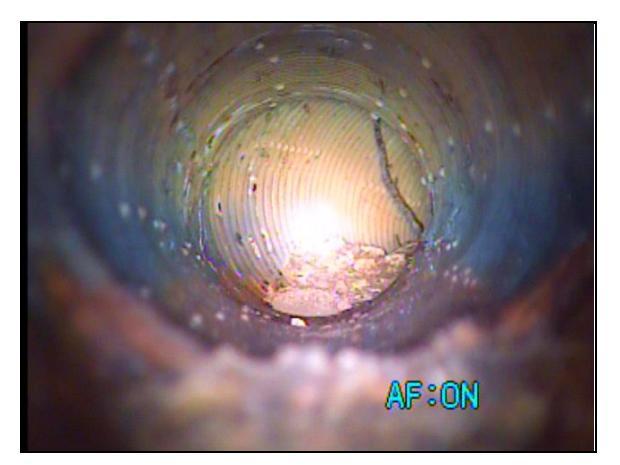
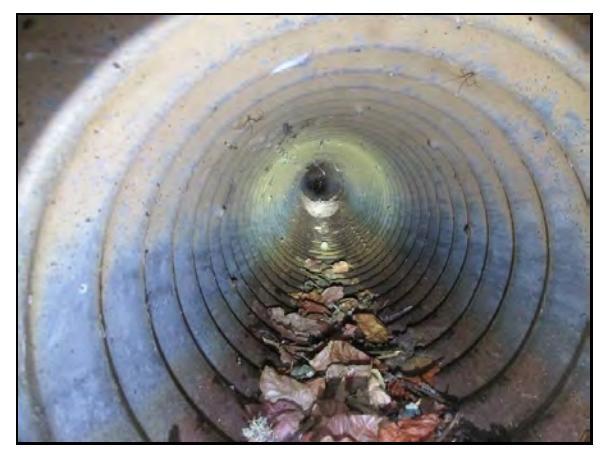
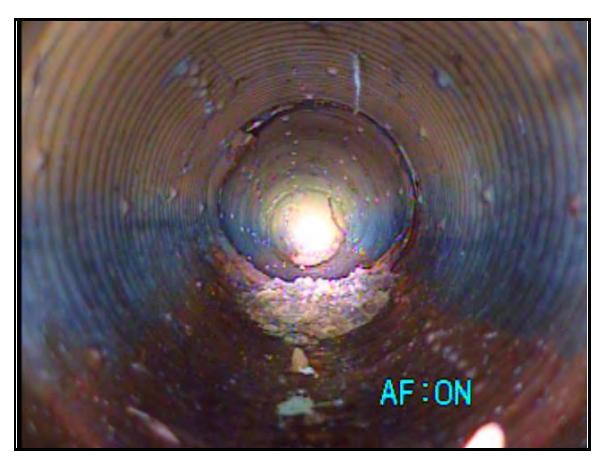
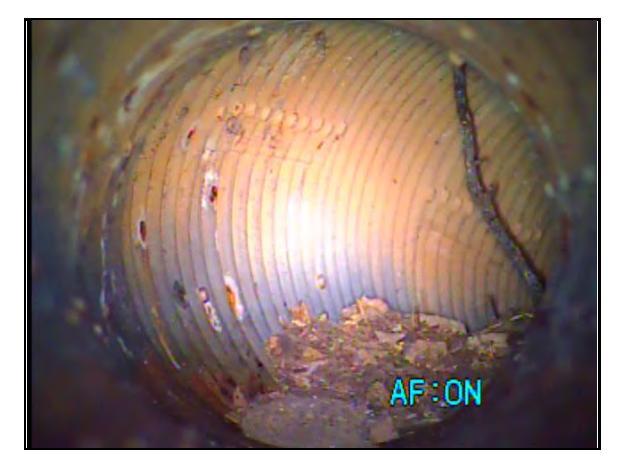
Culvert A-4

Pipe runs under the road. Apparent offset joint inside pipe. Asphalt and other debris at invert. Pipe has loss of galvanizing at invert and minor corrosion.

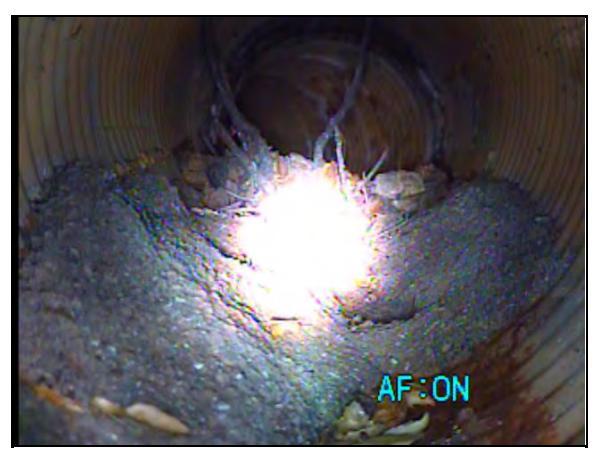
Asphalt inside culvert (viewed from outlet).

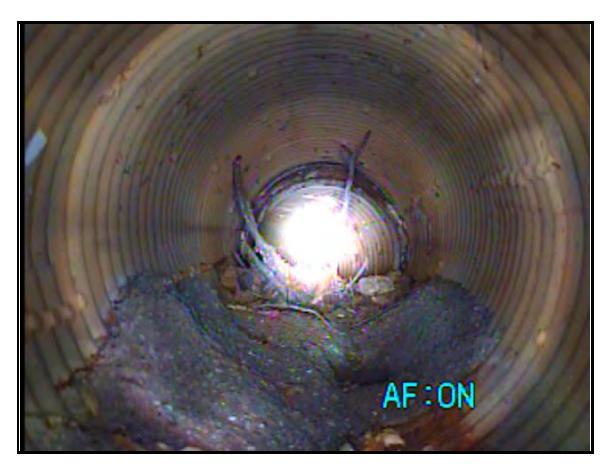
Debris and asphalt inside culvert (viewed from outlet).

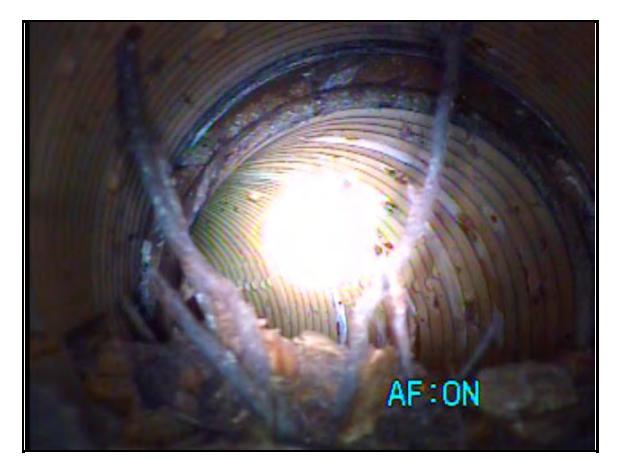
Debris inside culvert and apparent offset joint (viewed from outlet).

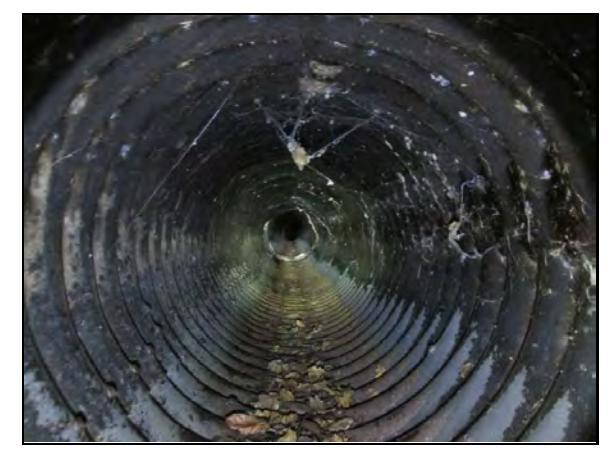
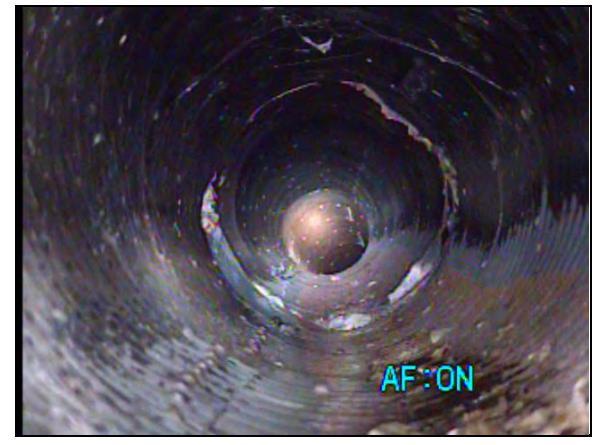
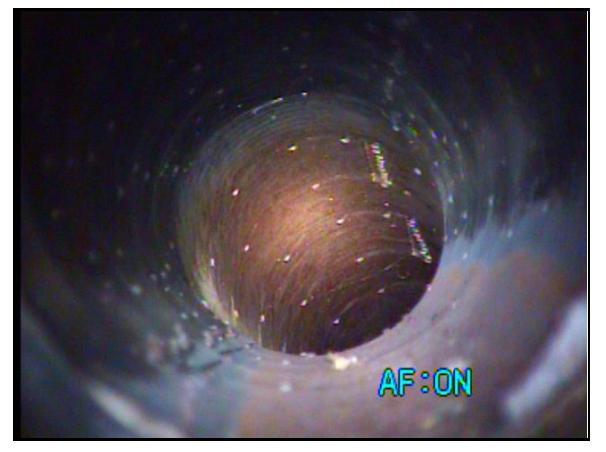
Culvert A-5

Could not locate downstream end of pipe due to slope and vegetation. Marker post is not labeled with A-5 identifier. Coating failure and minor corrosion at invert. Possible deterioration at joints.

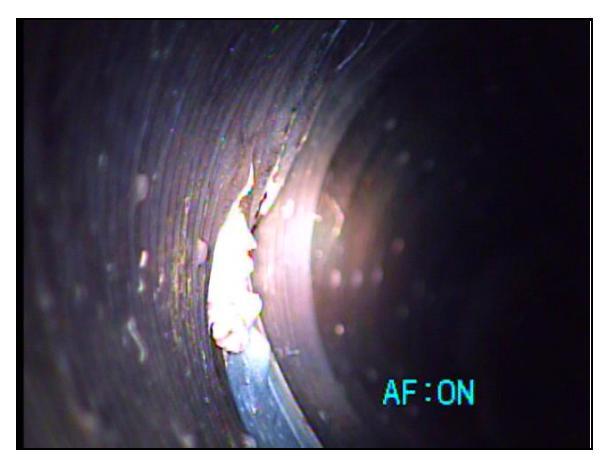
Possible deterioration at joint (viewed from inlet).

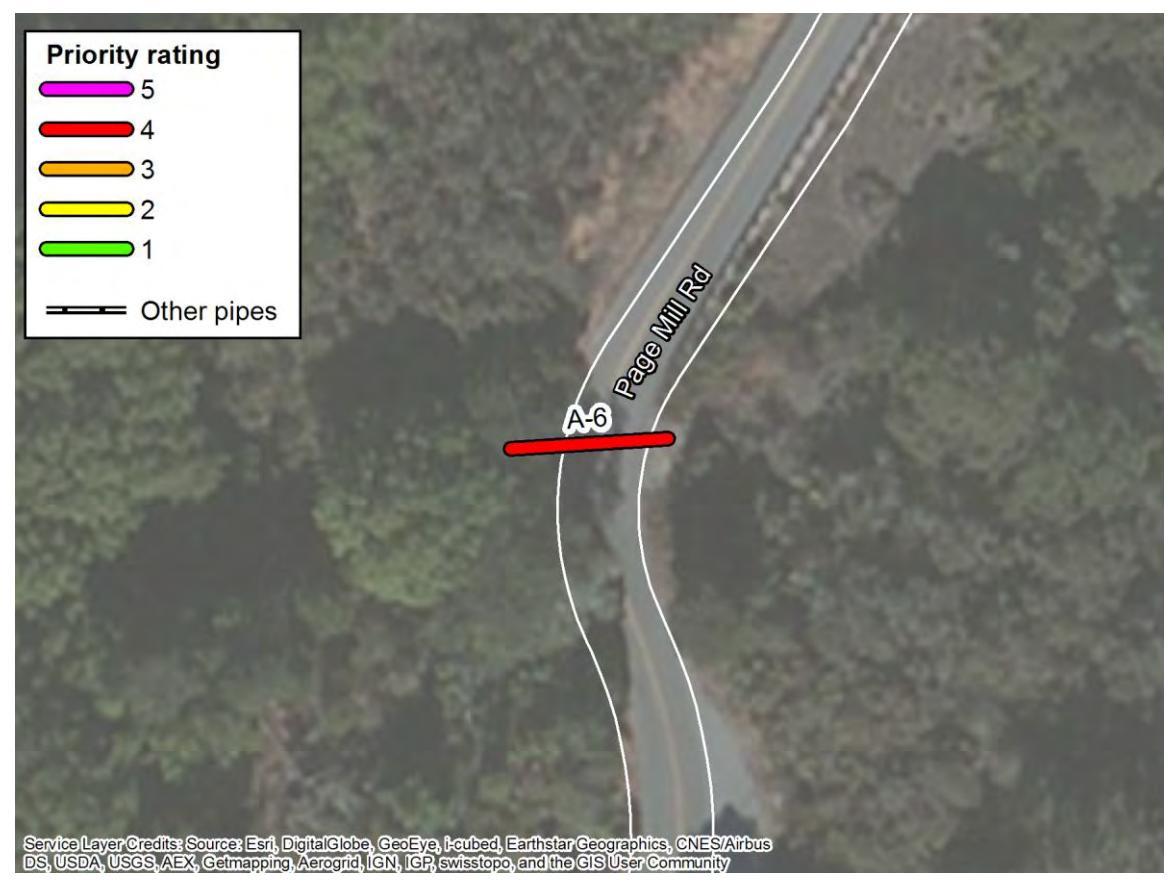
Culvert A-6

Pipe runs under the road. Downstream end not accessible. Pipe has loss of galvanizing and minor corrosion at invert. Possible separated or offset joint inside pipe.

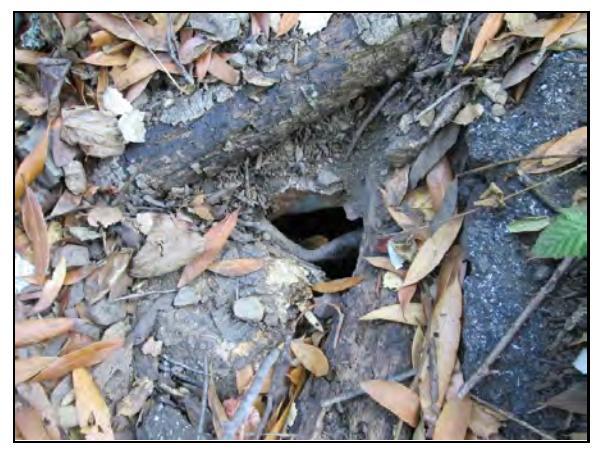
Inlet mostly obstructed by debris.

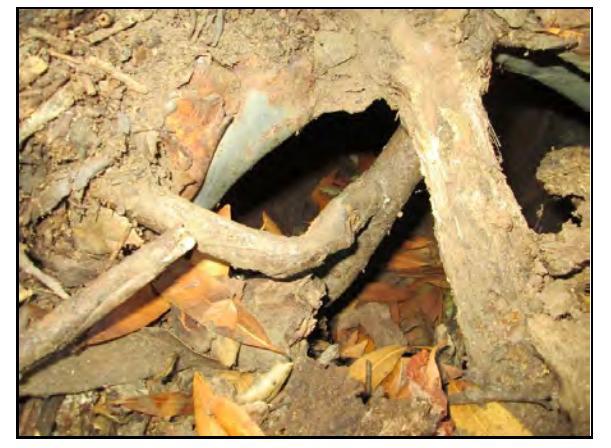
Inlet mostly obstructed by debris.

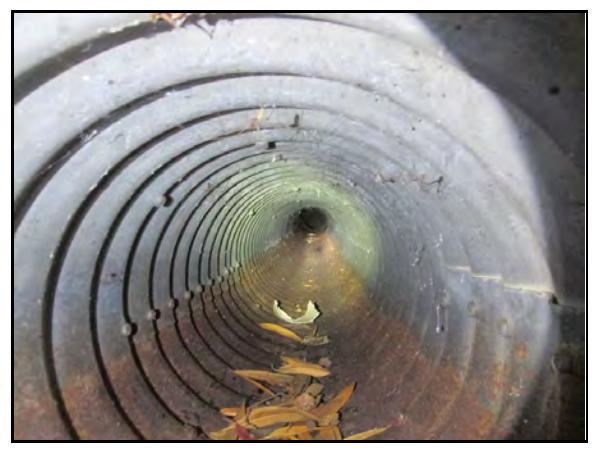
View inside inlet. Apparent offset joints within pipe.

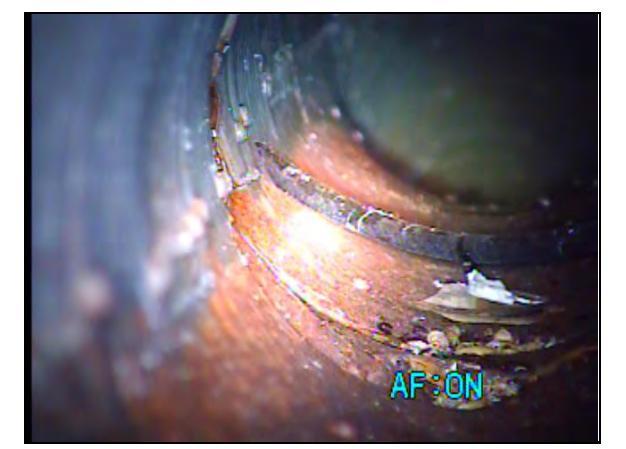
Possible offset joint within pipe.

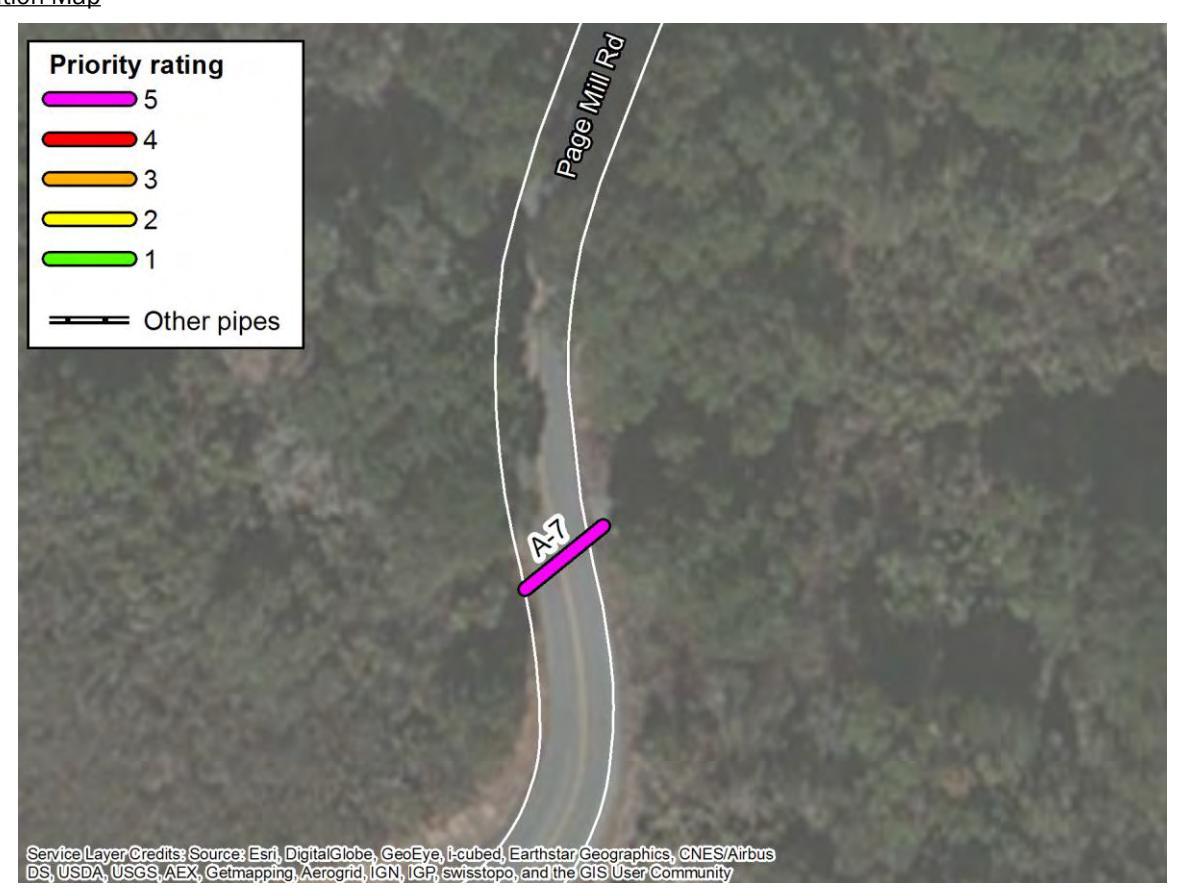
Culvert A-7

Inlet is buried and filled with sediment and debris. Large hole in exposed portion of CMP at inlet. Outlet could not be located.

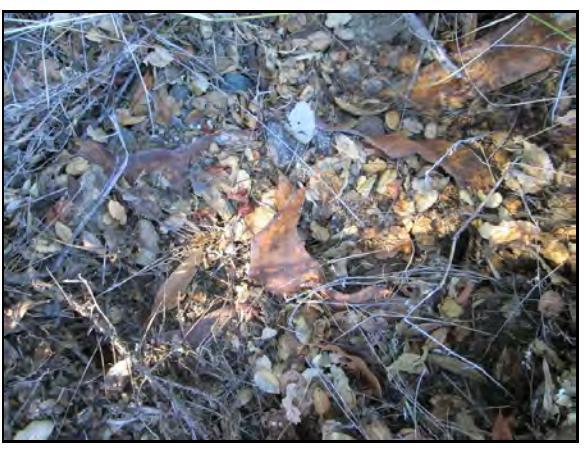
Inlet. Large section of pipe wall missing.

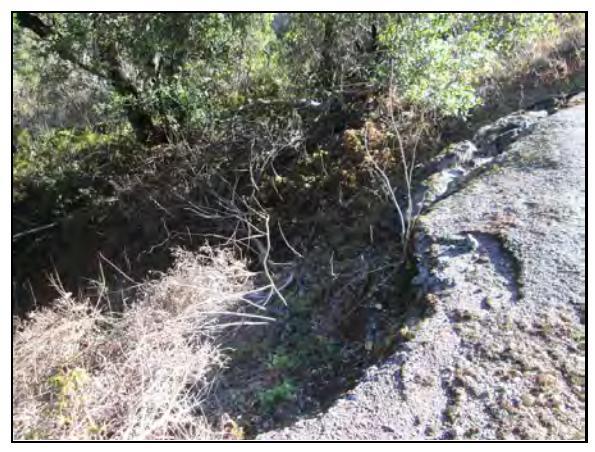
Area near outlet. Outlet could not be located.

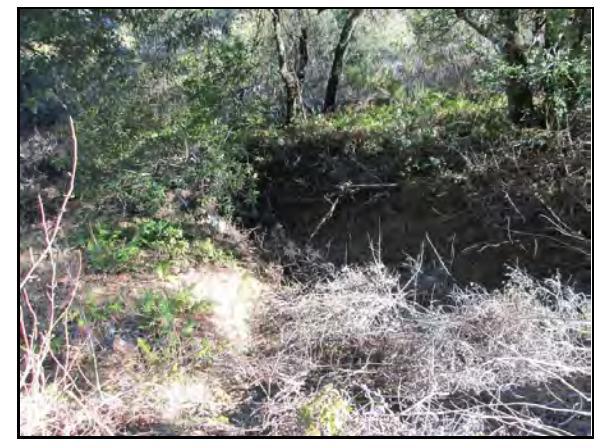
Area near outlet. Outlet could not be located.

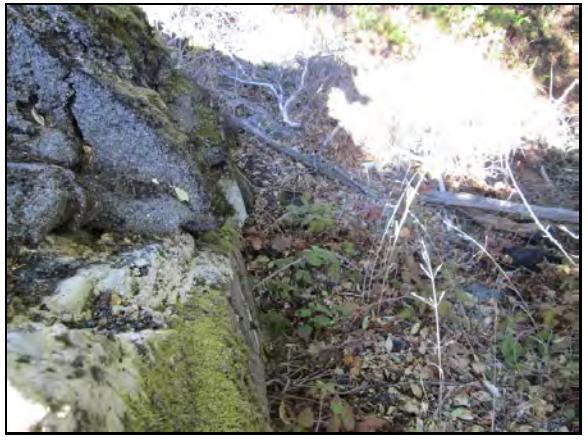
Area near outlet. Outlet could not be located.

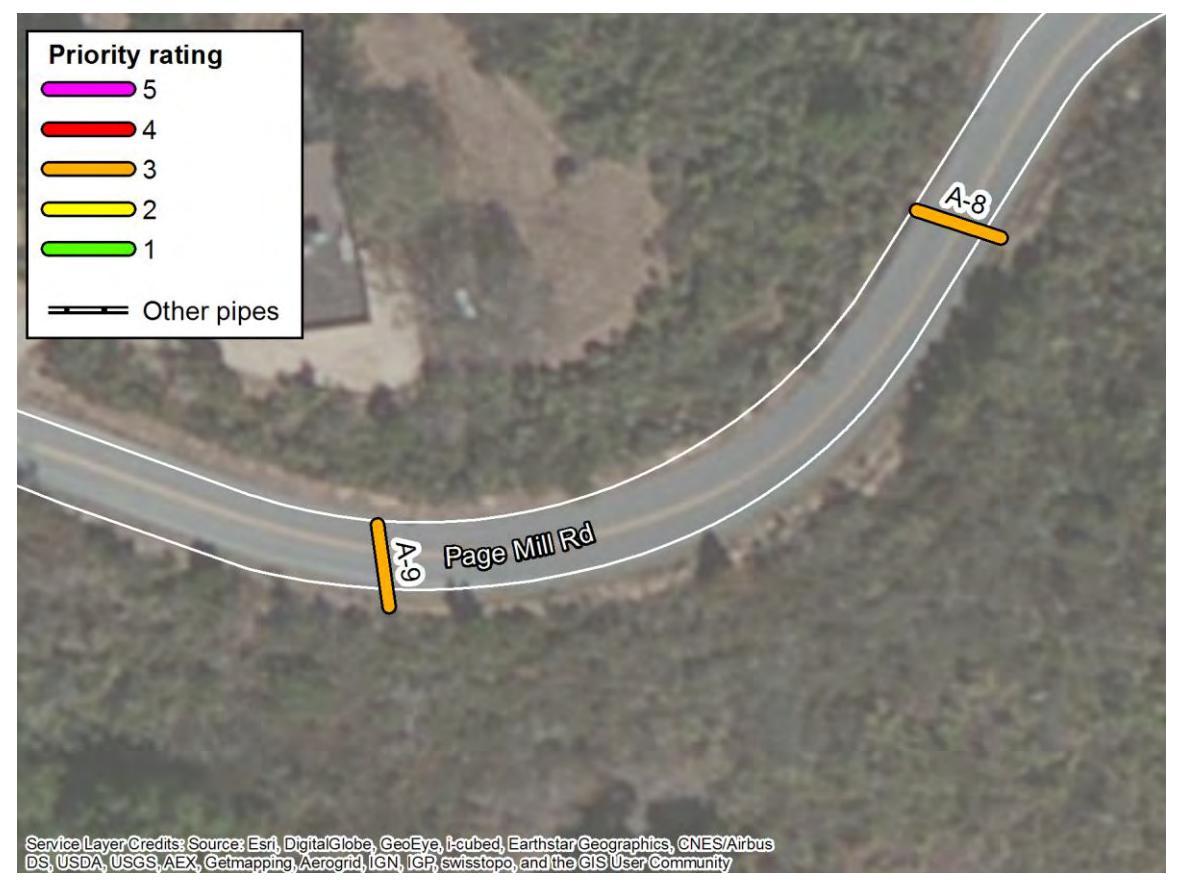
Culvert A-8

Could not locate downstream end of pipe. Coating failure and minor to moderate corrosion at invert. Potential offset or separated joints within pipe.

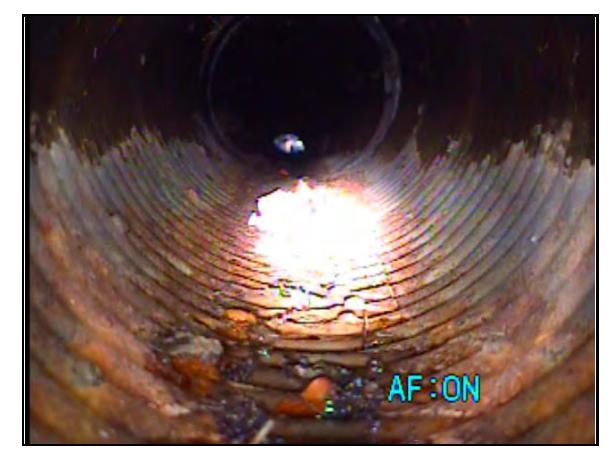
View inside inlet.

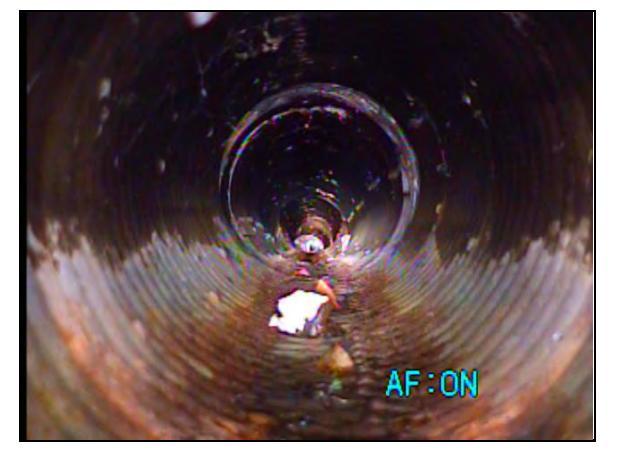
View inside inlet.

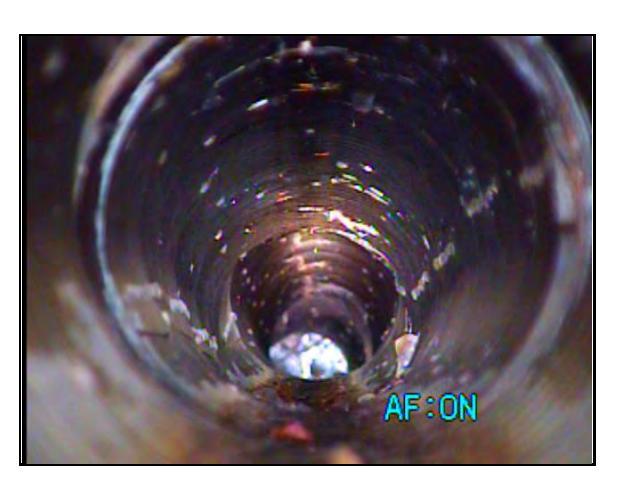
View inside inlet.

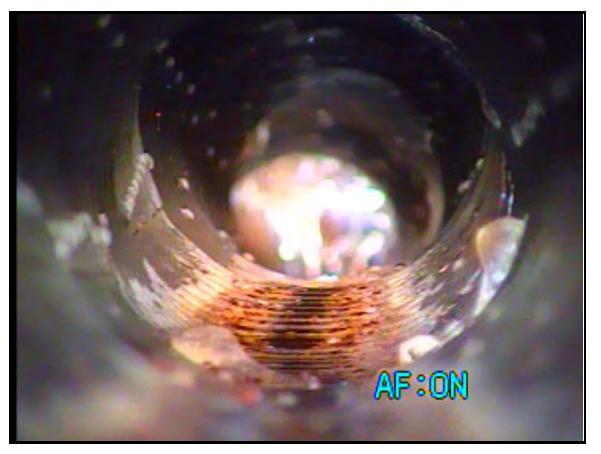
View inside inlet.

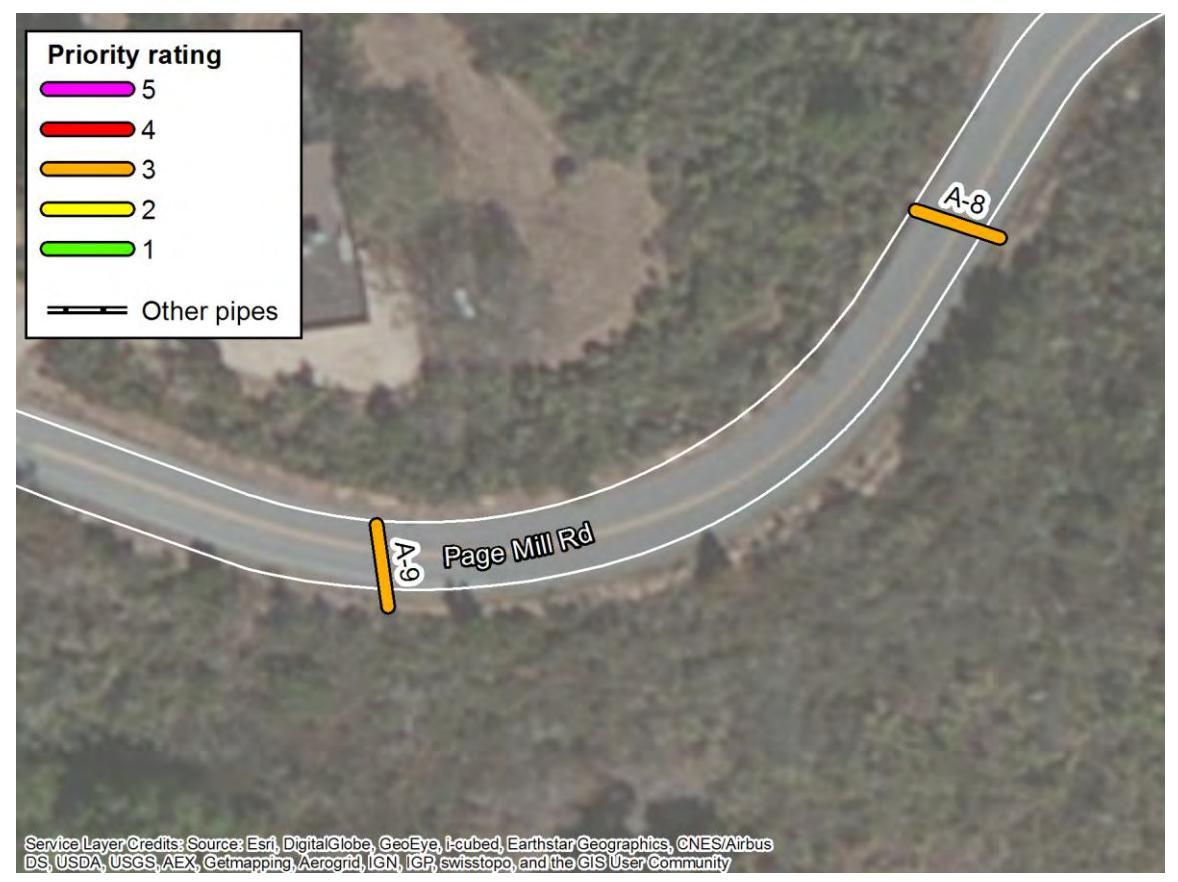
Culvert A-9

Could not locate downstream end of pipe. Pipe appears to be cement-mortar-lined steel pipe for a few feet near the inlet and transitions to CMP downstream. Pipe deflects at transition point, so it is possible that the joint is open. Pipe deflected at inlet. CMP portion of culvert has loss of galvanizing and minor to moderate corrosion at invert.

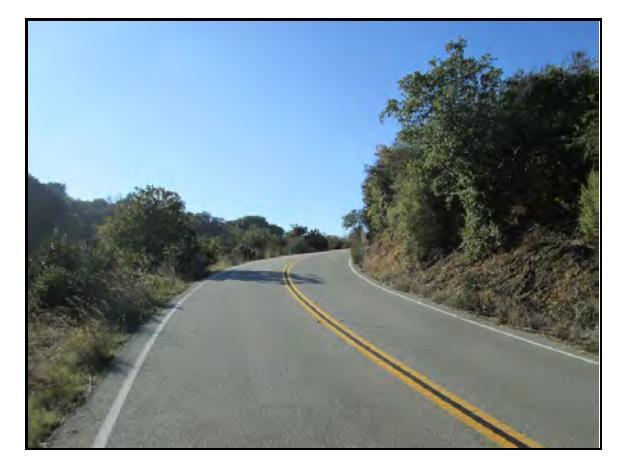
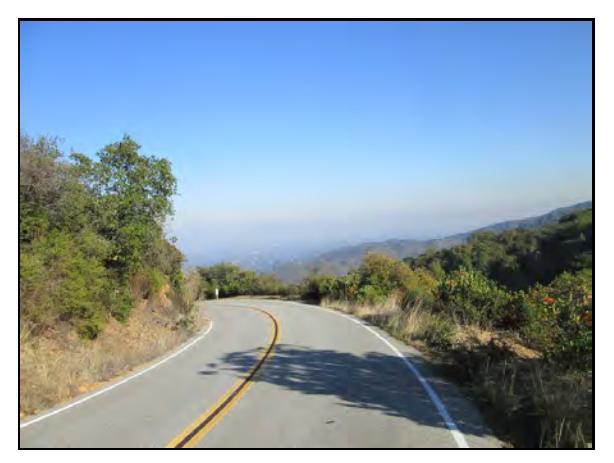
Photos

Area view.

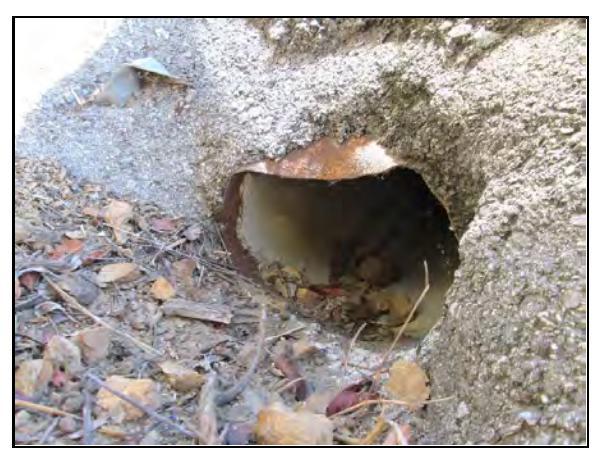
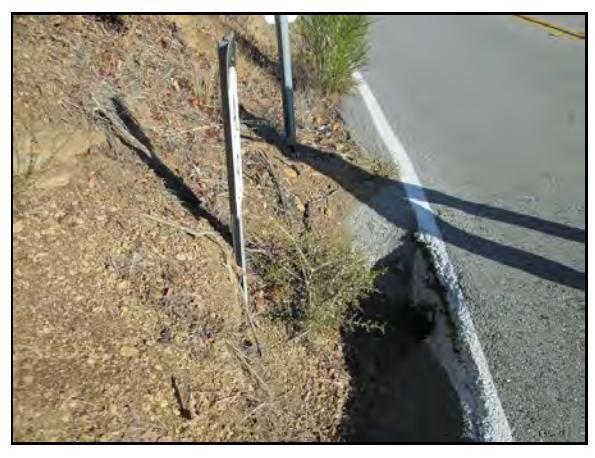
Culvert A-9

Inlet.

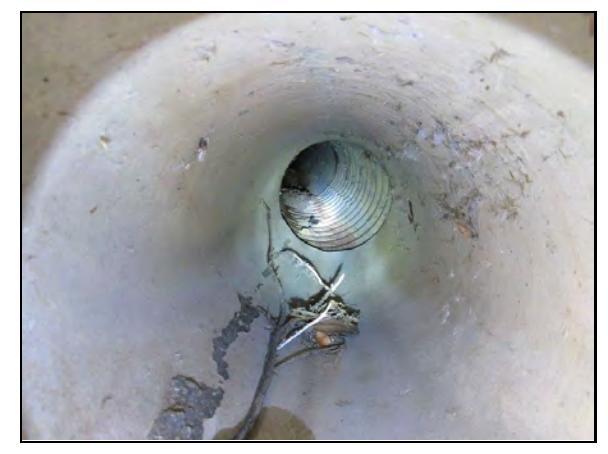
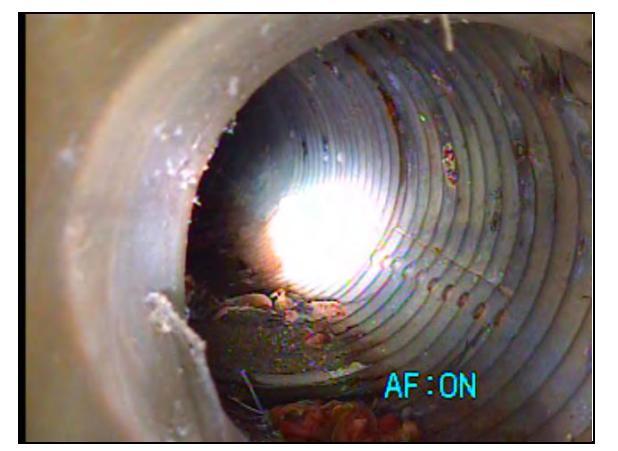
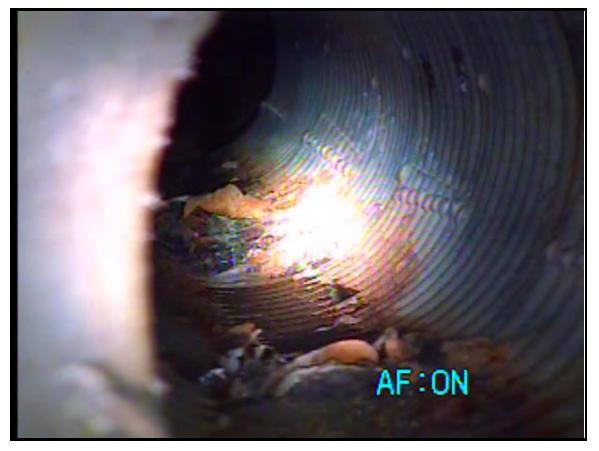
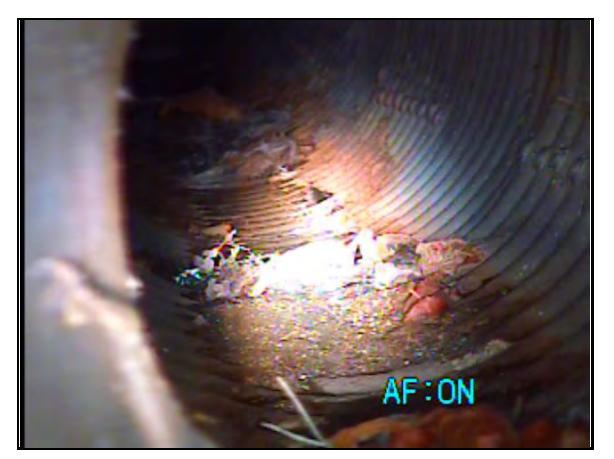
Culvert A-9

View inside inlet.

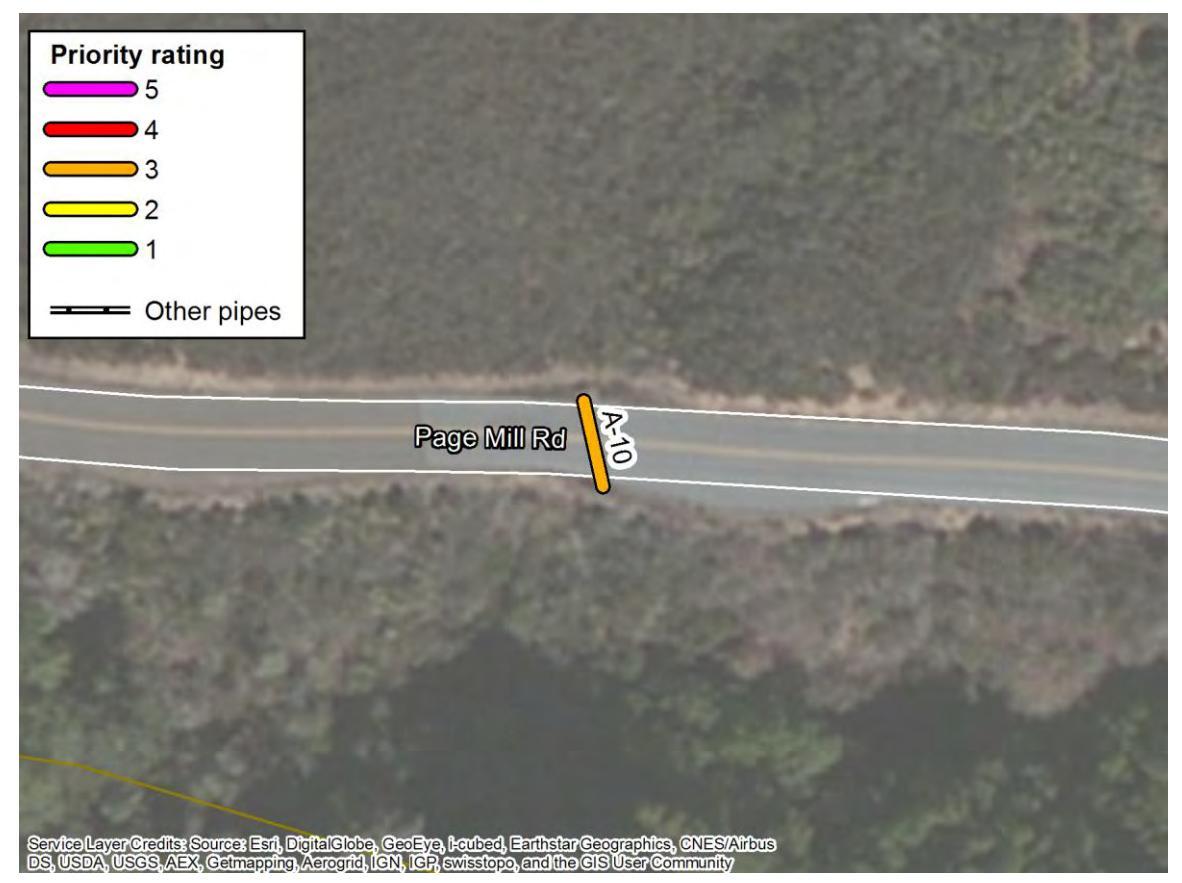
Culvert A-10

Could not locate downstream end of pipe. Pipe has coating failure and loss of galvanizing at invert with minor corrosion. Pipe appears to have been supplied with a paved invert, which was installed at about the 10:00 position rather than at the invert.

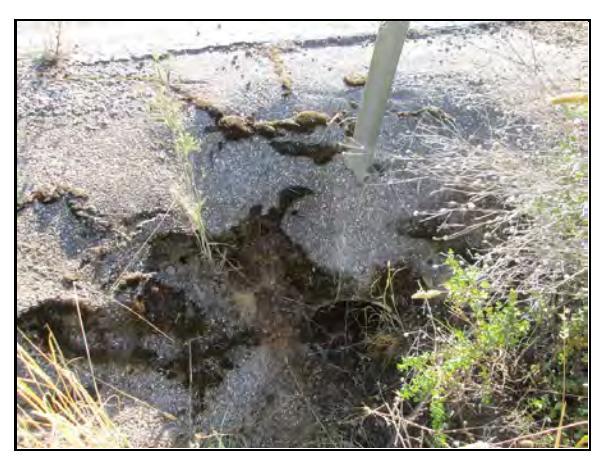
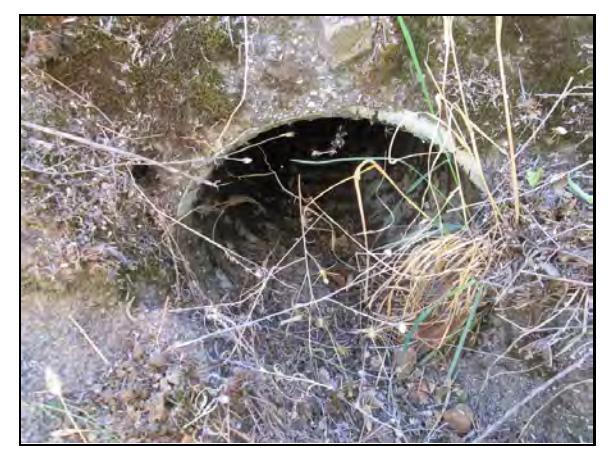
Inlet.

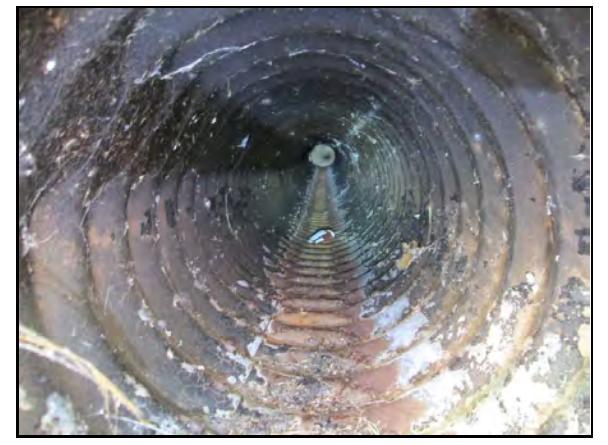
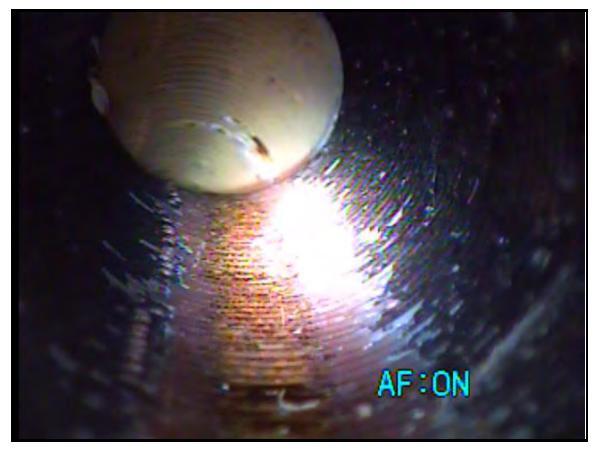
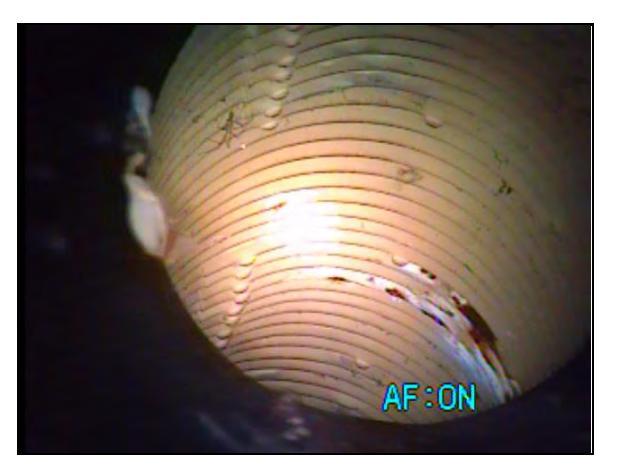
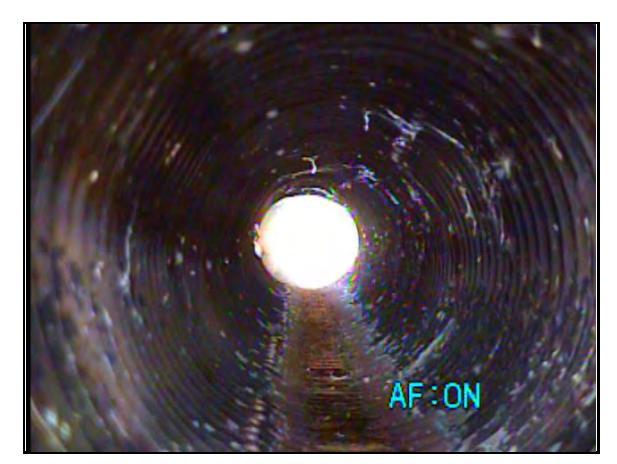
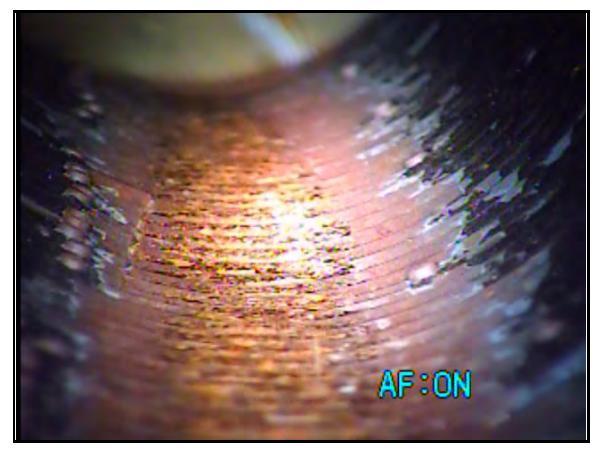
Culvert A-10

View inside inlet.

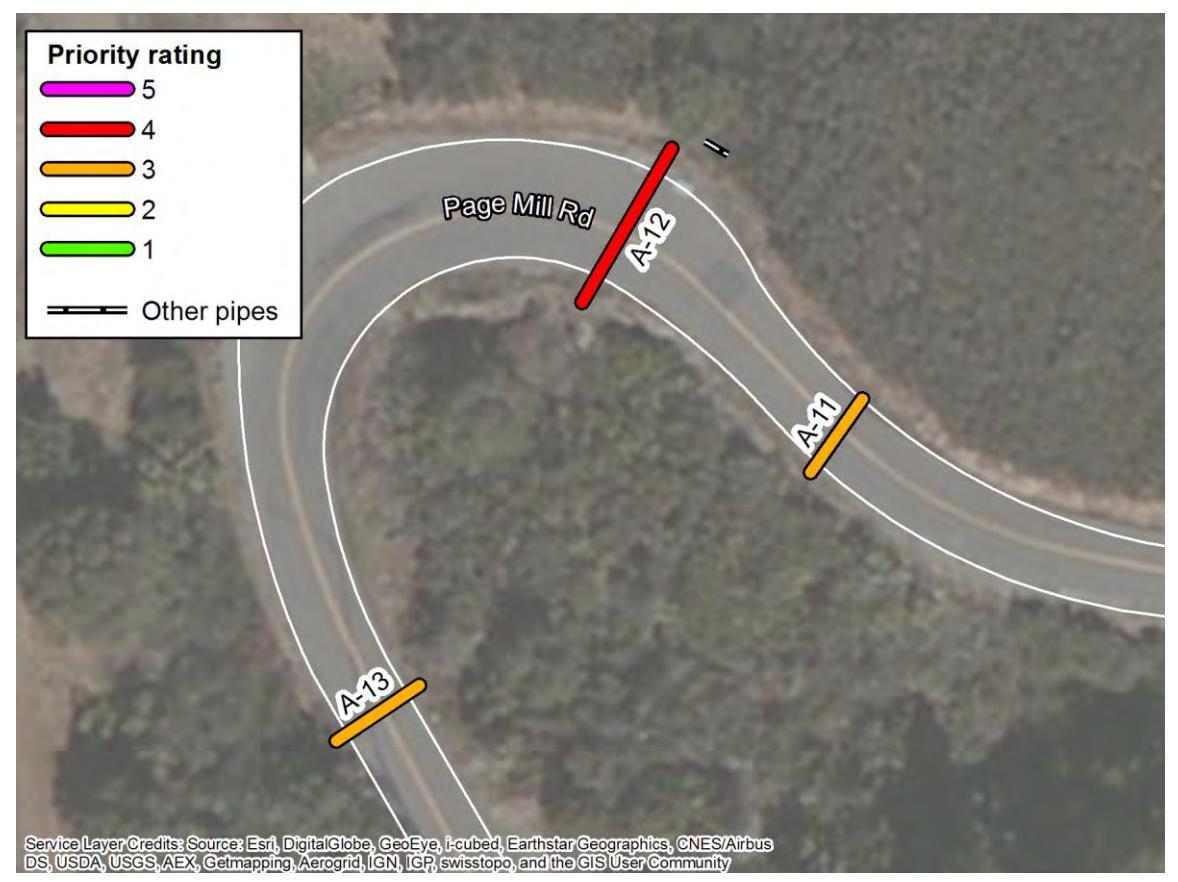
Culvert A-11

Pipe runs under the road. Coating failure and minor corrosion on interior surfaces of pipe. Possible section of different pipe material in middle section of culvert.

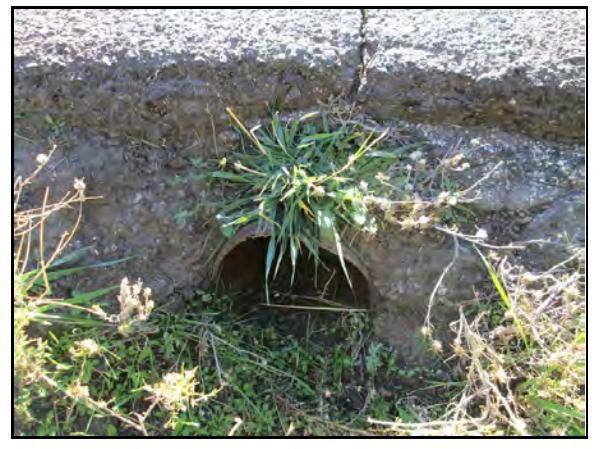
Inlet.

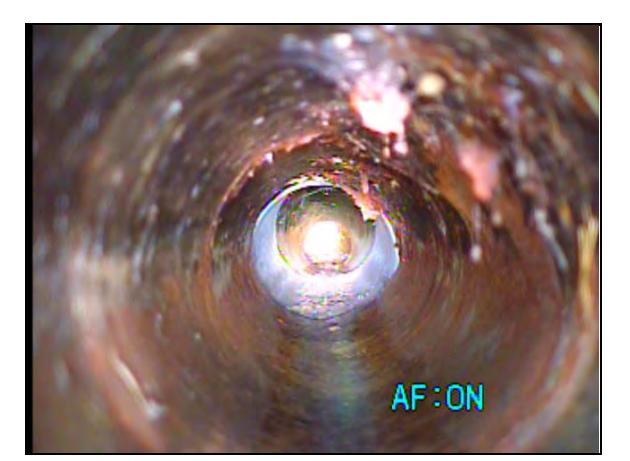
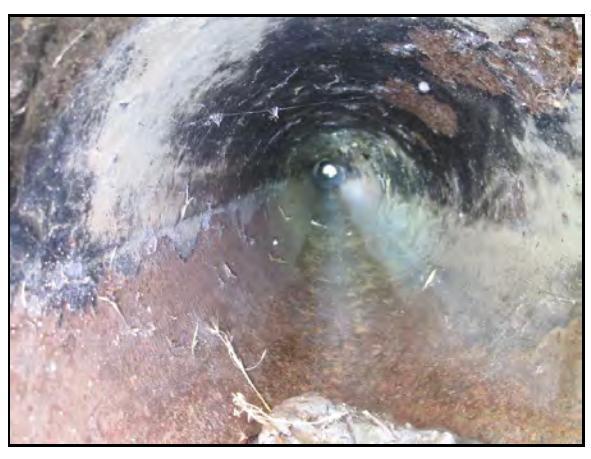
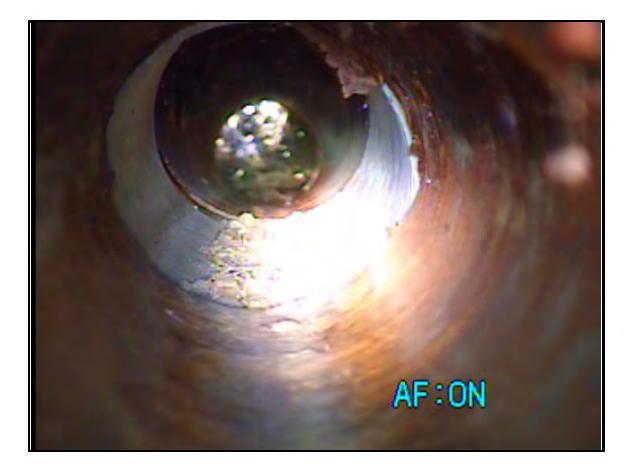
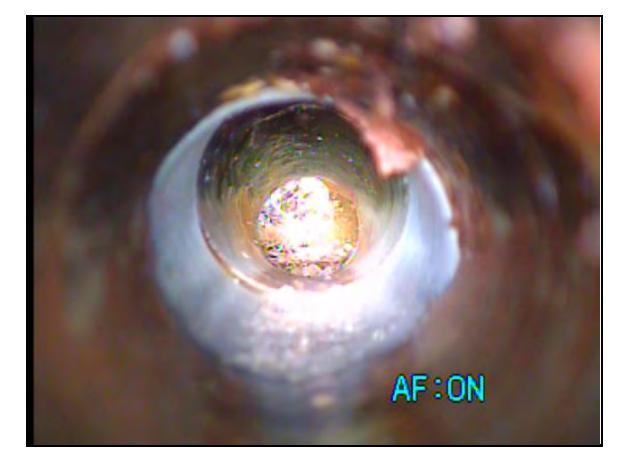
Culvert A-11

View inside inlet.
