Storm Drain Master Plan Update

June 2015

Public Works Department/Engineering Services Division

Schaaf & Wheeler CONSULTING CIVIL ENGINEERS

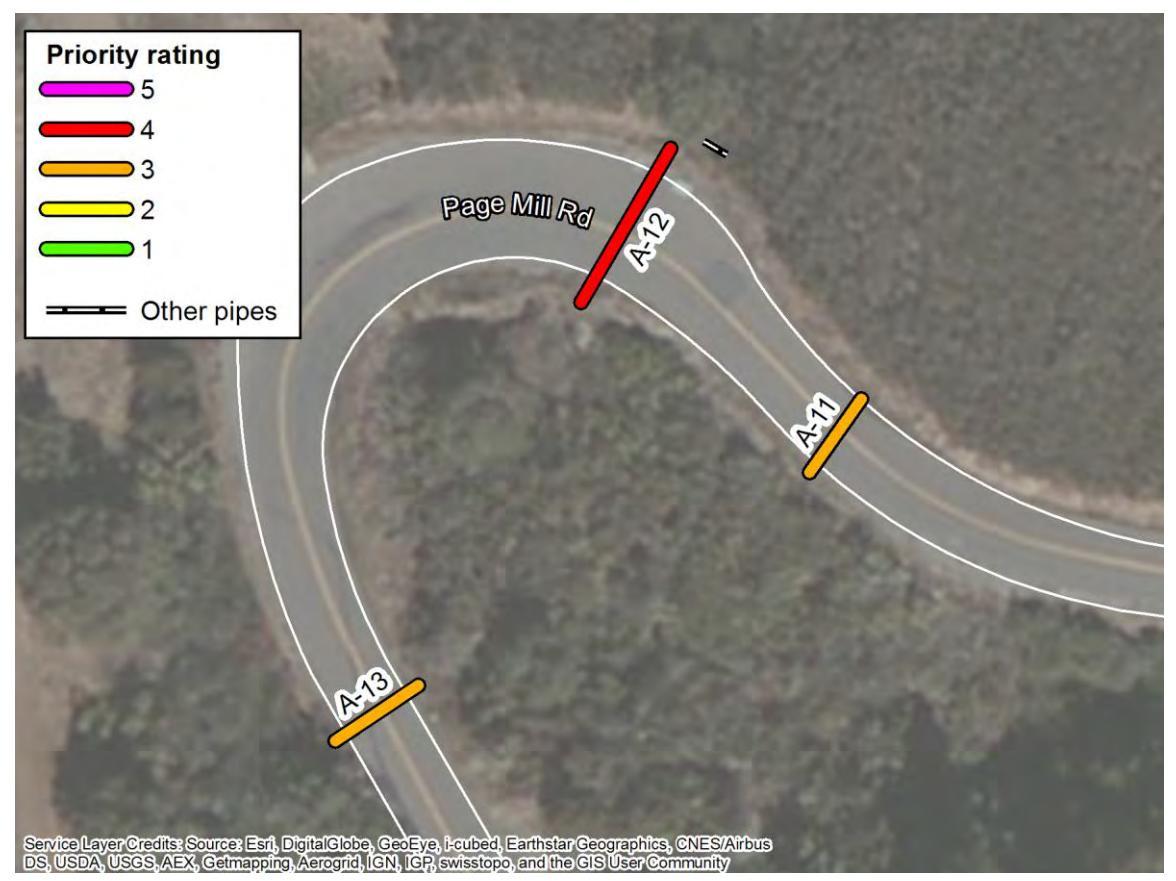
Culvert A-12

Cable of unknown origin penetrates and runs through culvert. Voids above pipe at outlet. Apparent open joint and deflection (localized) at one of the joints within the pipe. Loss of galvanizing and moderate corrosion (exfoliation) at invert. Short additional culvert adjacent to inlet is in similar condition.

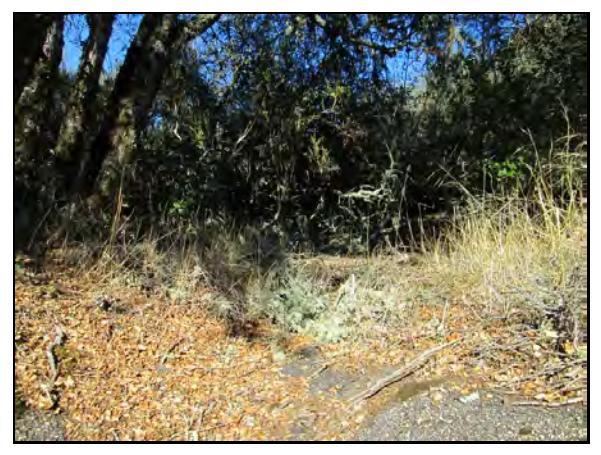
Inlet. Short additional culvert in background.

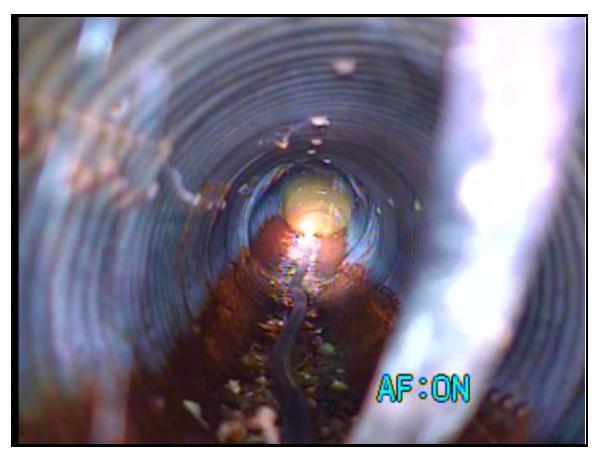
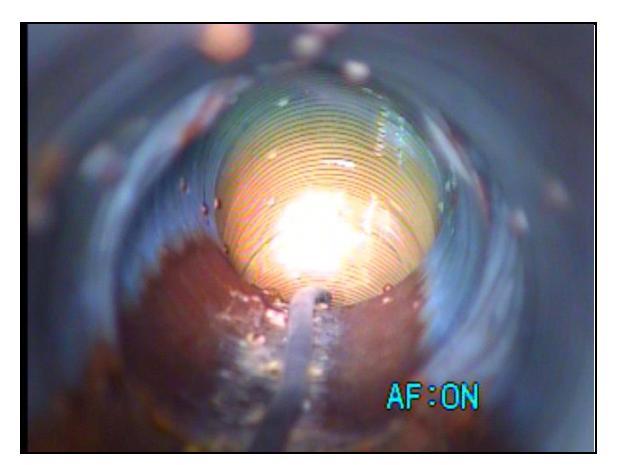
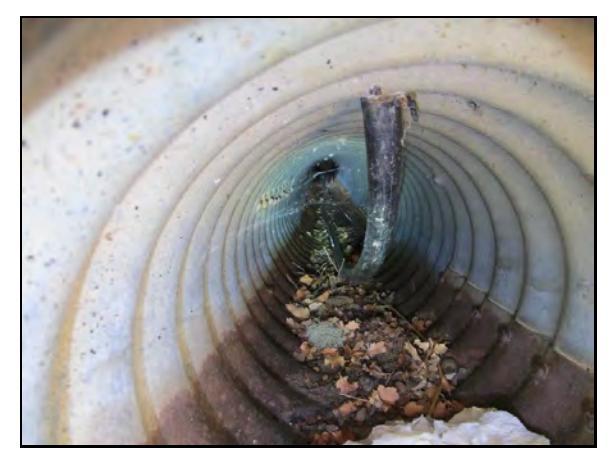
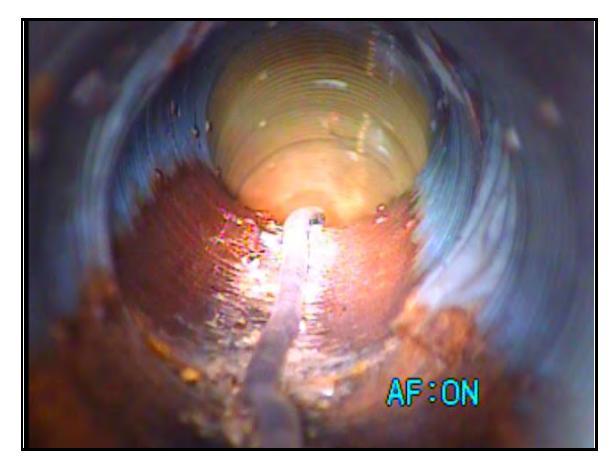
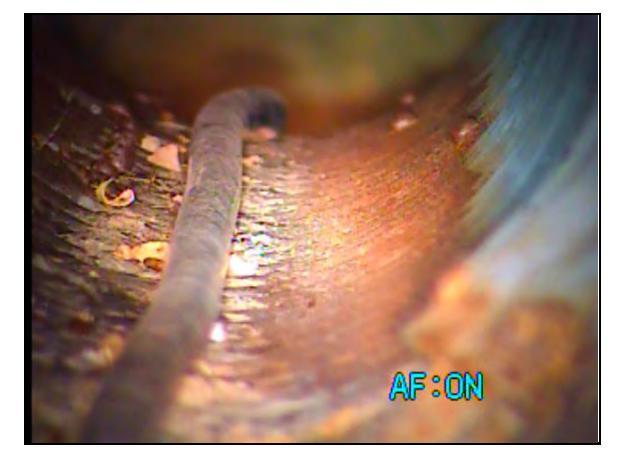
View inside inlet.

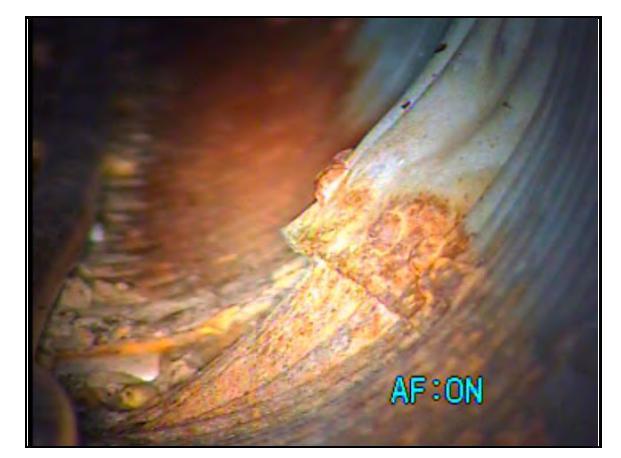
View inside inlet. Apparent open joint and deflection within pipe.

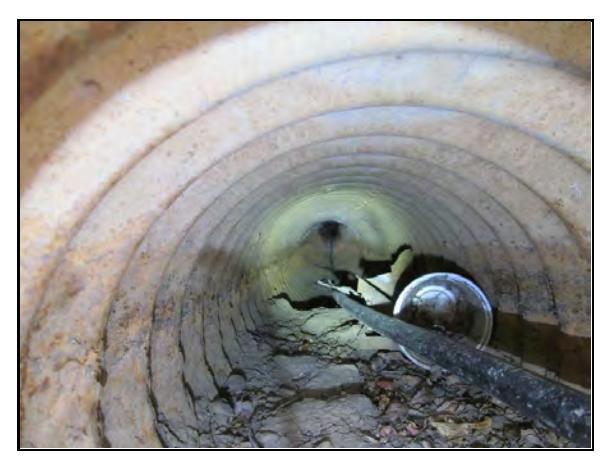
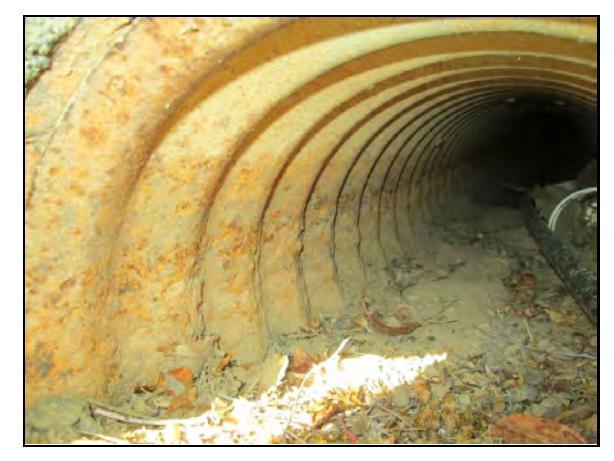
View inside outlet.

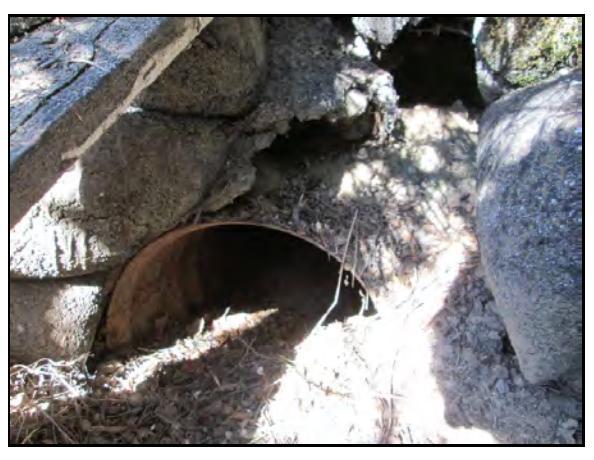
Outlet. Note voids above pipe.

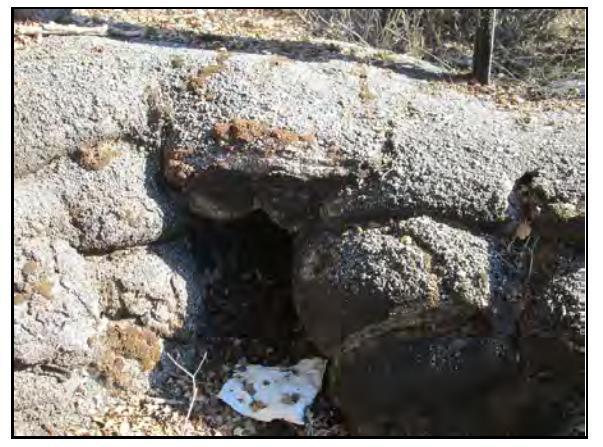
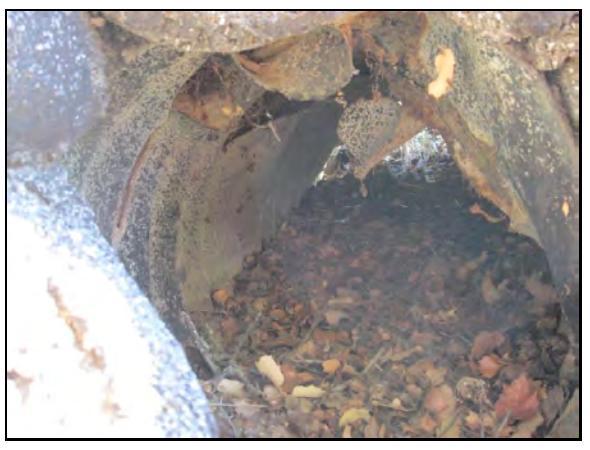
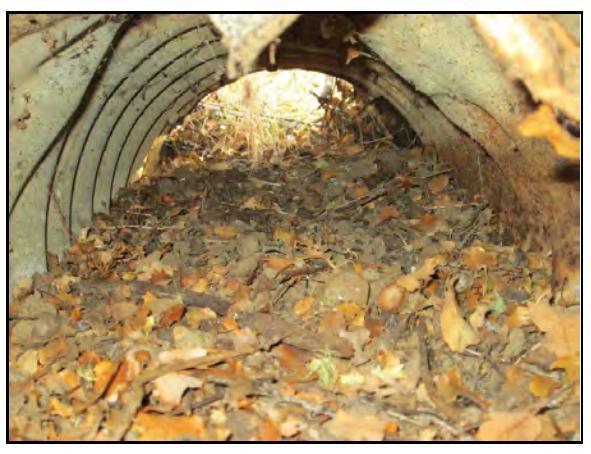
Short additional culvert near inlet of A-12.

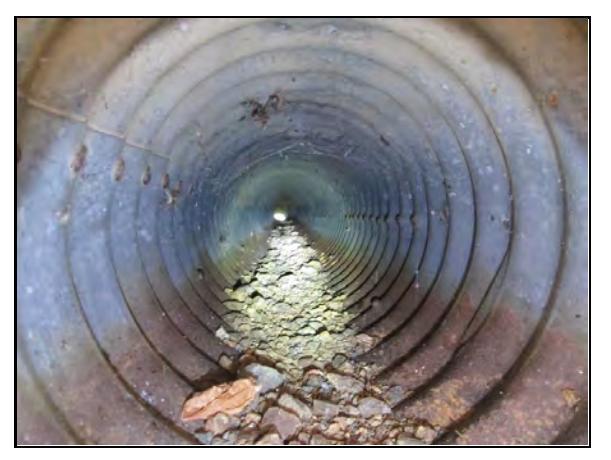
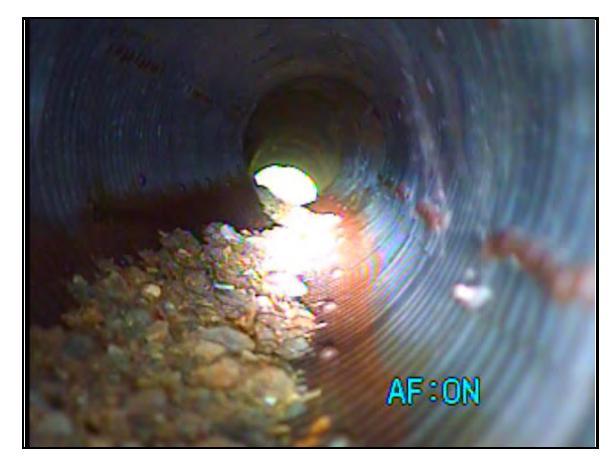
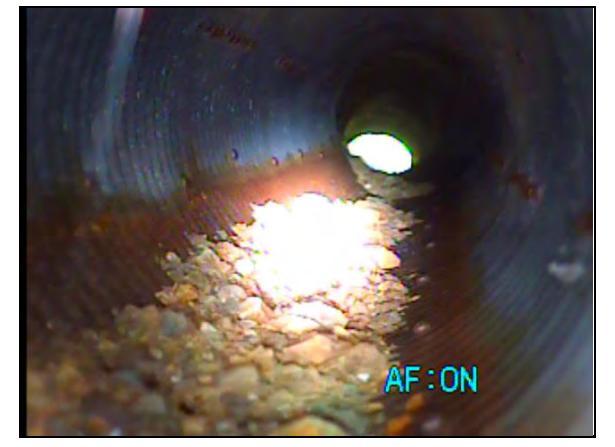
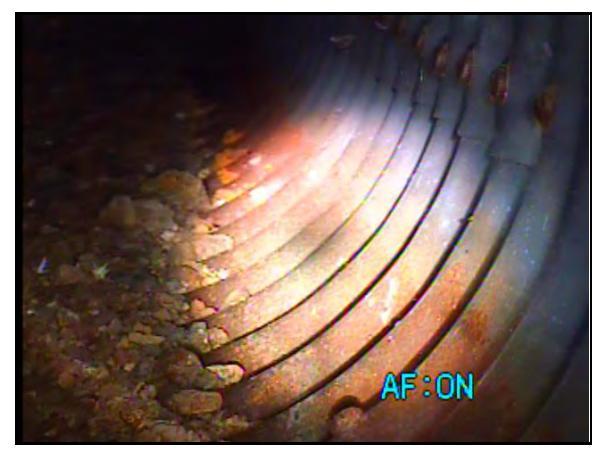
Pipe runs under the road. Loss of galvanizing and minor corrosion at invert.

View inside inlet.

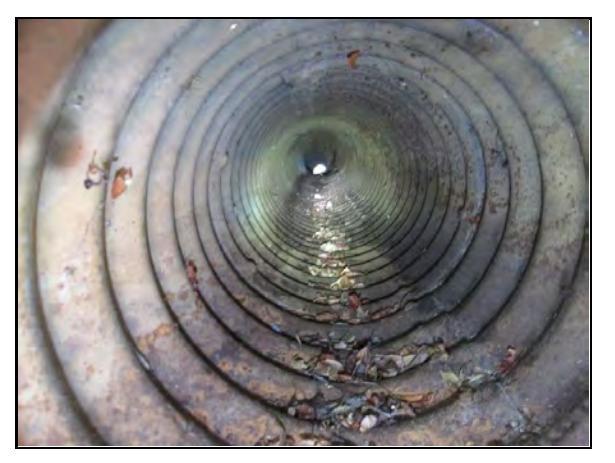
View inside outlet.

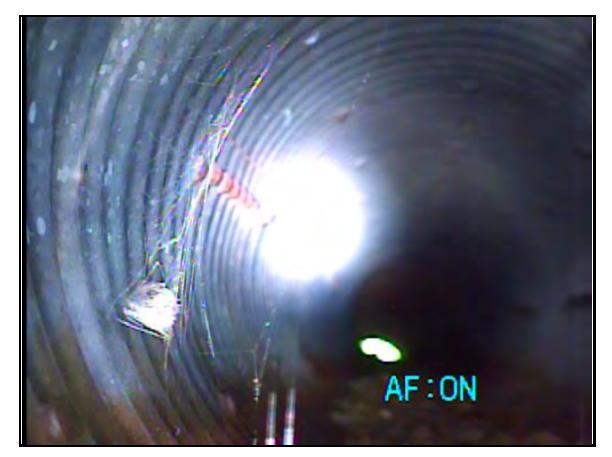
View inside inlet.

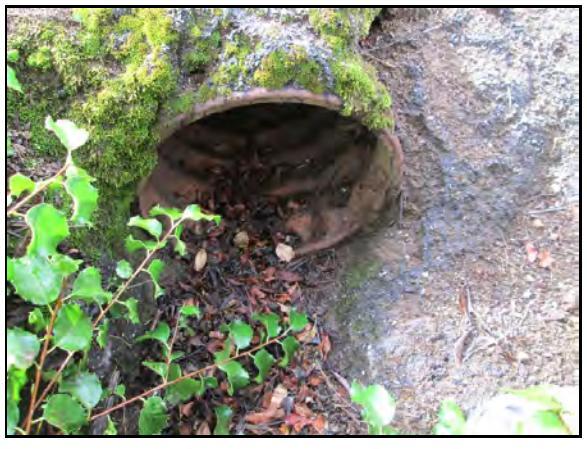
Outlet.

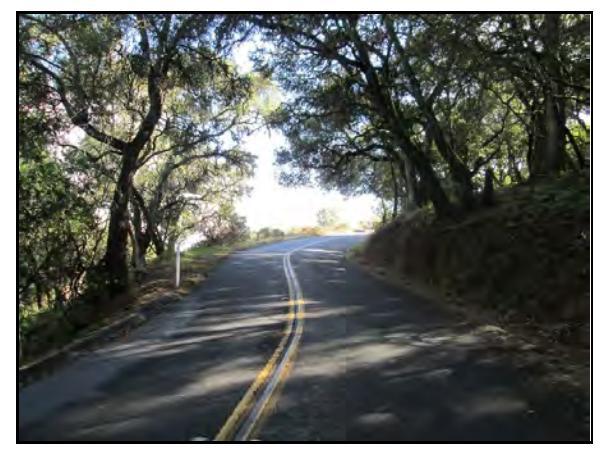
Area view.

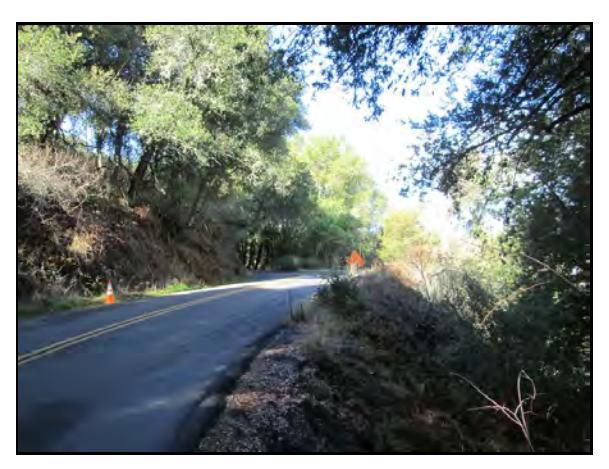
Area view.

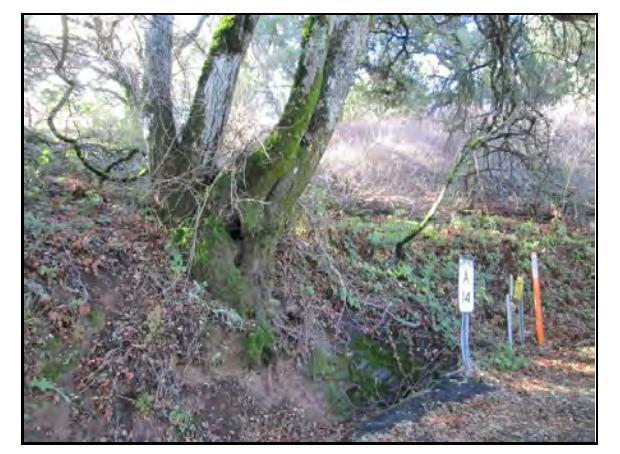
Area near inlet.

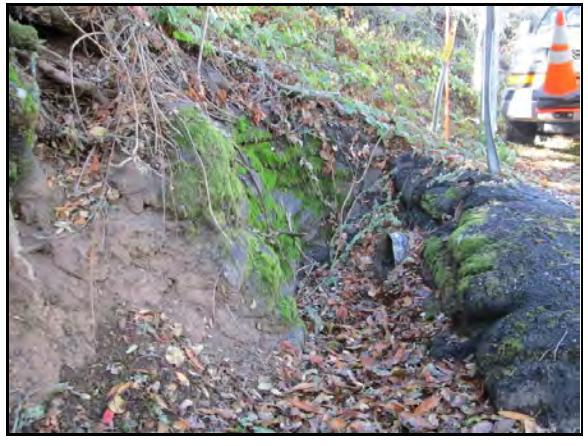
Inlet.

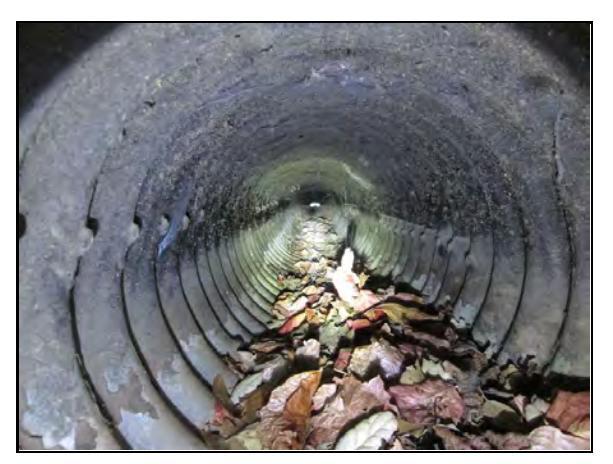
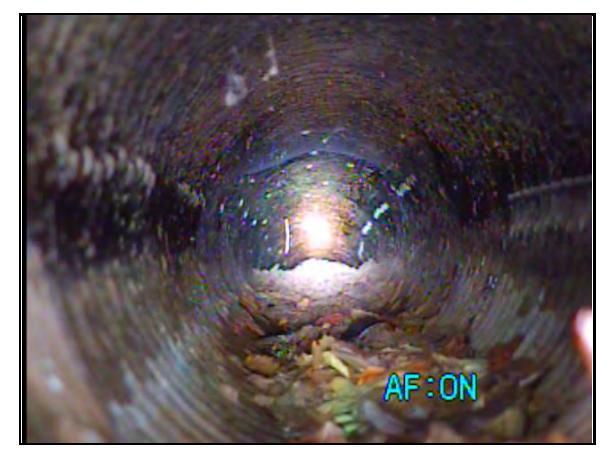
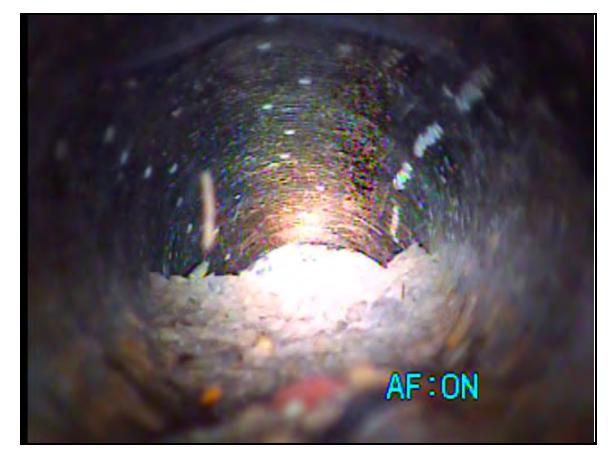
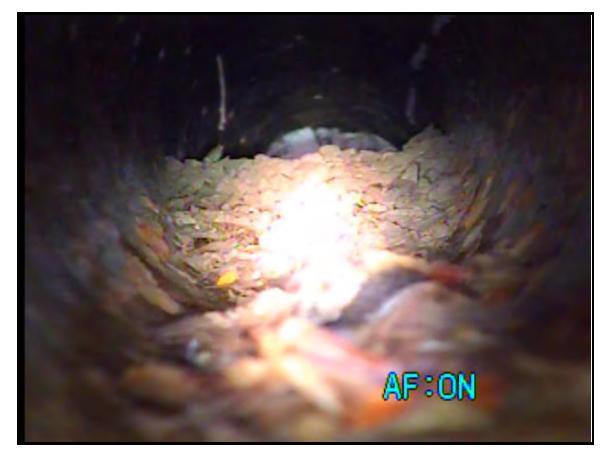
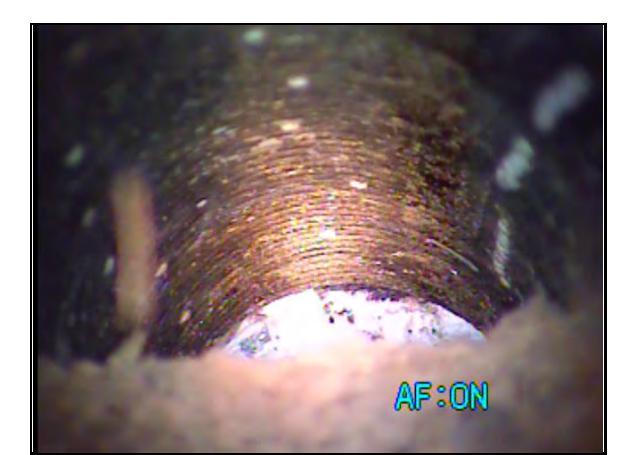
Pipe runs under the road. Downstream end of culvert is plastic pipe. Transition from CMP to plastic pipe appears to be offset. CMP portion has coating failure and minor corrosion at invert. CMP appears to be moderately to severely corroded near transition to plastic pipe.

View inside inlet.

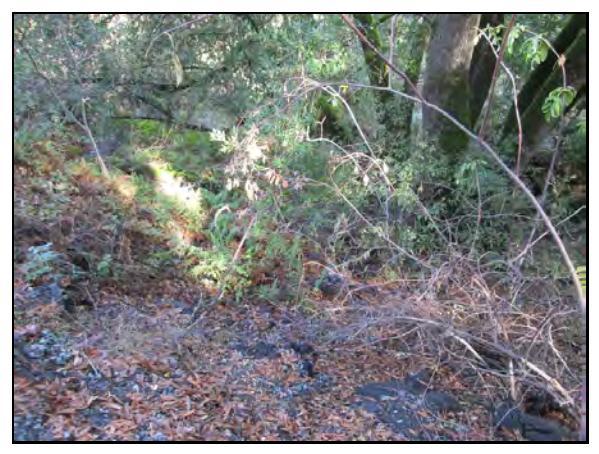
Area near outlet.

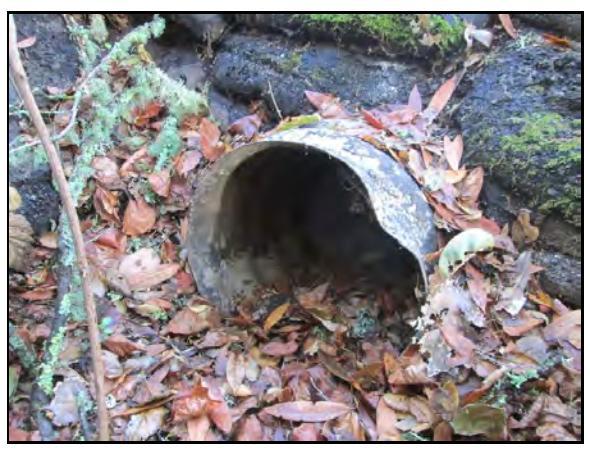
Inlet.

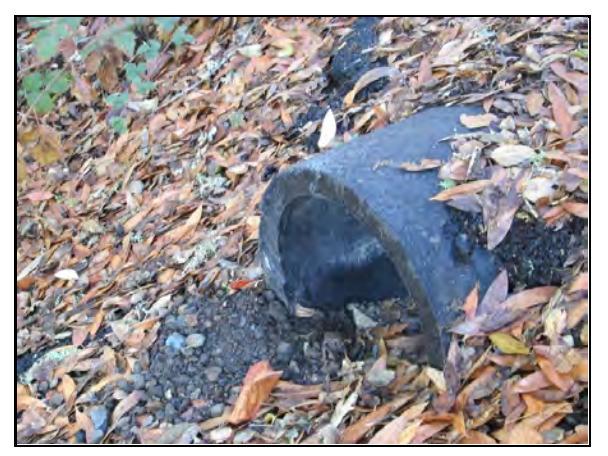
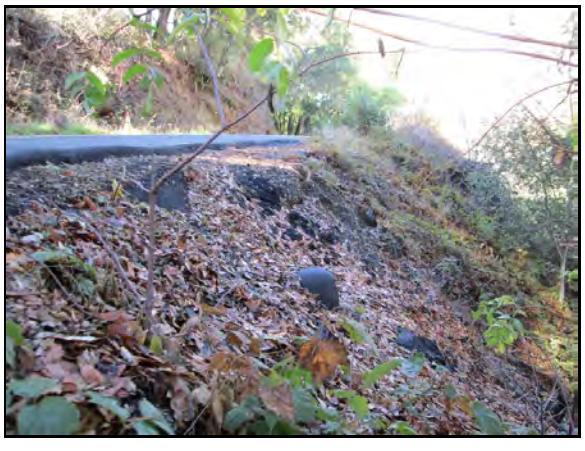
Outlet.

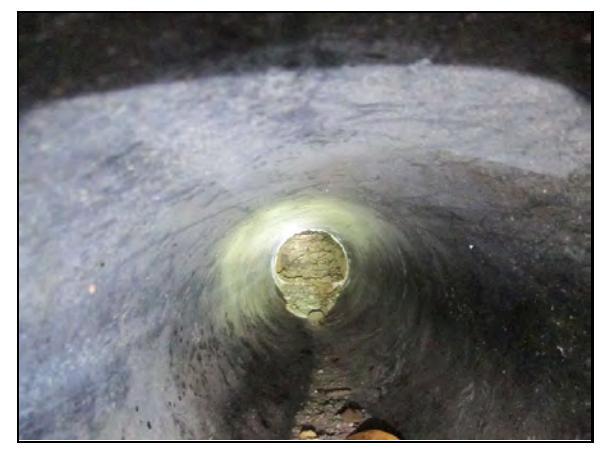
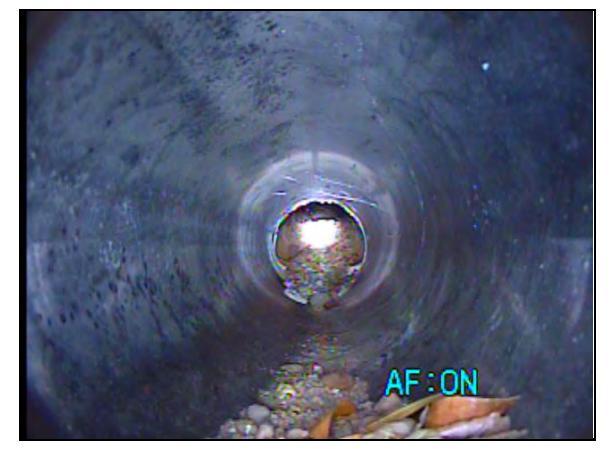
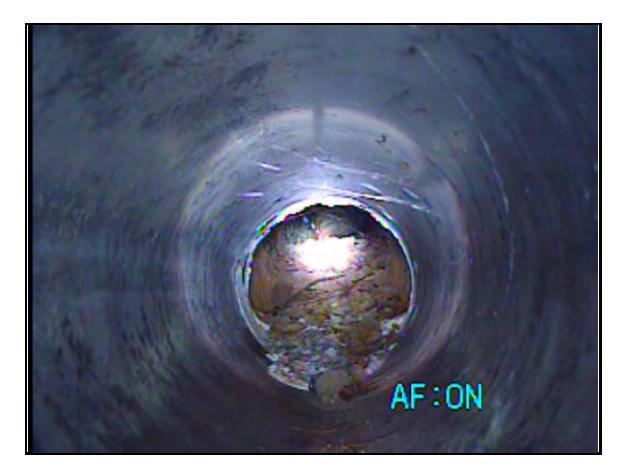
View inside outlet.

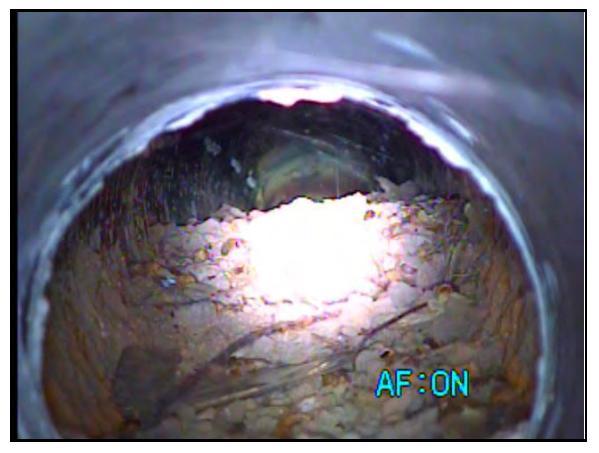
View inside outlet. CMP portion appears to be corroded at right.

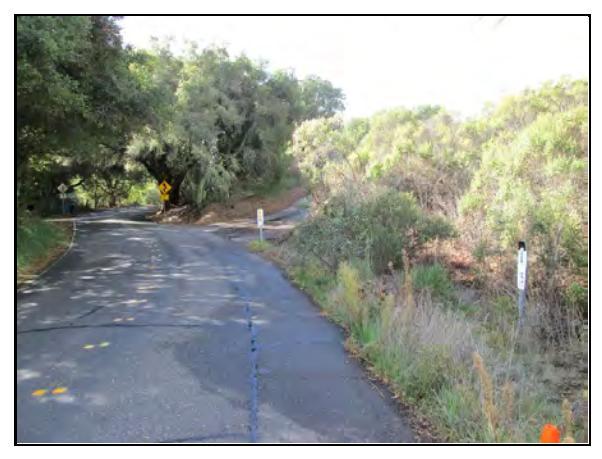
Area view.

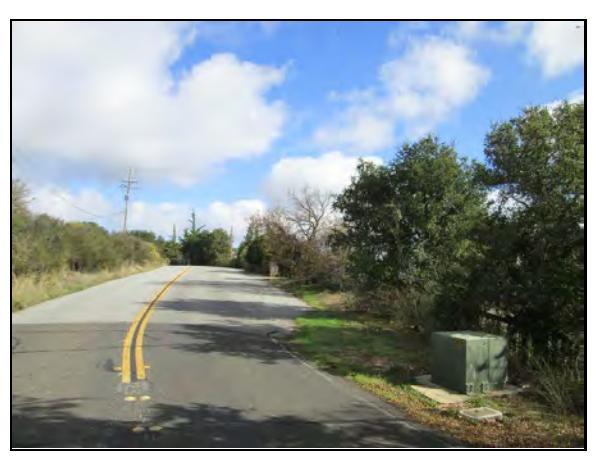
Area view.

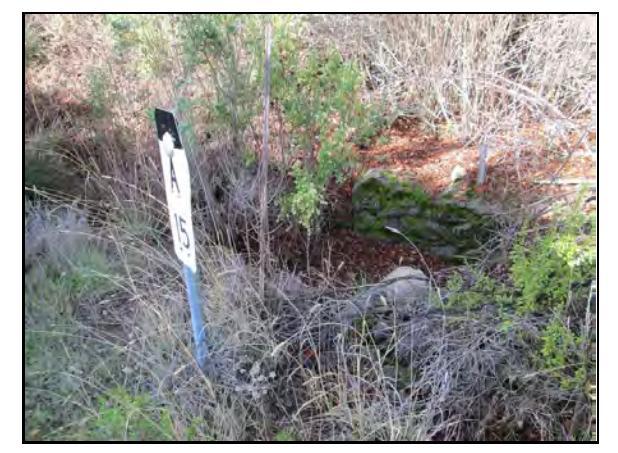
Area near inlet.

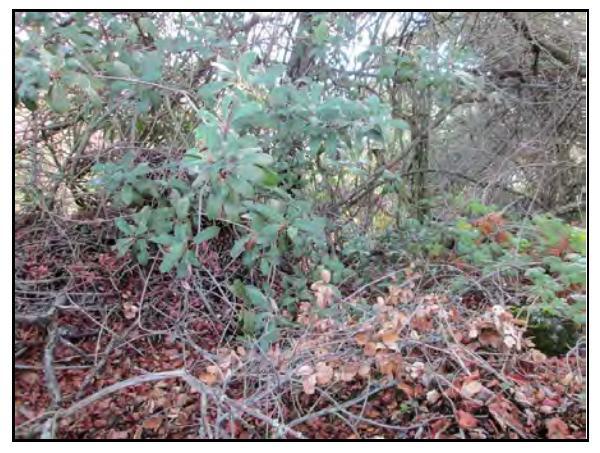
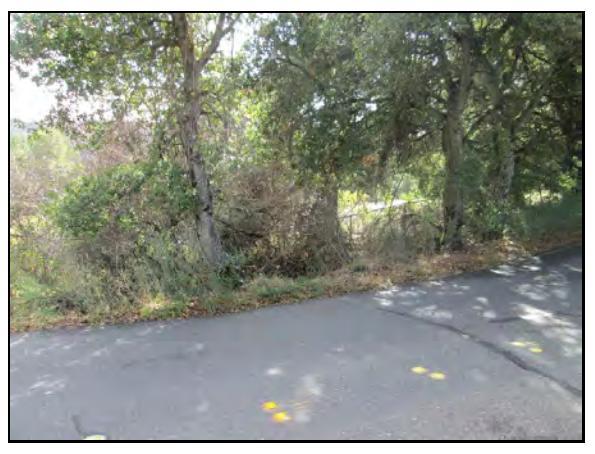
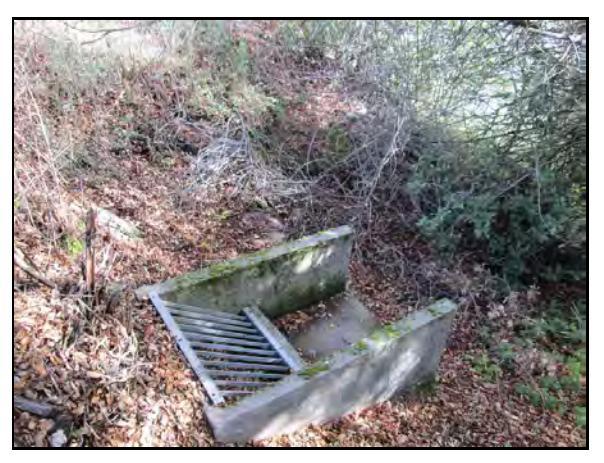
Area near outlet.

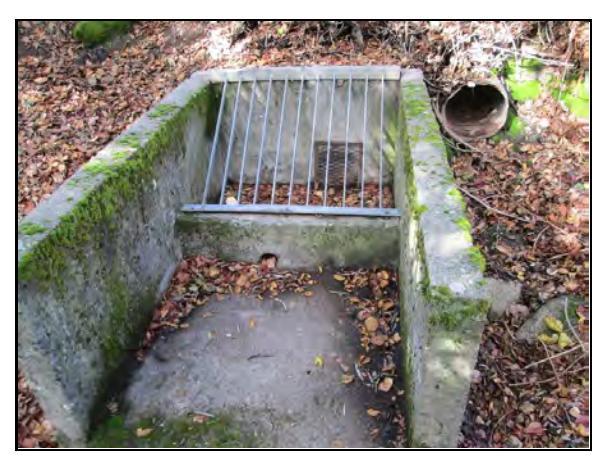
Area near outlet. Concrete headwall structure does not appear to be related to storm drainage.

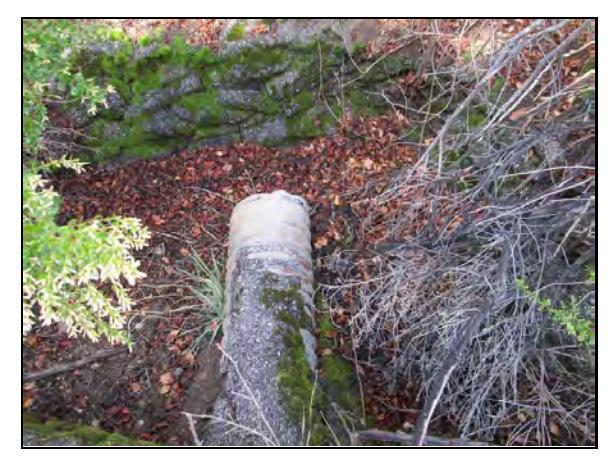
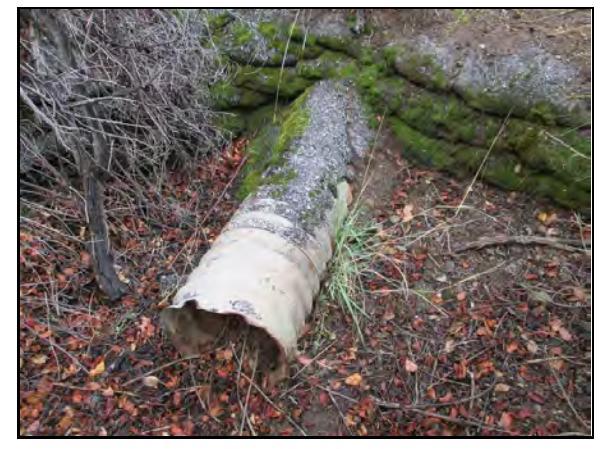
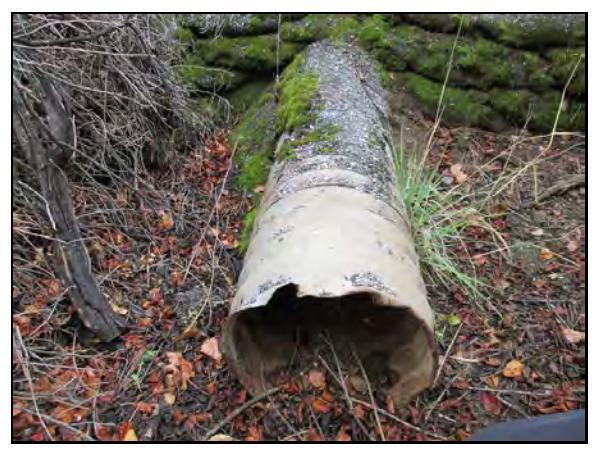
Inlet.

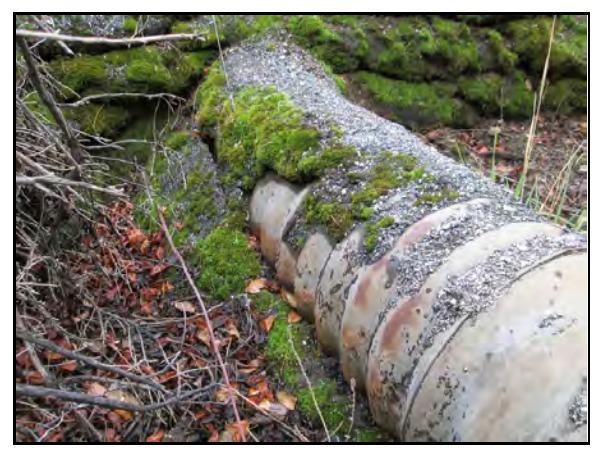
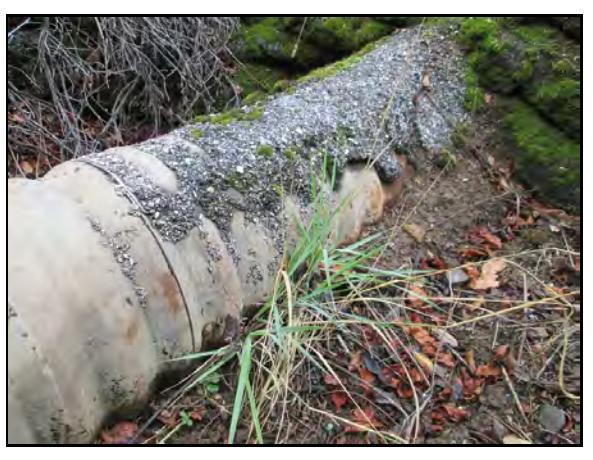
Exposed CMP at inlet.

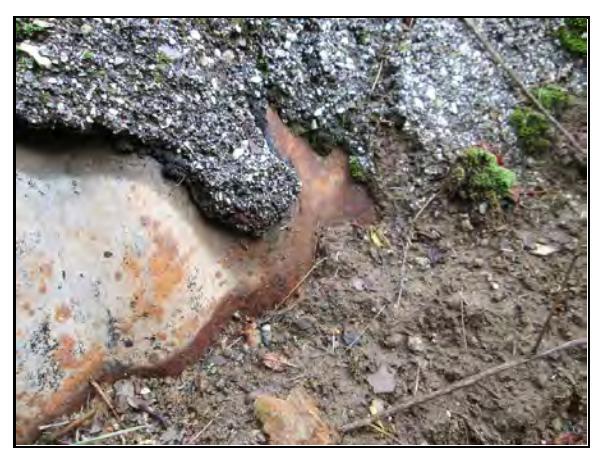
Exposed CMP at inlet with minor surface corrosion above soil.

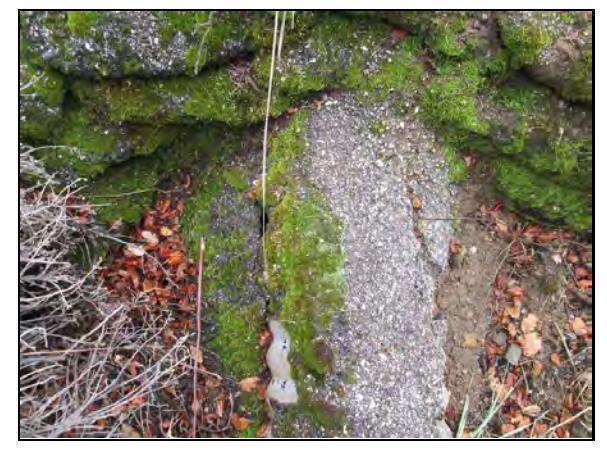
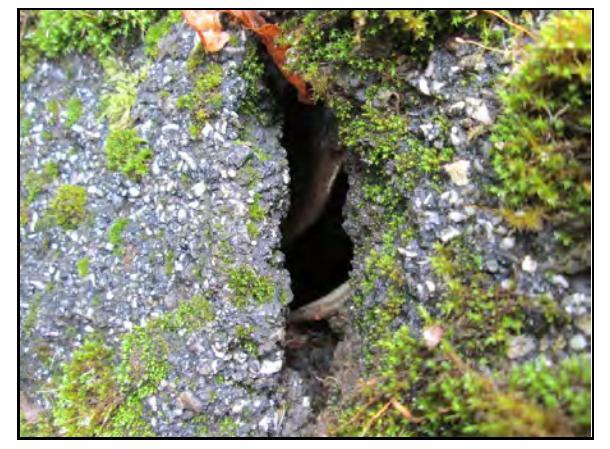
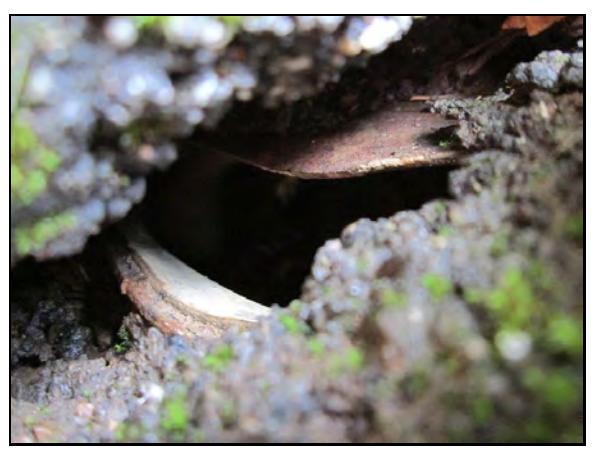
Pipe runs under the road. Marker post at inlet may penetrate the pipe. Possible additional third-party damage downstream from intlet. Coating failure and minor corrosion at invert. Void in soil next to outlet.

Separated joint near inlet.

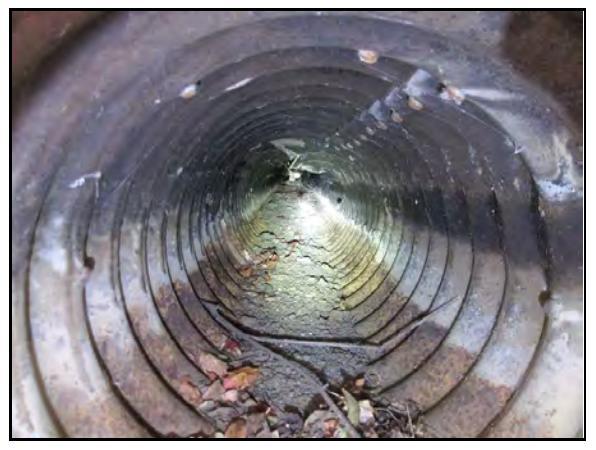
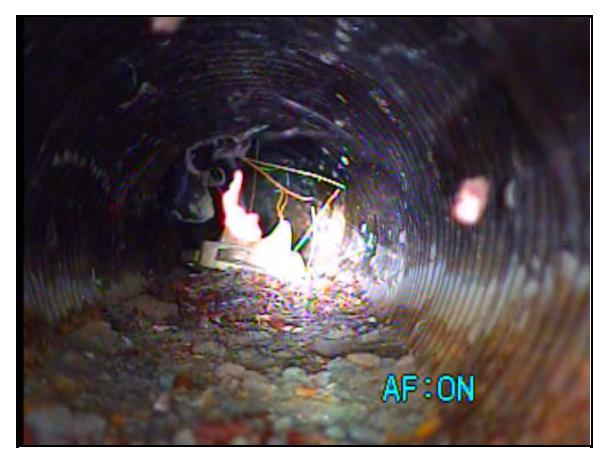
View inside inlet.

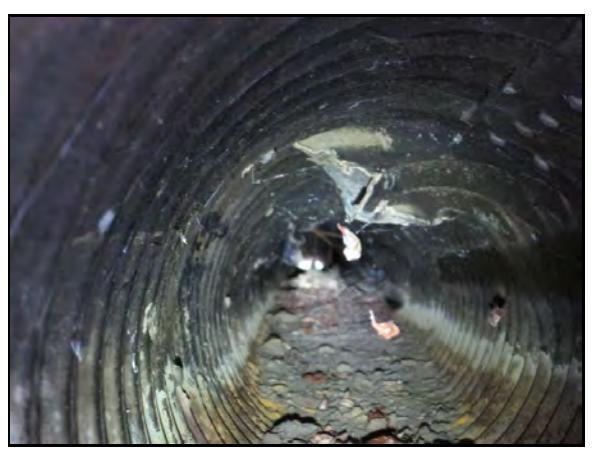
Puncture (possibly from marker post) at crown of pipe near inlet.

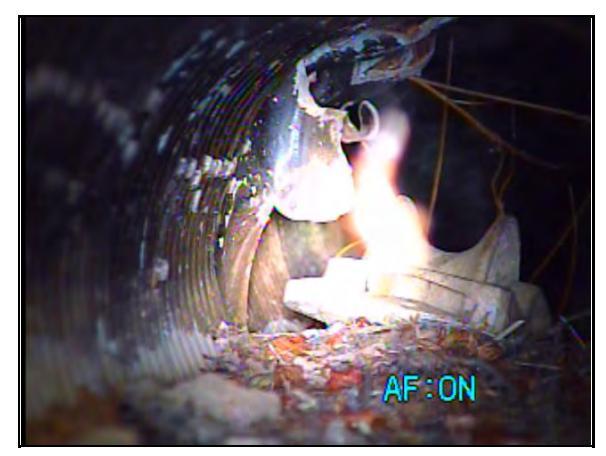
View inside inlet.

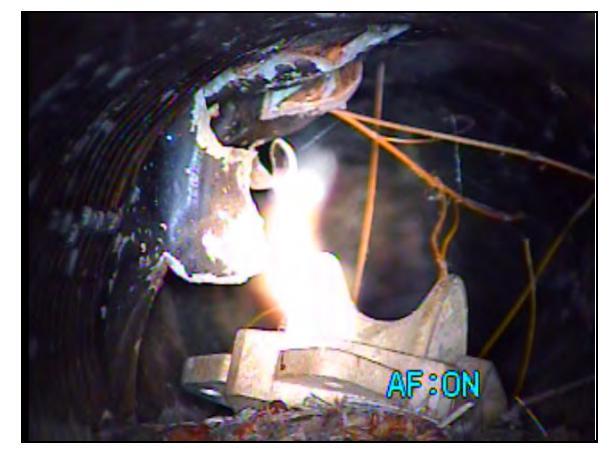
View inside inlet. Pipe may have third-party damage (puncture and debris inside) downstream from inlet.

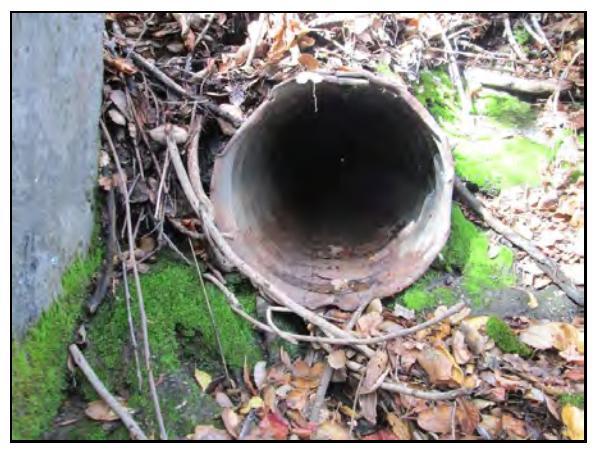
Outlet.

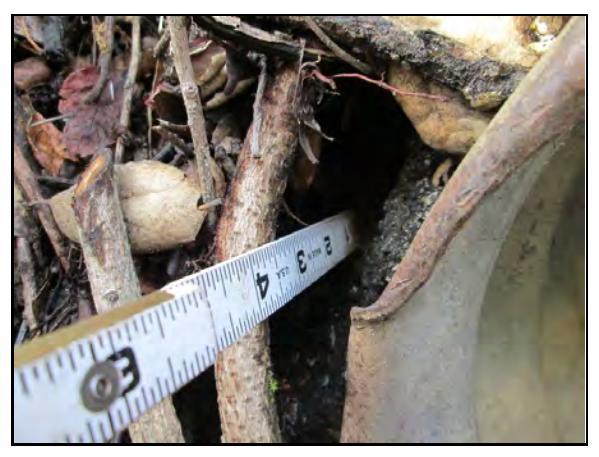
Void adjacent to outlet.

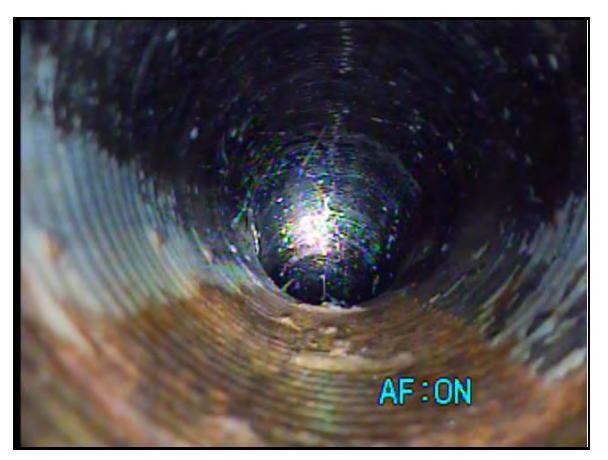
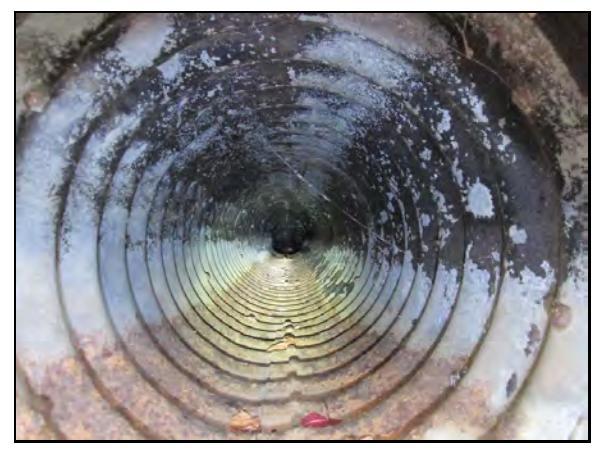
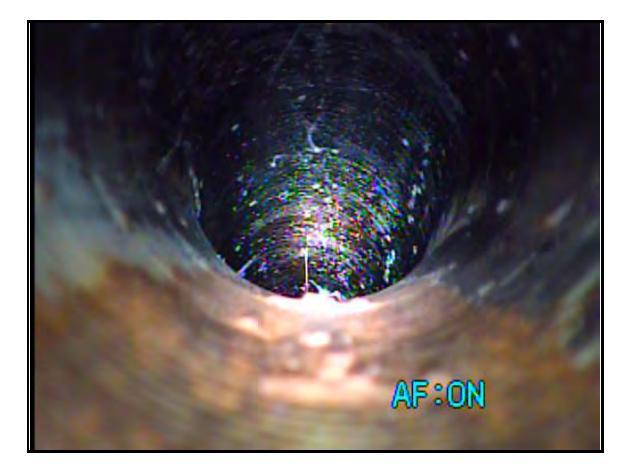
View inside outlet.

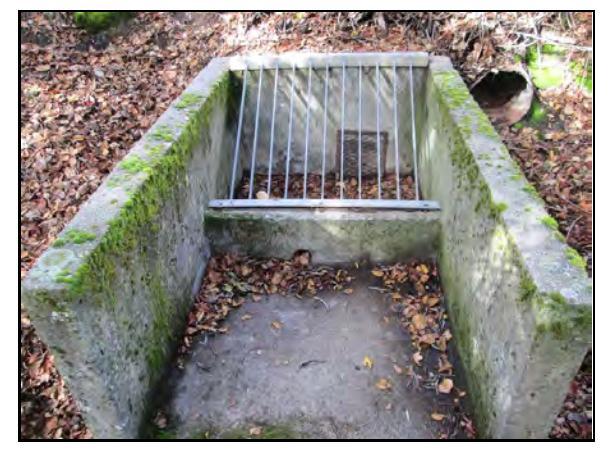
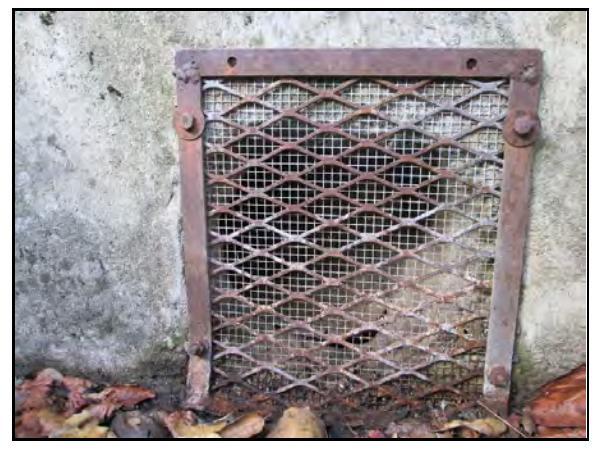
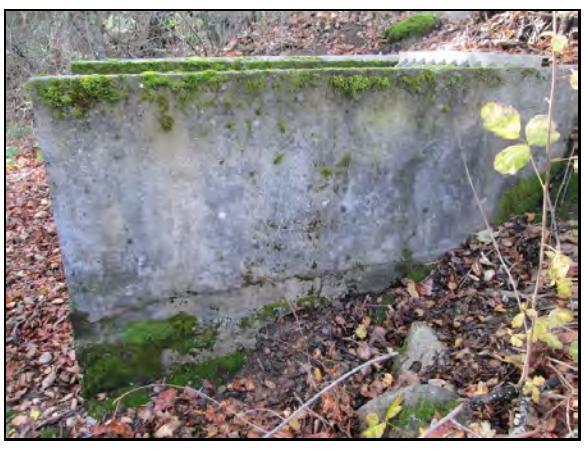
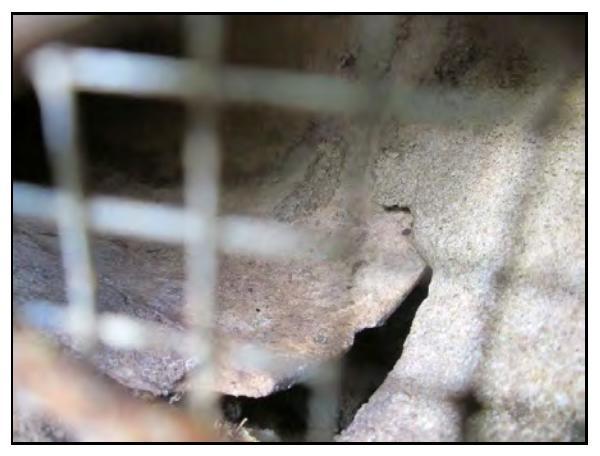
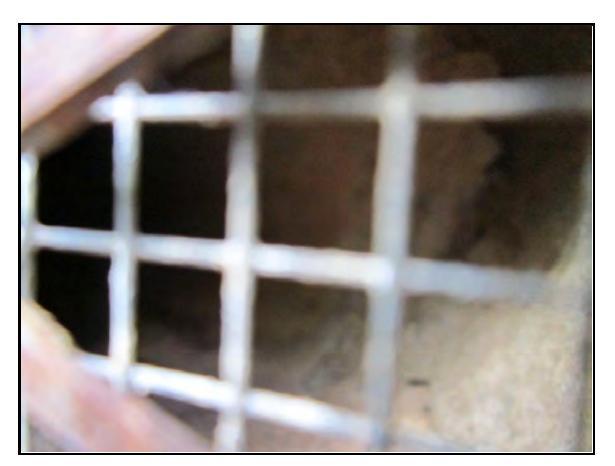
Outfall structure adjacent to culvert outlet.

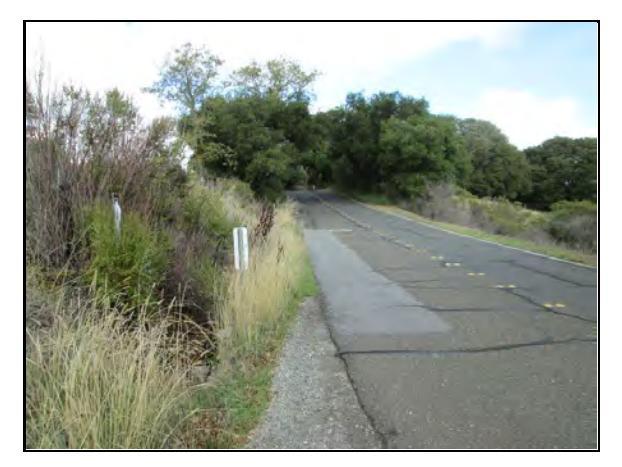
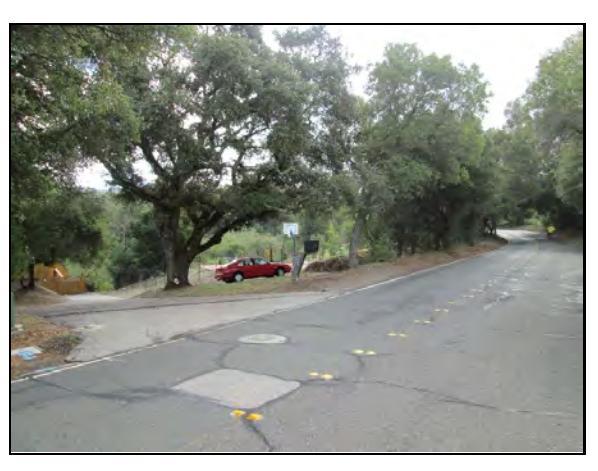
Culvert A-16

Pipe runs under the road. Coating failure and moderate corrosion near invert of pipe.

Area view.

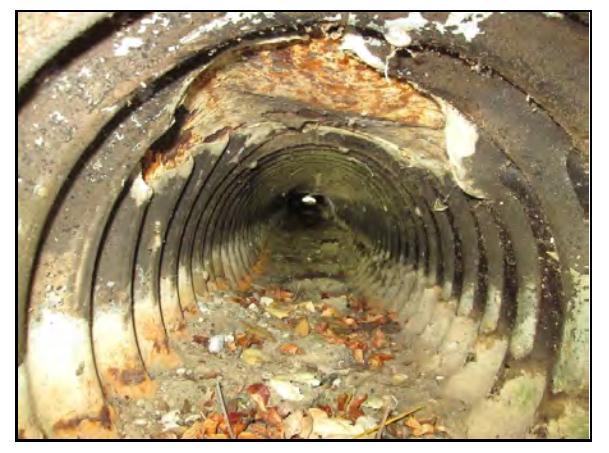
View inside inlet. Note hole in pipe at crown, apparently covered by concrete-filled bags.

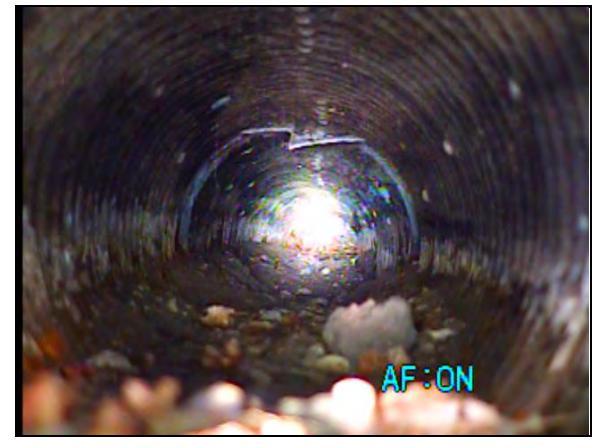
View inside inlet. Apparent deflection at crown at joint downstream.

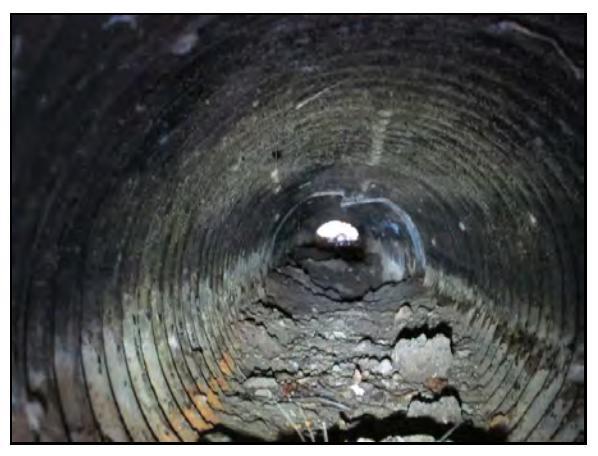
View inside inlet. Apparent deflection at crown at joint downstream.

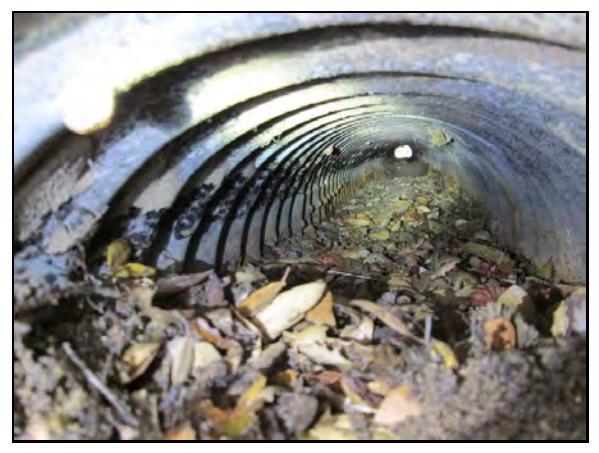
View inside outlet.

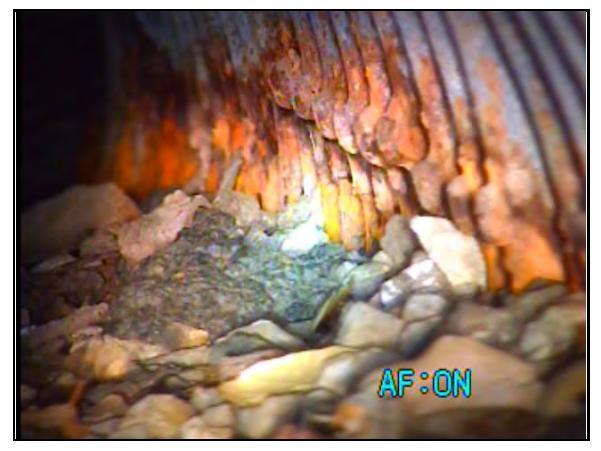
View inside outlet. Note moderate corrosion.

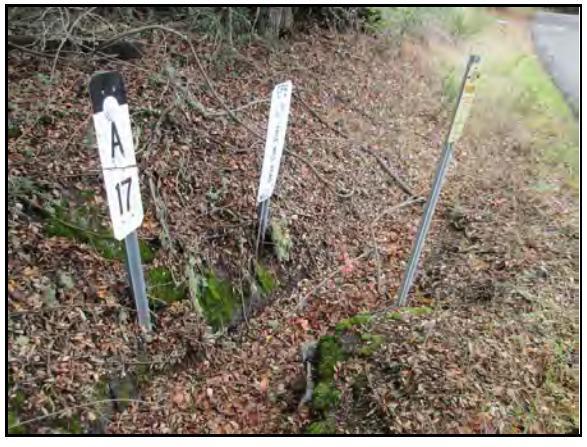
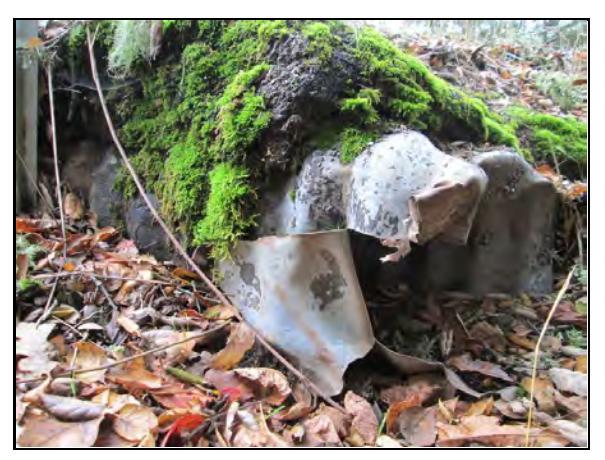
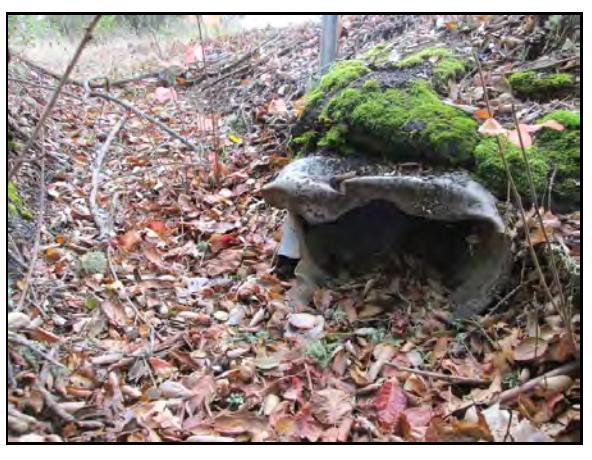
Culvert A-17

Pipe runs under the road. Pipe deflected and torn at inlet. Coating failure and minor corrosion at invert.

Inlet.
