Storm Drain Master Plan Update

June 2015

Public Works Department/Engineering Services Division

Schaaf & Wheeler CONSULTING CIVIL ENGINEERS

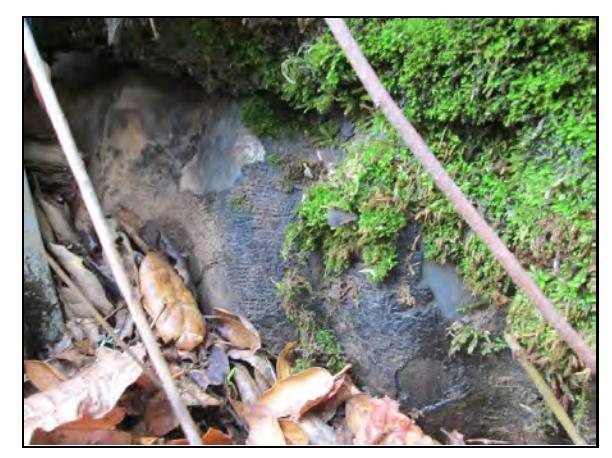
Coating failure on exterior of CMP at inlet.

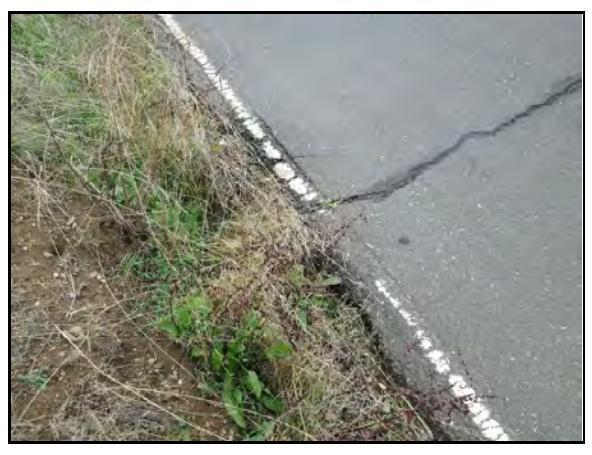
Crack in pavement extends across road above culvert.

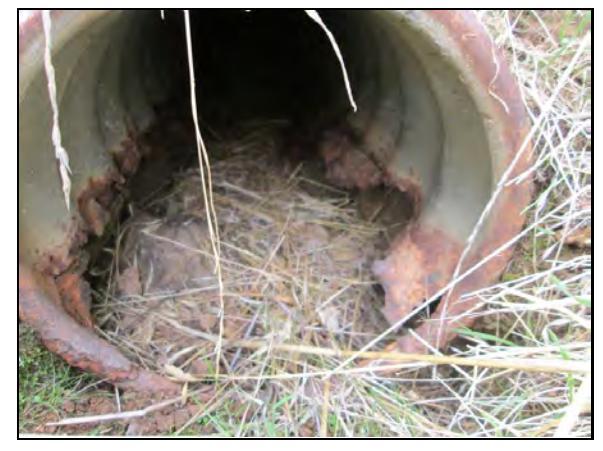
Inlet. Invert has corroded away.

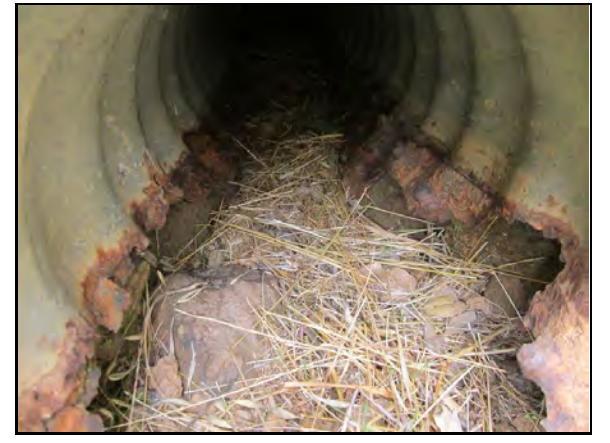
Missing invert at inlet.

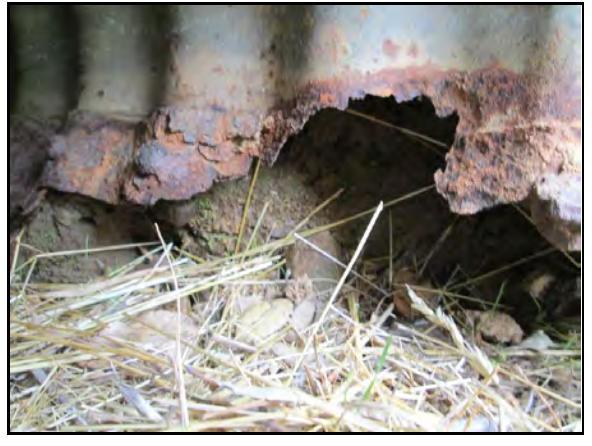
Missing invert at inlet.

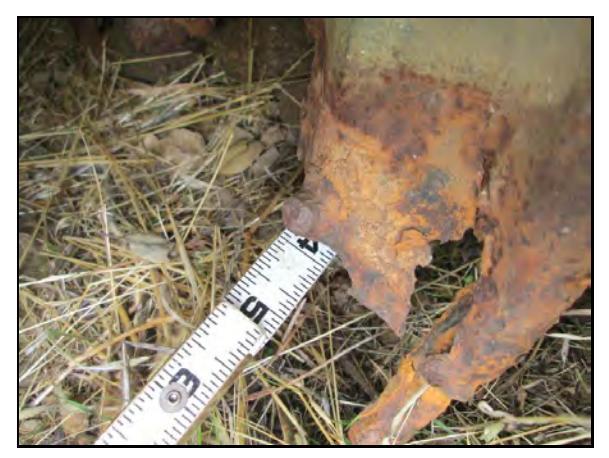
Missing invert at inlet.

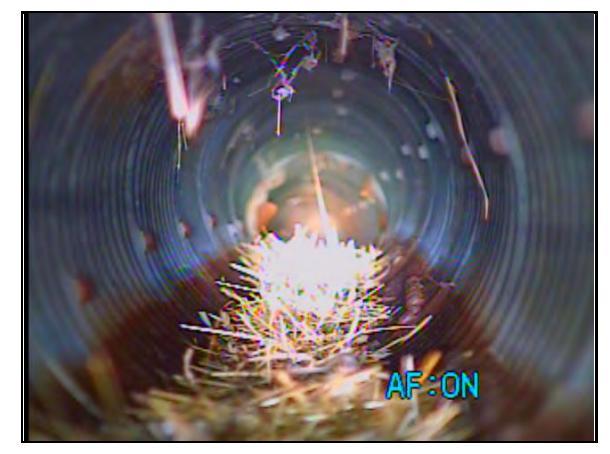
View inside inlet.

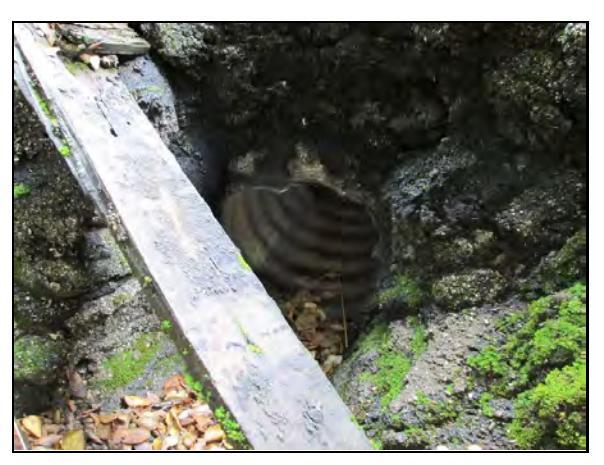
View inside inlet. Joint within pipe appears to be deflected.

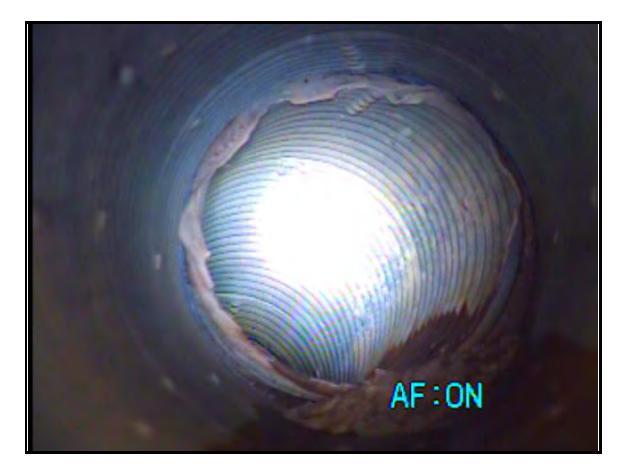
View inside outlet. Possible deflection at joint within pipe.

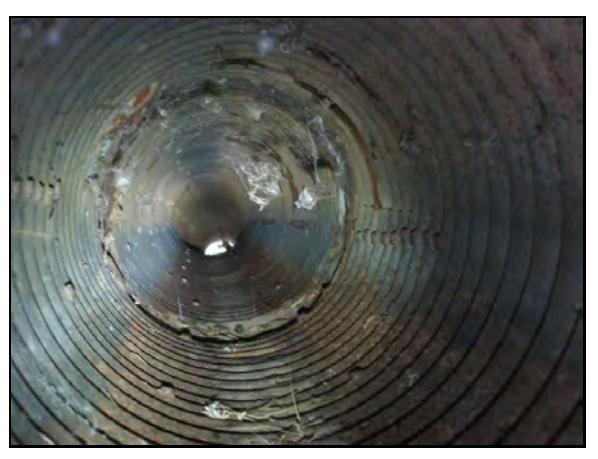
Pipe runs under the road. Outlet not accessible. Loss of galvanizing and moderate corrosion at invert. Separated or offset joint within pipe with soil visible.

View inside inlet. Separated or offset joint within pipe with soil visible.

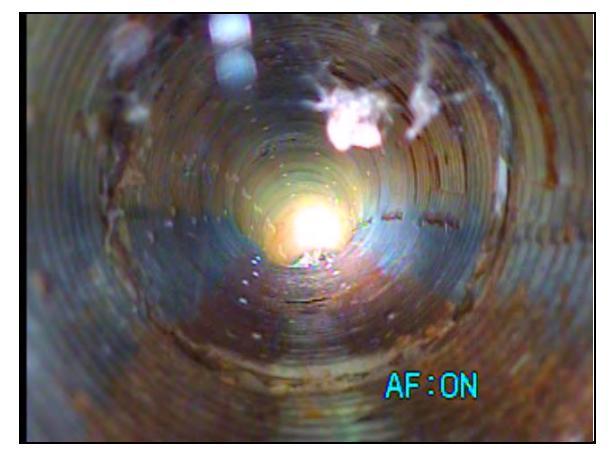
View inside inlet. Separated or offset joint within pipe with soil visible.

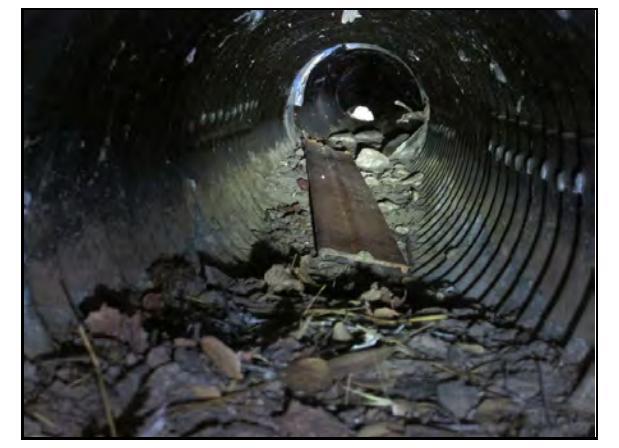
Pipe runs under the road. Outlet not accessible. Coating failure and minor corrosion at invert of CMP. Apparent separated joint within pipe near inlet. Ends of CMP deflected. Nearby short RCP culvert is in good condition.

View inside inlet.

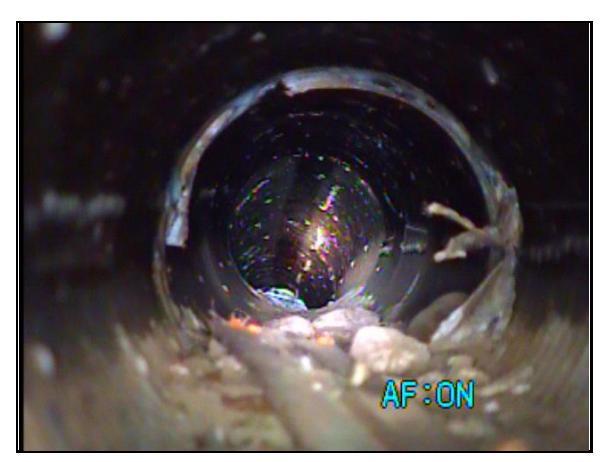
View inside inlet. Apparent separated joint within pipe.

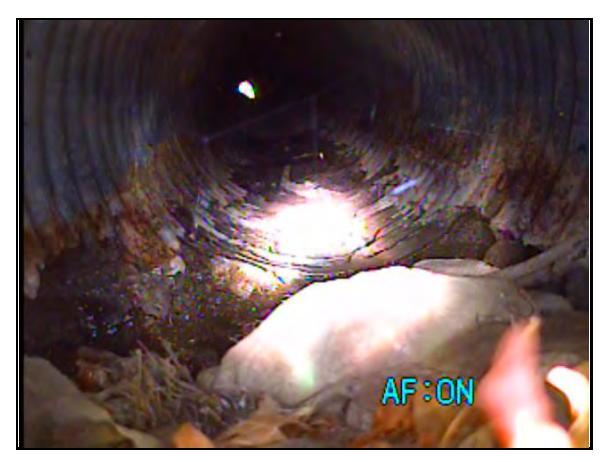
Invert missing along section of pipe downstream from inlet. Outlet not accessible.

View inside inlet. Invert missing over significant distance due to corrosion.

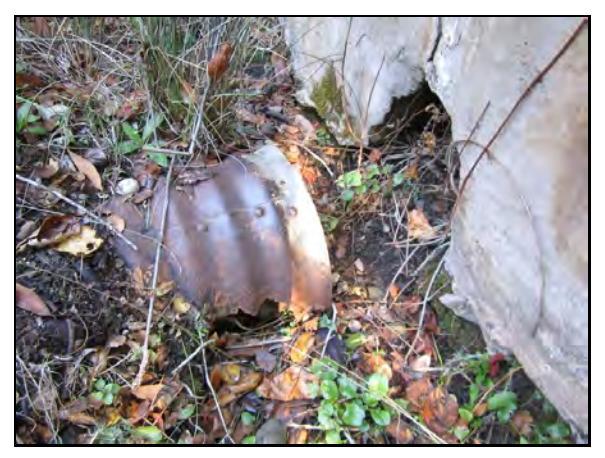
Pipe runs under the road. Moderate corrosion. Invert missing at inlet but not visible through majority of culvert due to debris. Concrete structure just upstream of inlet (purpose of structure is unknown) may obstruct flow into culvert; hole at bottom of structure does not allow flow to pass through.

Inlet. Purpose of concrete structure at right is unknown. Hole at bottom of concrete structure does not appear to allow flow to pass through. Invert of CMP at inlet is missing due to corrosion.

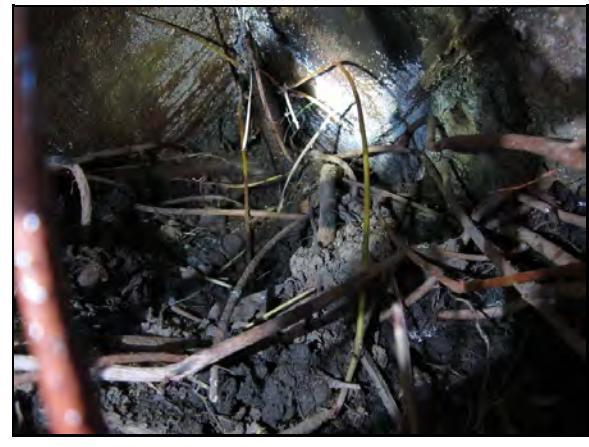
View inside hole at bottom of concrete structure near inlet. Hole is full of debris and may not pass all the way through the structure.

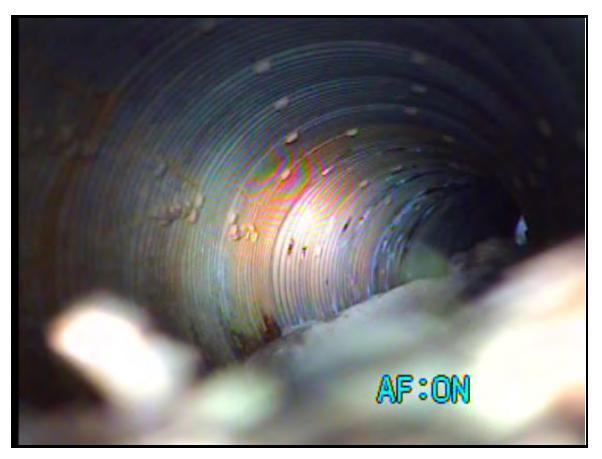
View inside outlet.

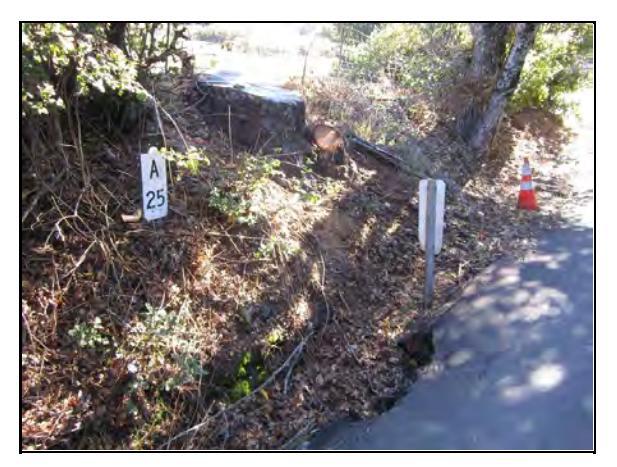
Culvert A-25

About 75 percent sediment in the downstream end. Loss of galvanizing and moderate corrosion at invert. Edge of pavement at inlet is becoming undermined.

Area view.

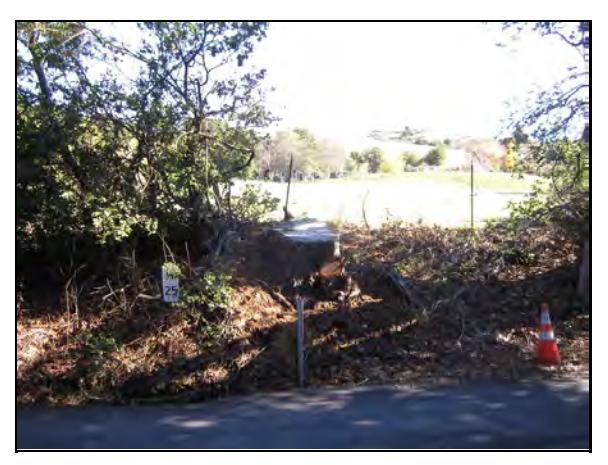
Area near inlet.

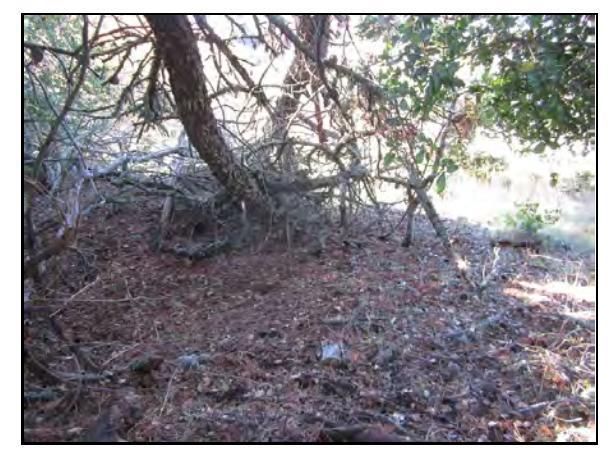
Area near outlet.

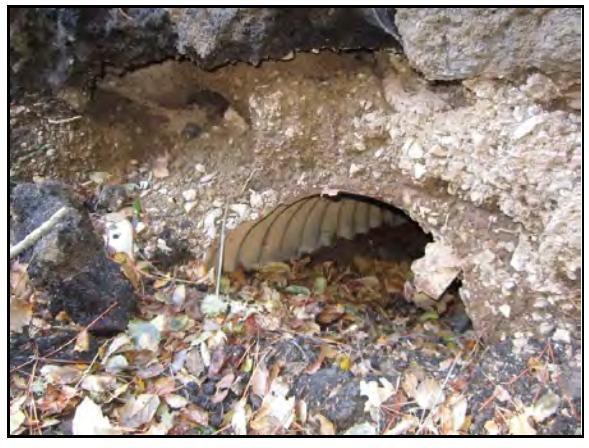
Inlet. Edge of pavement is becoming undermined.

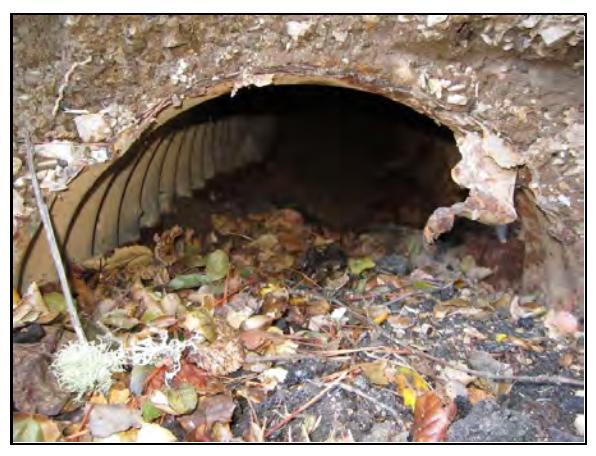
Inlet.

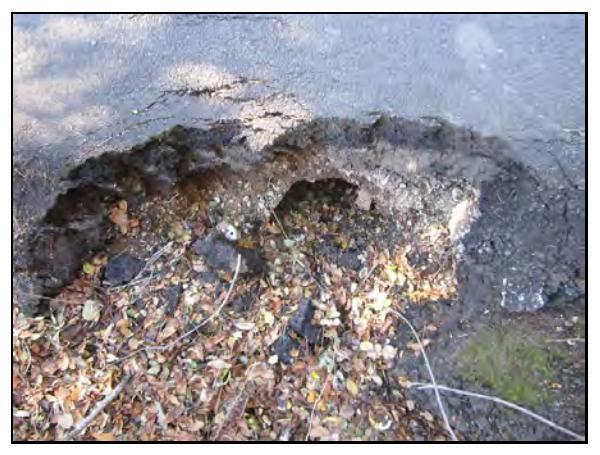
Inlet. Edge of pavement is becoming undermined.

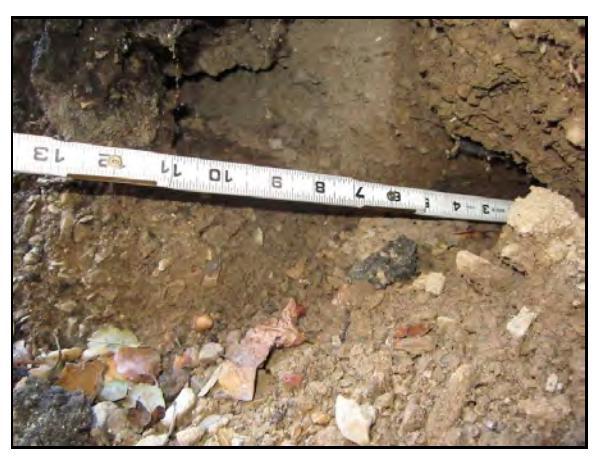
Void under pavement above inlet.

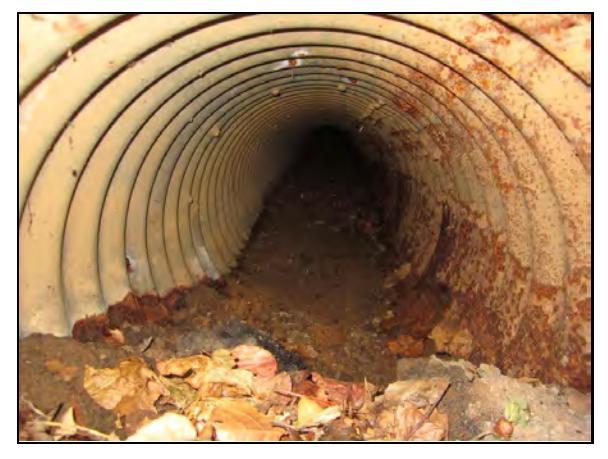
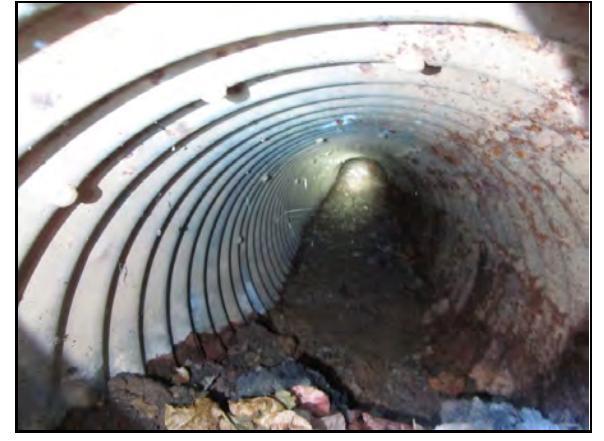
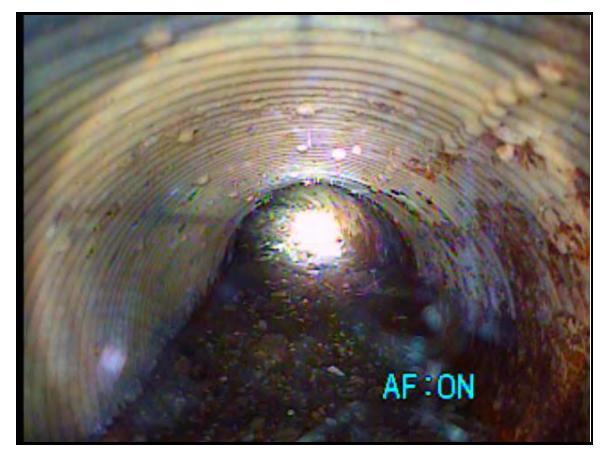
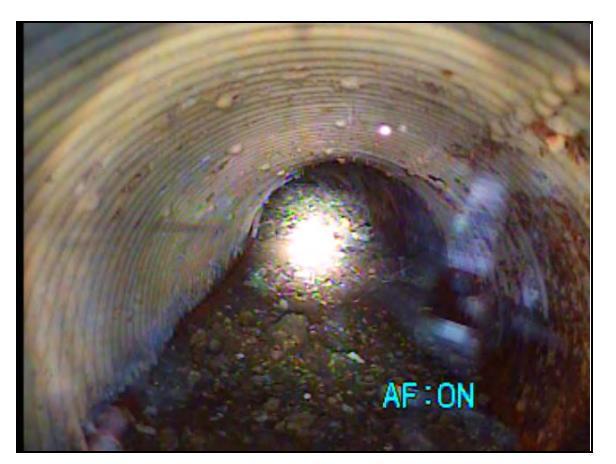
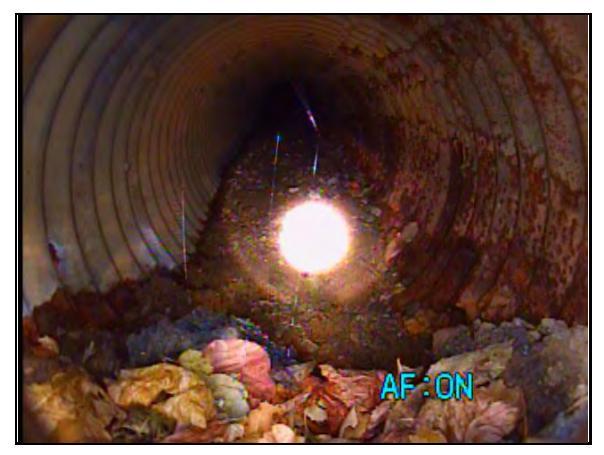
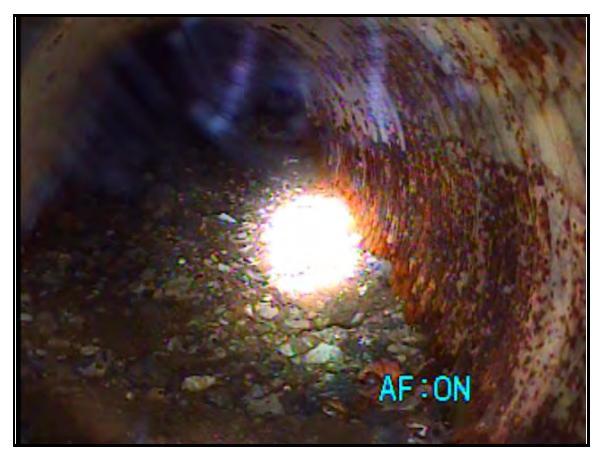
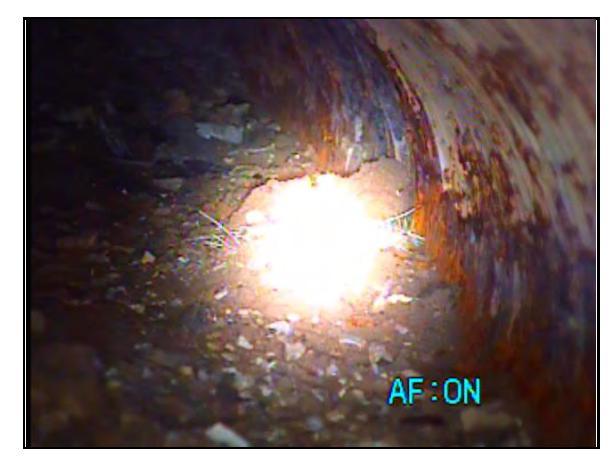
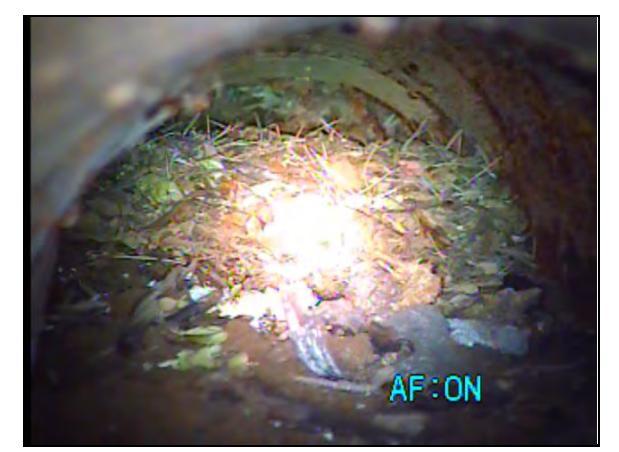
View inside inlet.

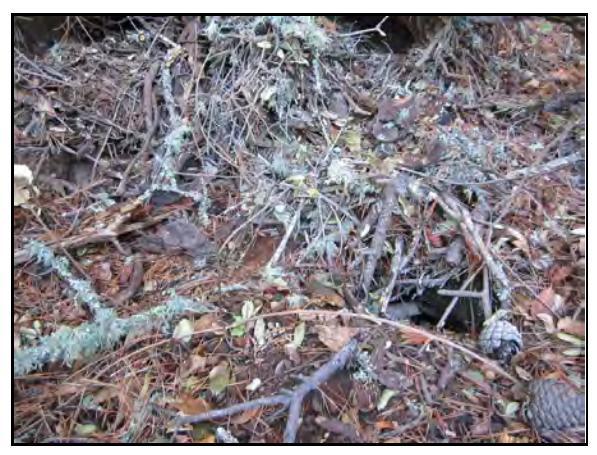
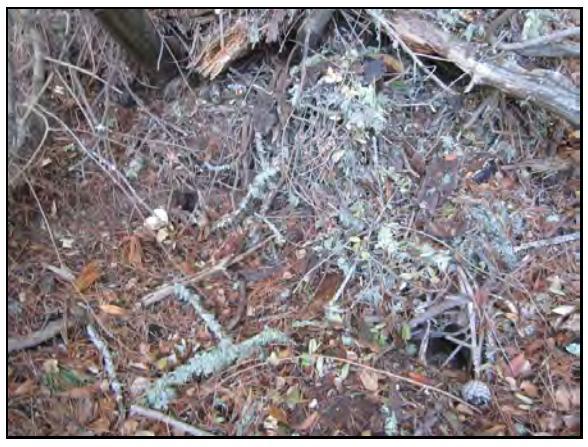
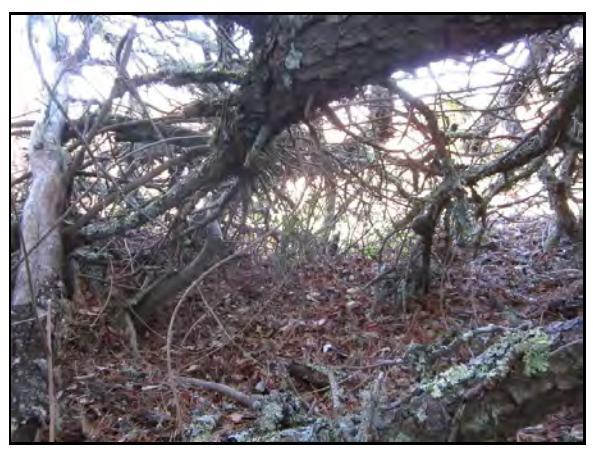
Outlet about 3/4 obstructed.

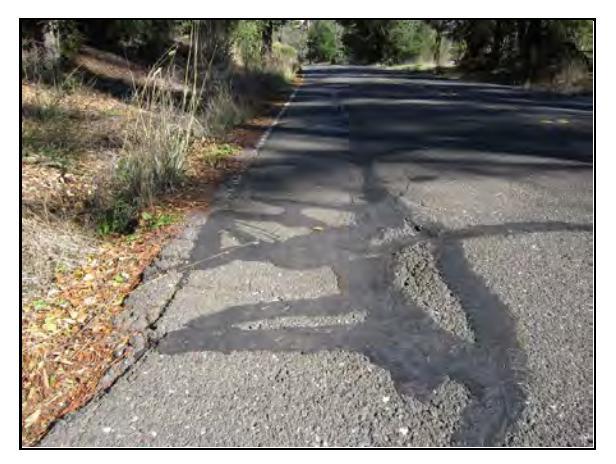
Culvert A-26

Culvert may be completely obstructed with soil, gravel, etc. Minor to moderate corrosion visible.

Area view.

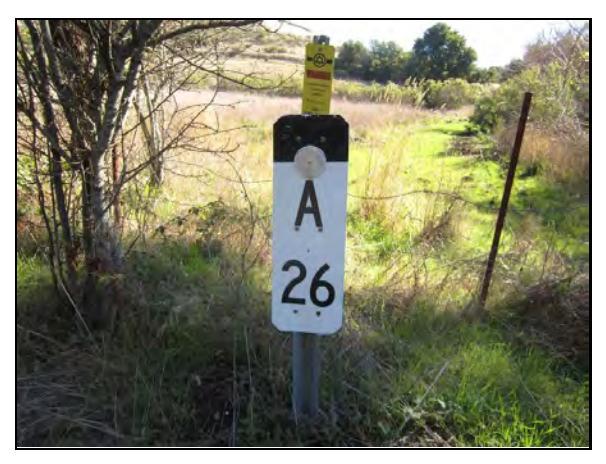
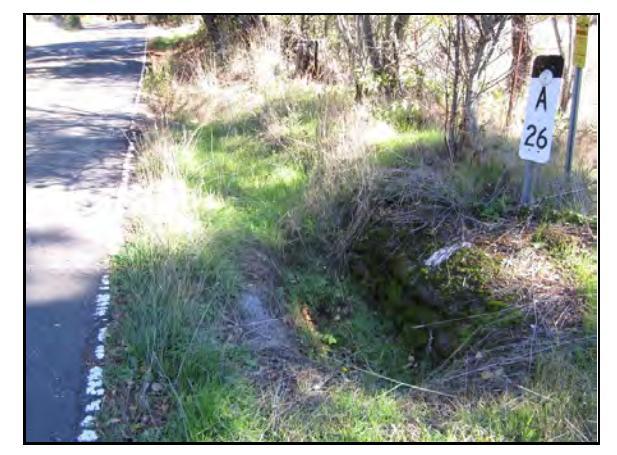
Area near inlet.

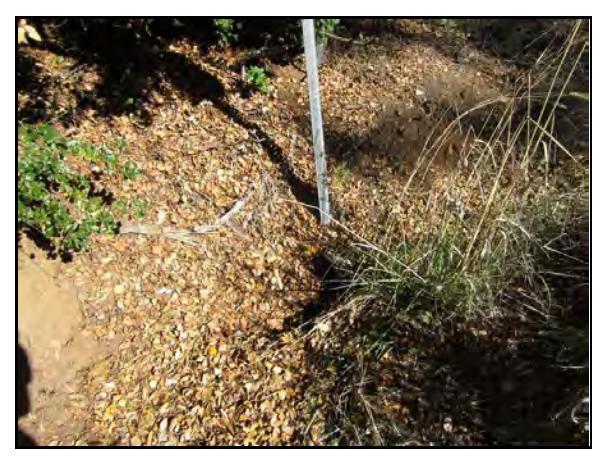
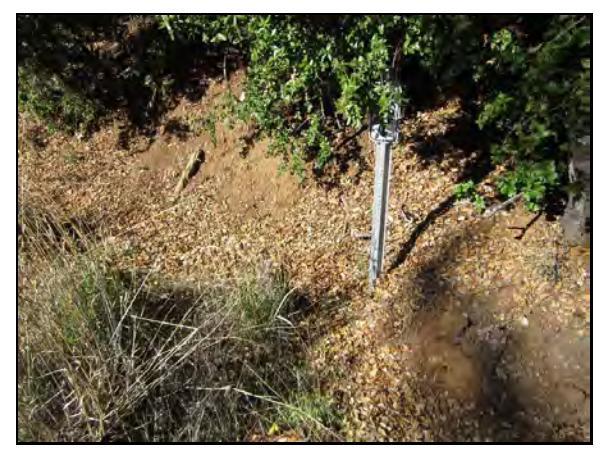
Area near outlet.

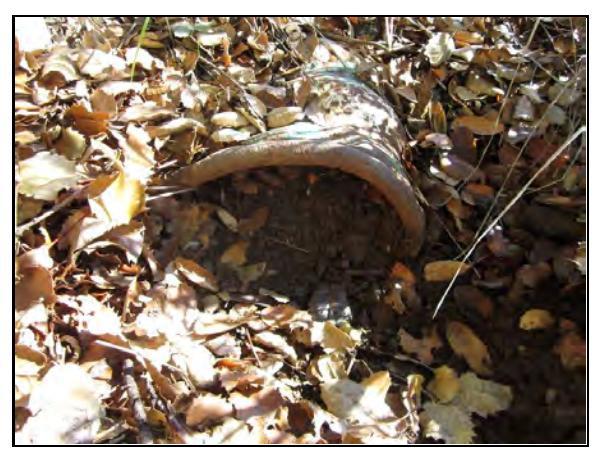
Outlet.

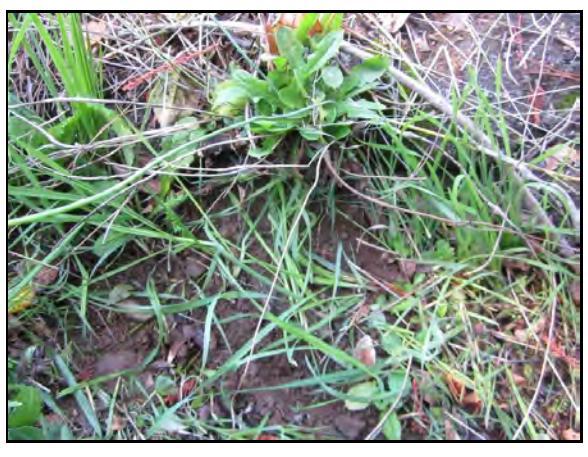
Inlet.

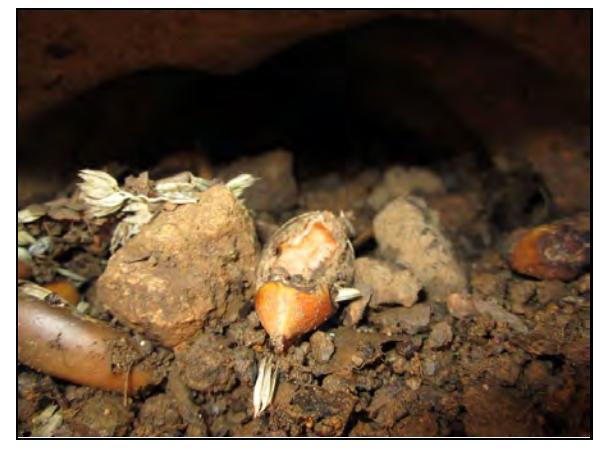
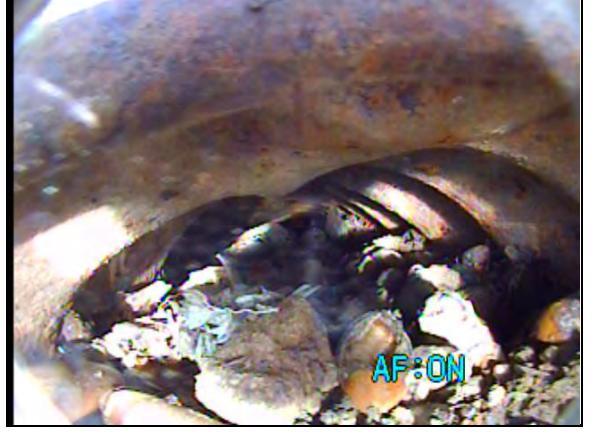
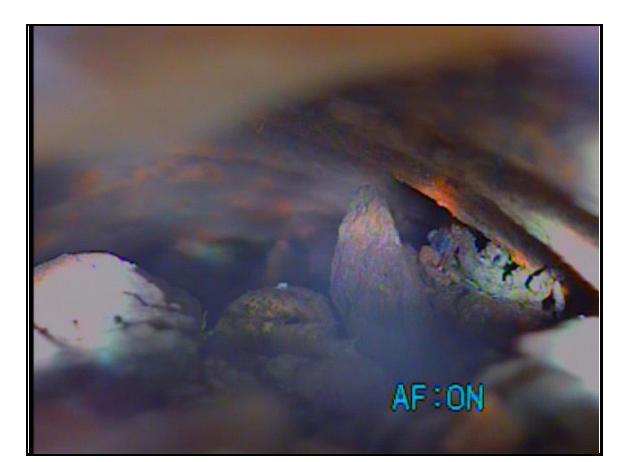
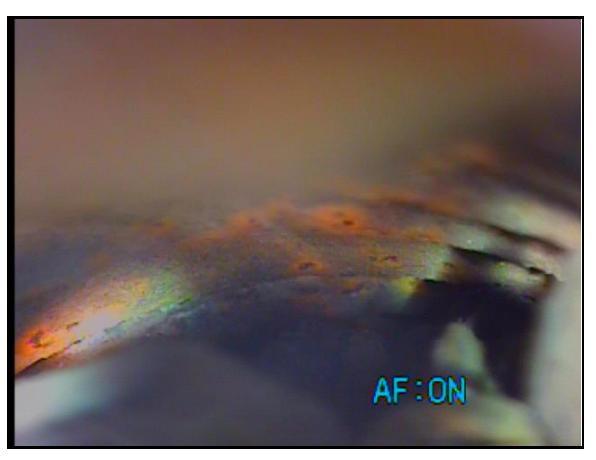
View inside outlet.

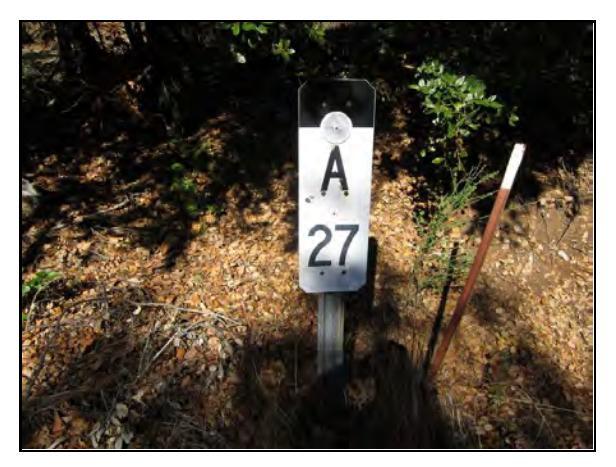
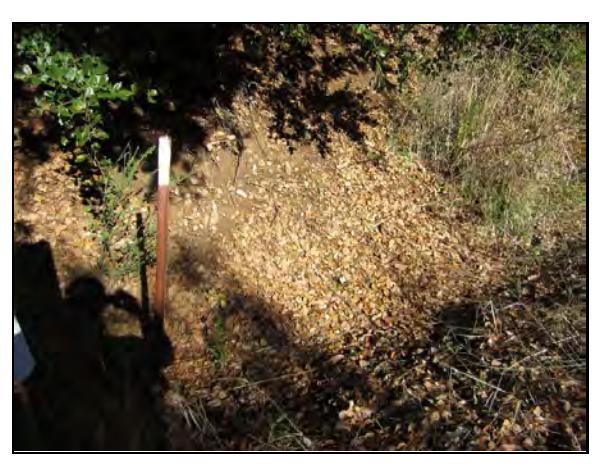
Culvert A-27

Loss of galvanizing and moderate corrosion on interior pipe surfaces. Pipe deflected at inlet.

Area near inlet.

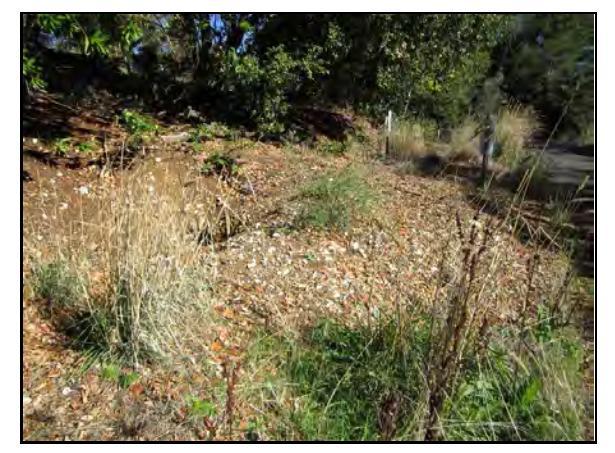
Area near outlet.

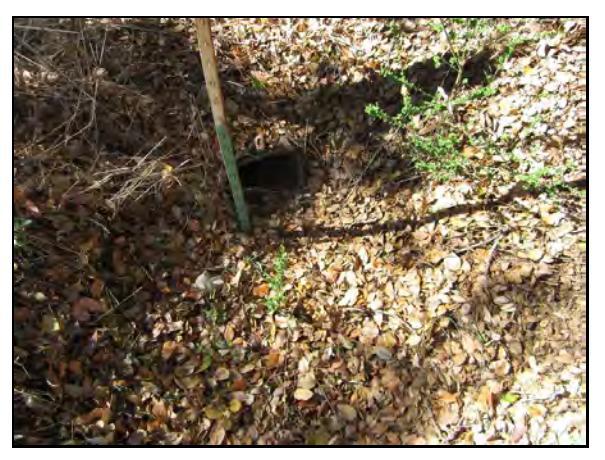
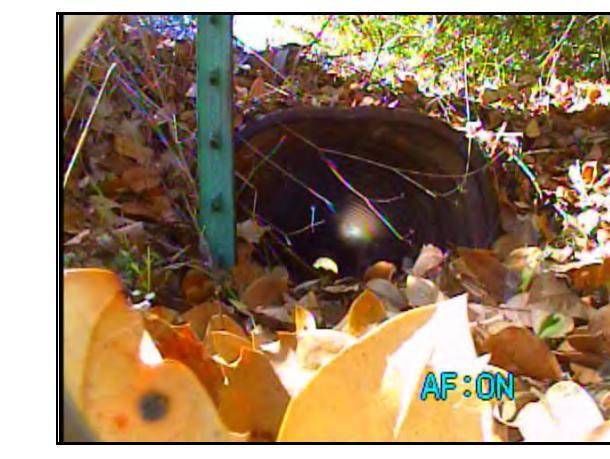
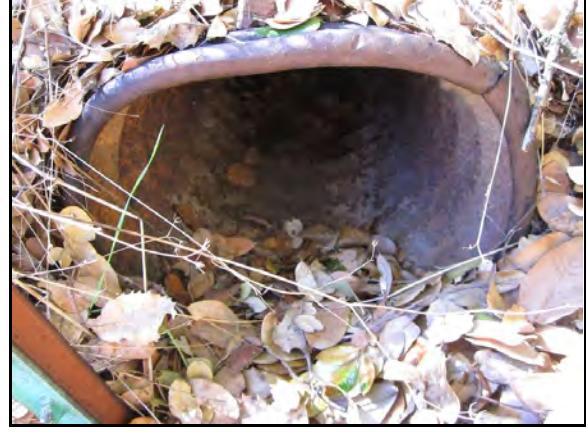
Inlet.

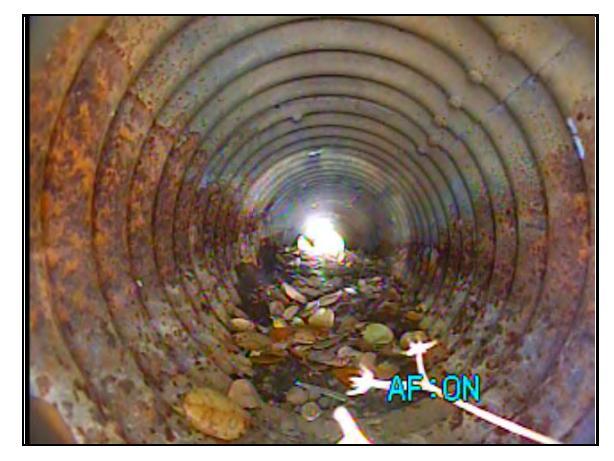
View inside inlet.

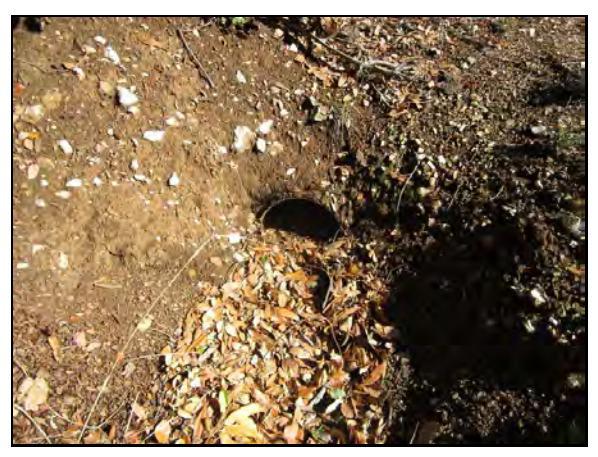
Outlet.

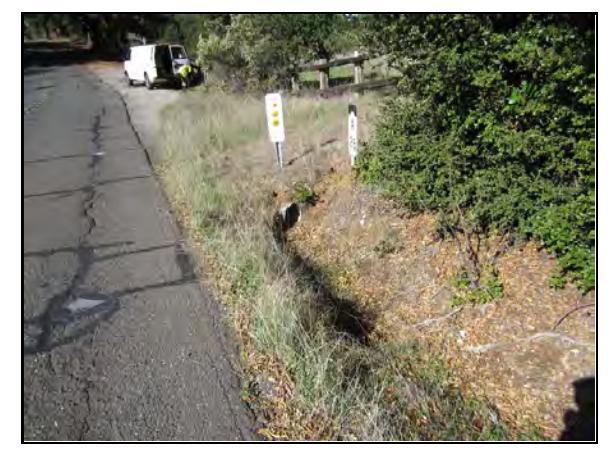
Area near inlet.

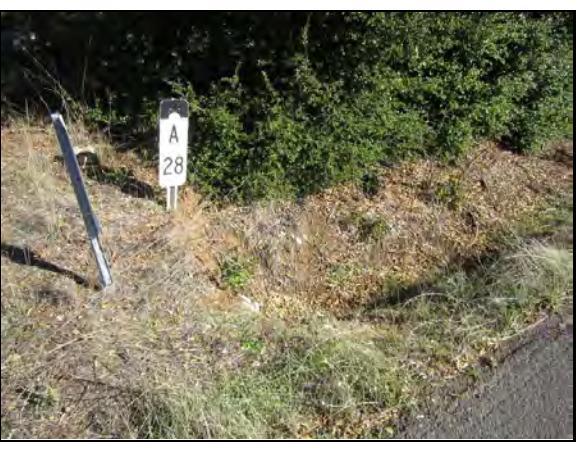
Area near inlet.

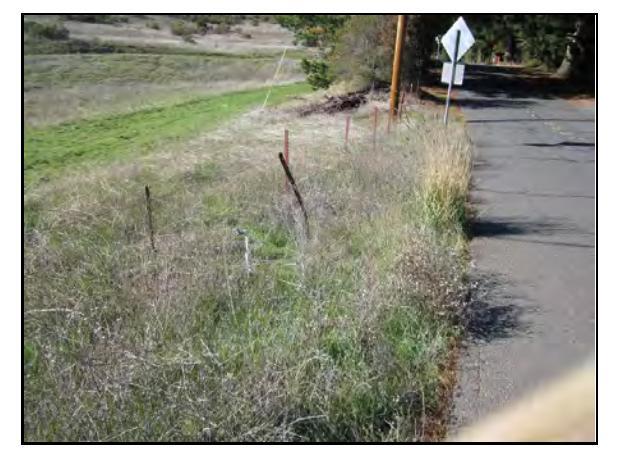
Area near outlet.

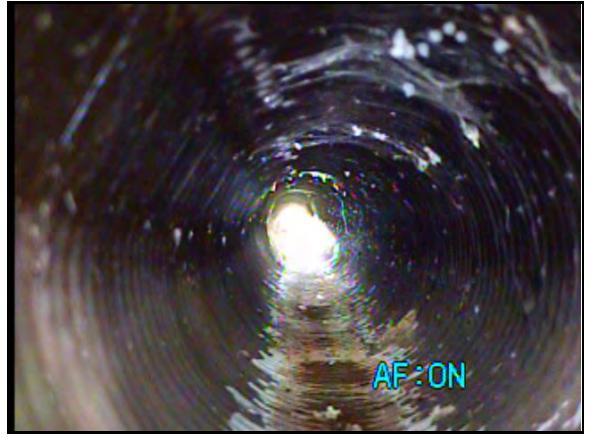
Pipe runs under the road. Coating failure and minor corrosion at invert.

View inside inlet.

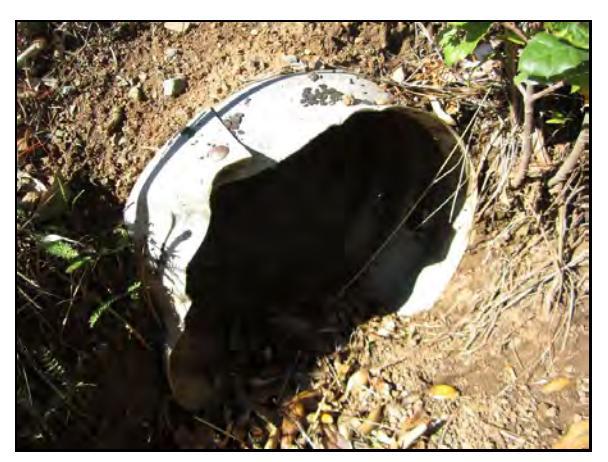
Inlet.

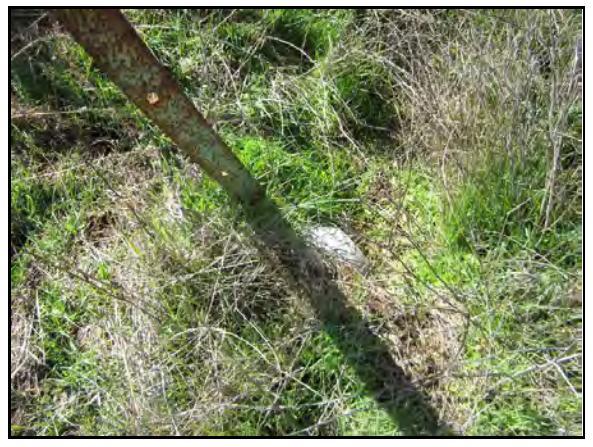
Outlet.

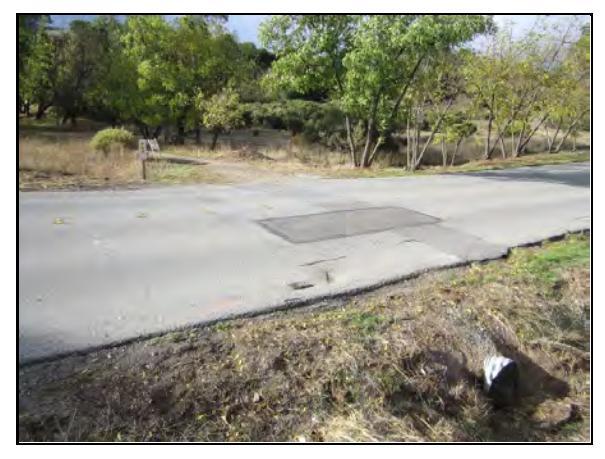
Area view.

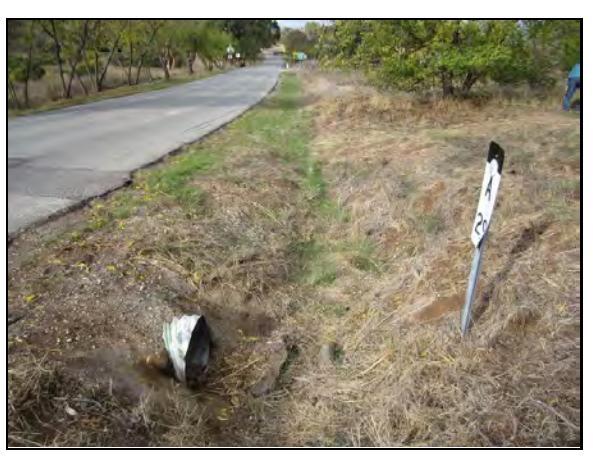
Area near inlet.

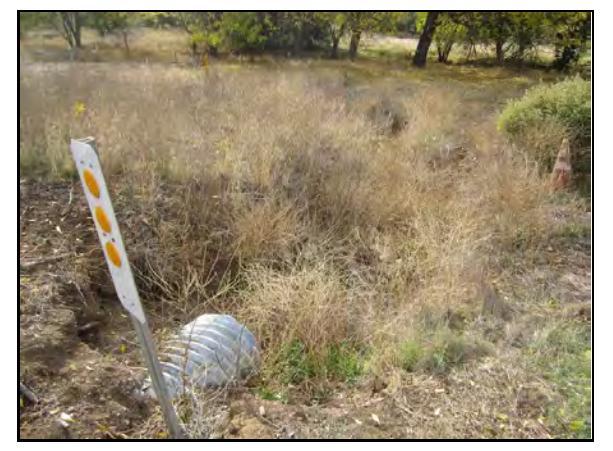
Area near outlet.

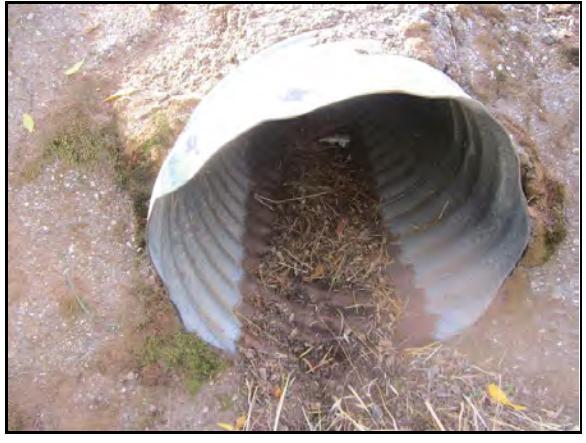
Inlet.

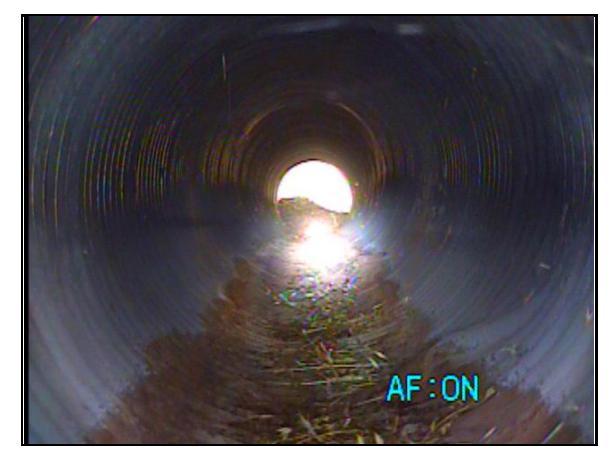
Pipe runs under the road. Possible small perforation and puncture near invert near inlet. Loss of galvanizing and minor corrosion at invert throughout culvert.

View inside inlet. Deflection and possible puncture at lower right.

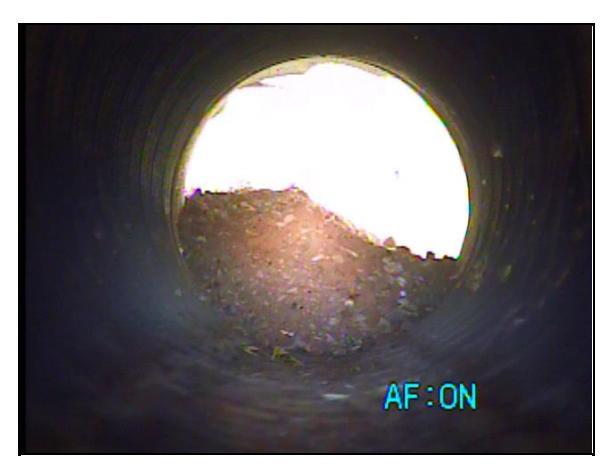
View inside inlet.

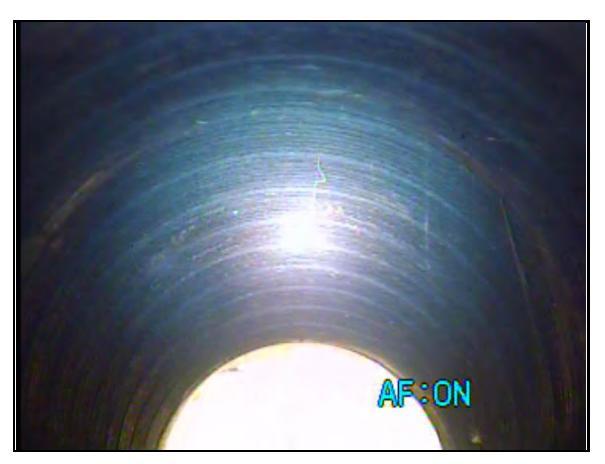
View inside inlet.

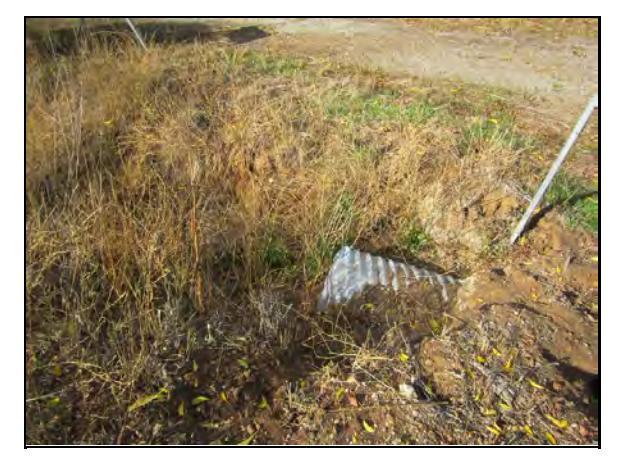
Outlet.

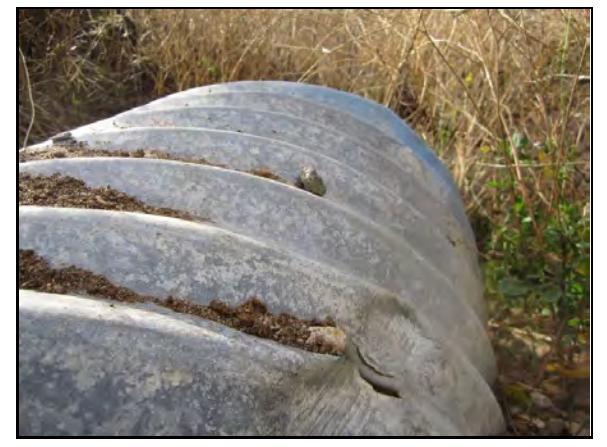
Exposed CMP at outlet.

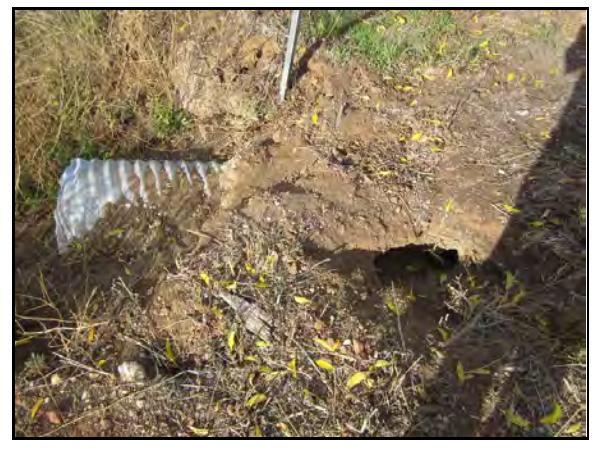
Void in soil above pipe at outlet.

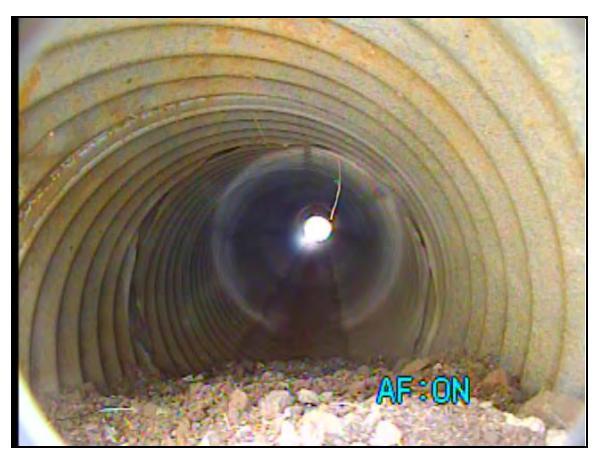
View inside outlet.

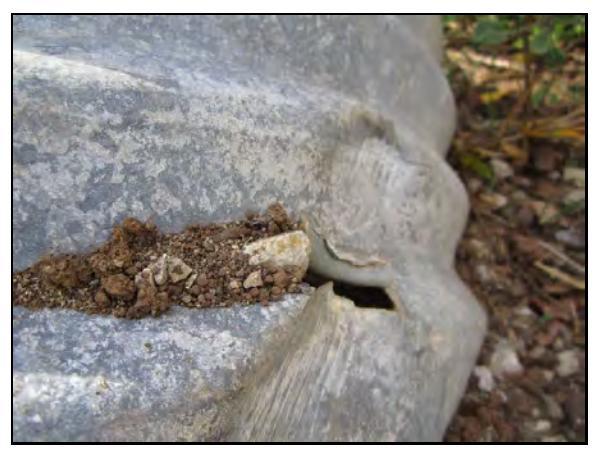
Puncture in exposed CMP at outlet.

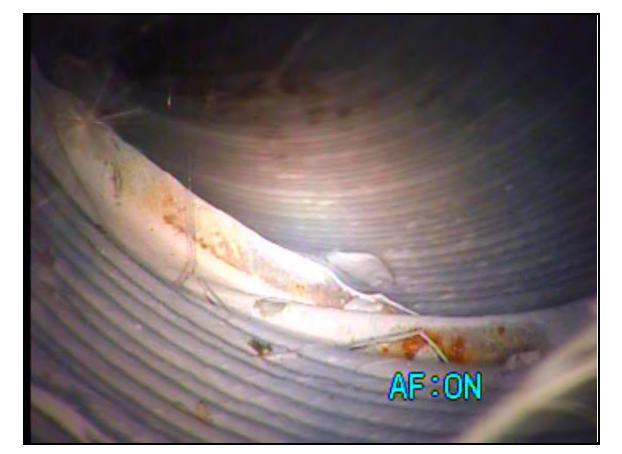
View inside outlet. Possible deflected joint.

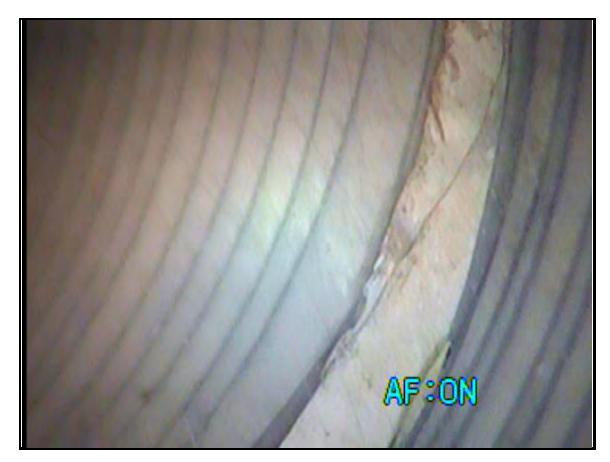
View inside outlet. Possible deflected or separated joint.

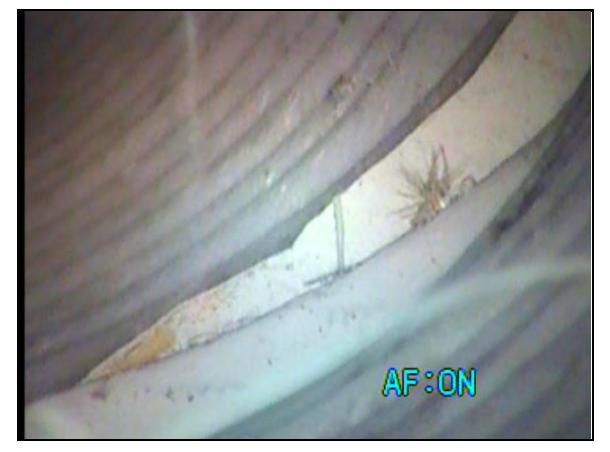
View inside outlet. Possible deflected or separated joint.

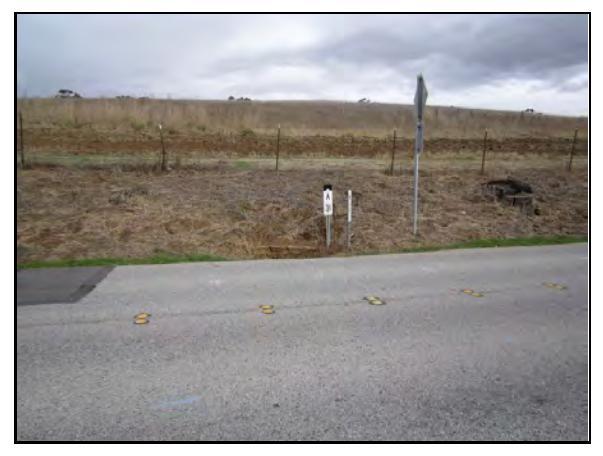
Culvert A-31

Pipe runs under the road. Invert appears to be perforated or missing near inlet due to corrosion.

Area view.

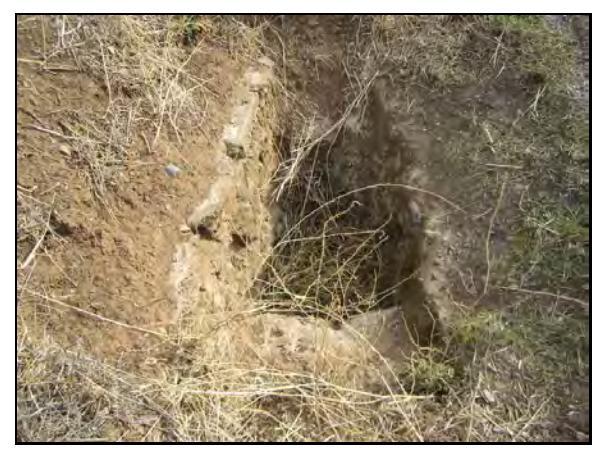
Inlet.

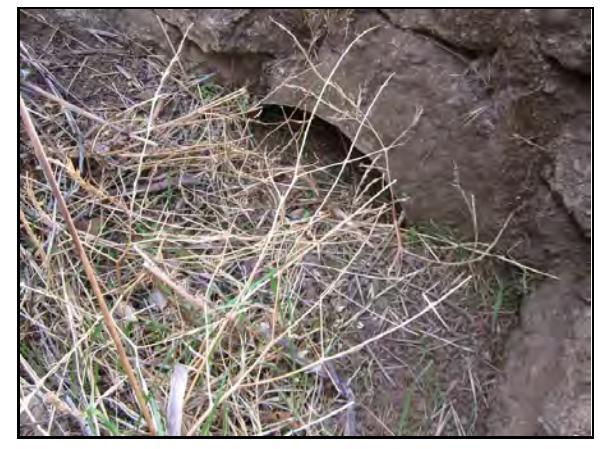
Culvert A-31

Inlet.

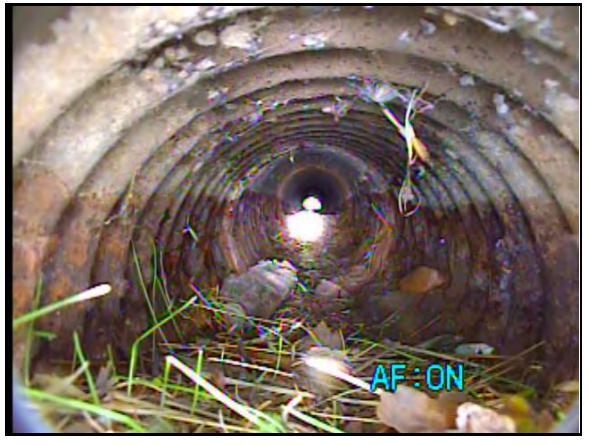
View inside inlet.

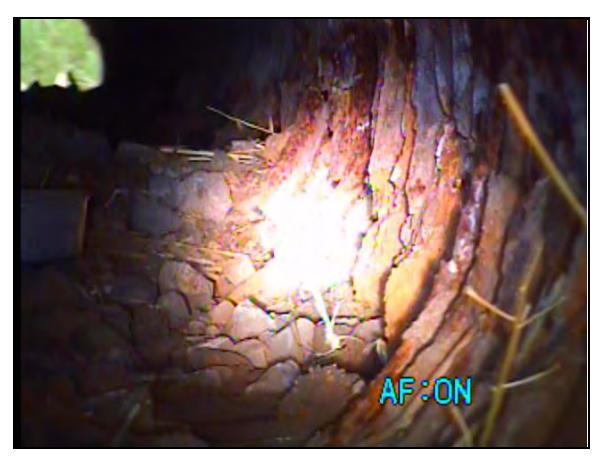
View inside inlet. Pipe appears to be perforated.
