Storm Drain Master Plan Update

June 2015

Public Works Department/Engineering Services Division

Schaaf & Wheeler CONSULTING CIVIL ENGINEERS

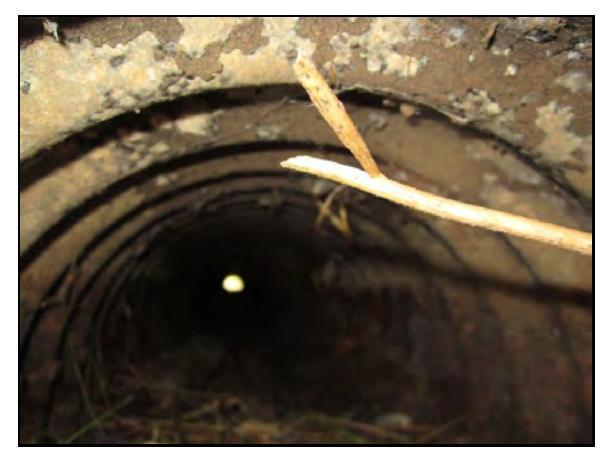
View inside inlet.

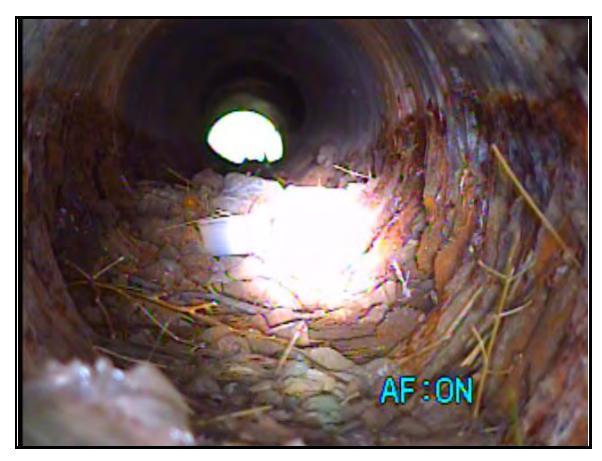
View inside inlet.

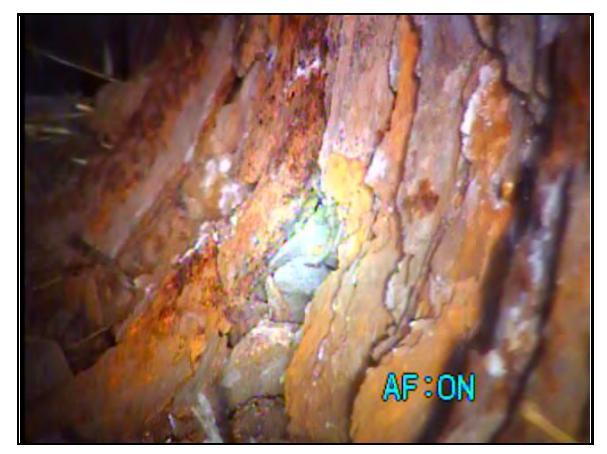
Pipe runs under the road. Invert appears to be perforated or missing near inlet due to corrosion.

View inside inlet. Pipe appears to be perforated.

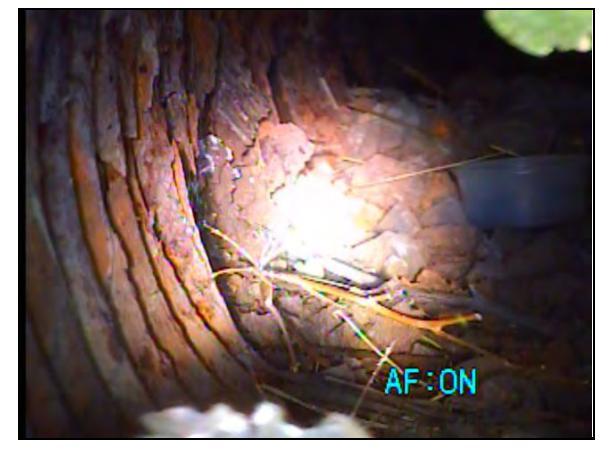
Culvert A-31

View inside inlet. Pipe appears to be perforated.

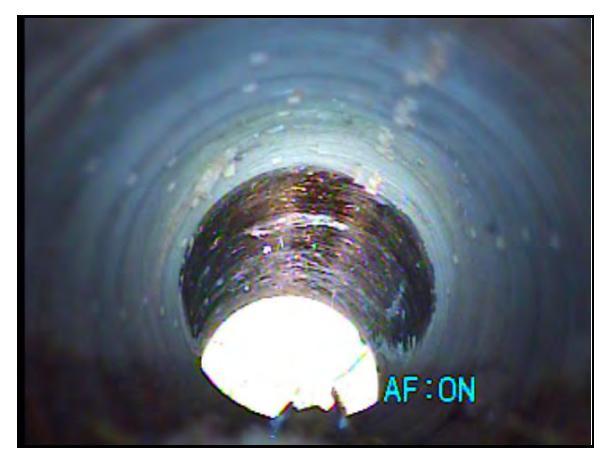
View inside inlet.

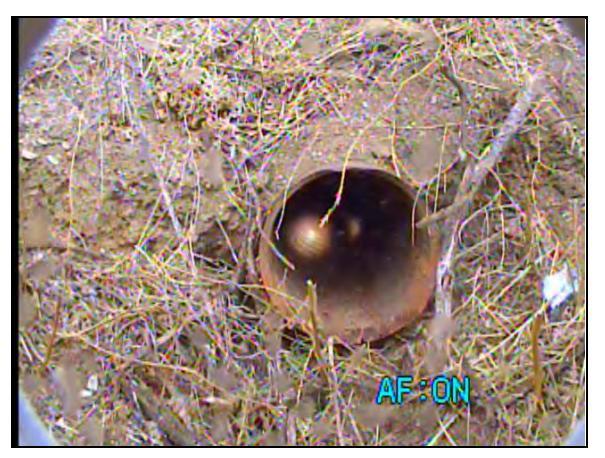
Outlet.

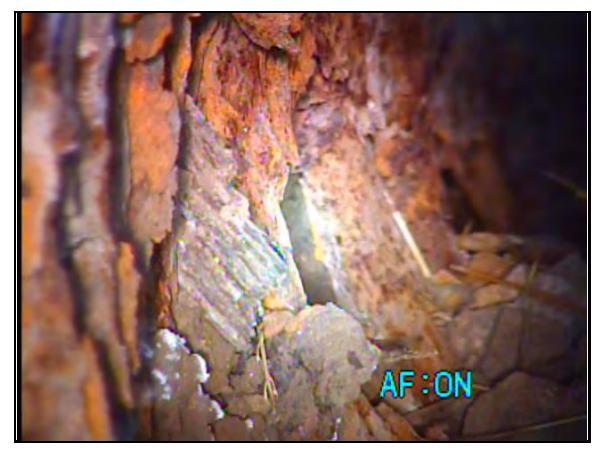
View inside inlet. Pipe appears to be perforated.

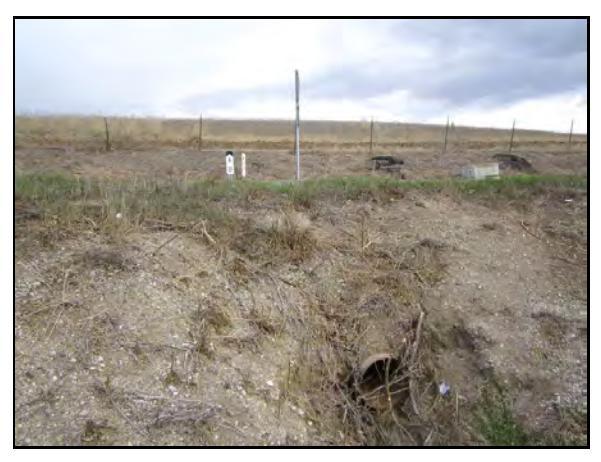
Outlet.

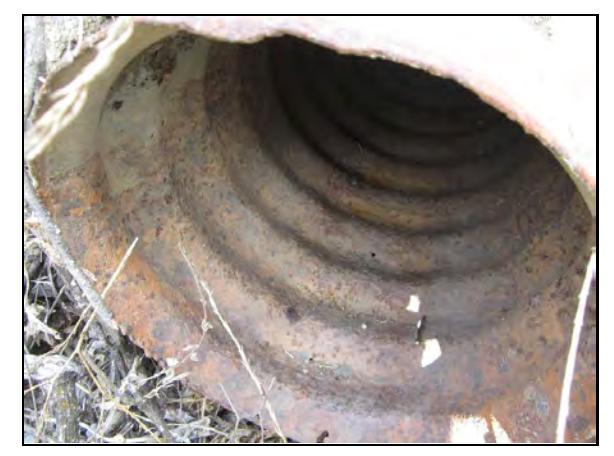
View inside outlet.

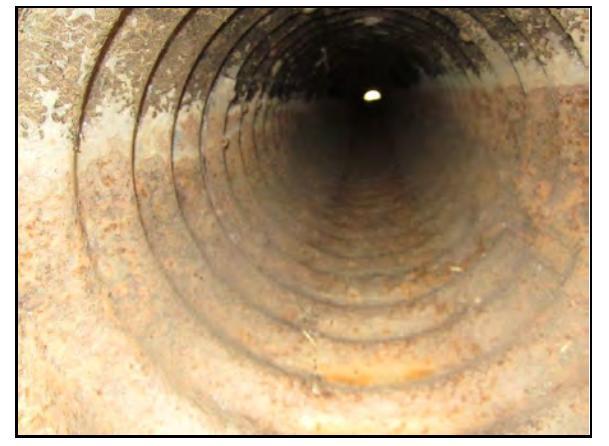
Culvert A-31

View inside outlet.

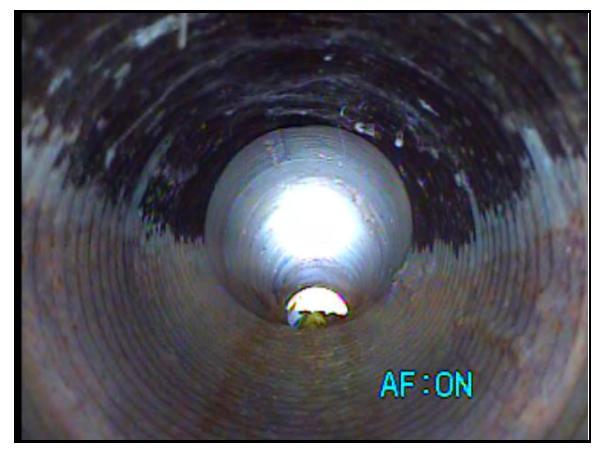
View inside outlet.

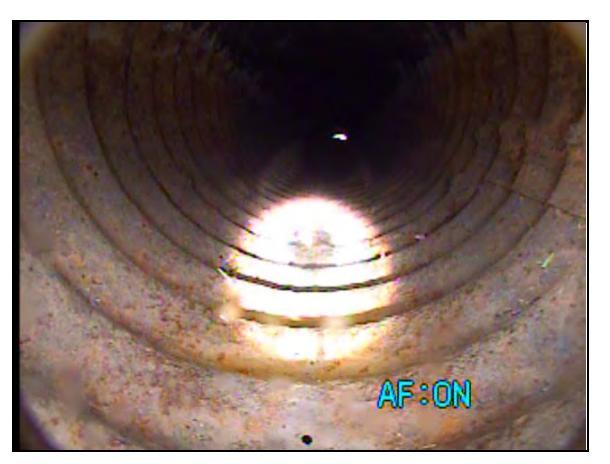
View inside outlet.

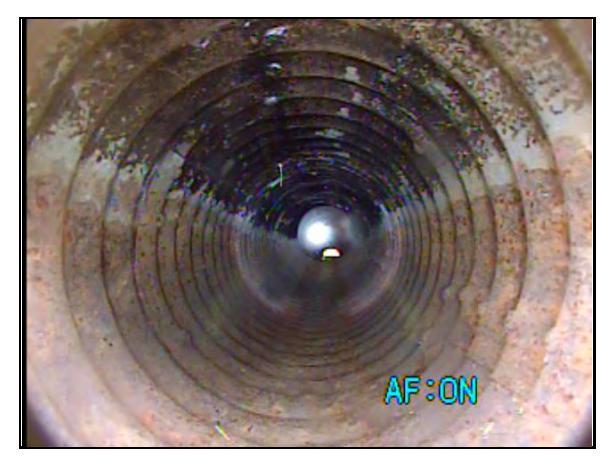
View inside outlet.

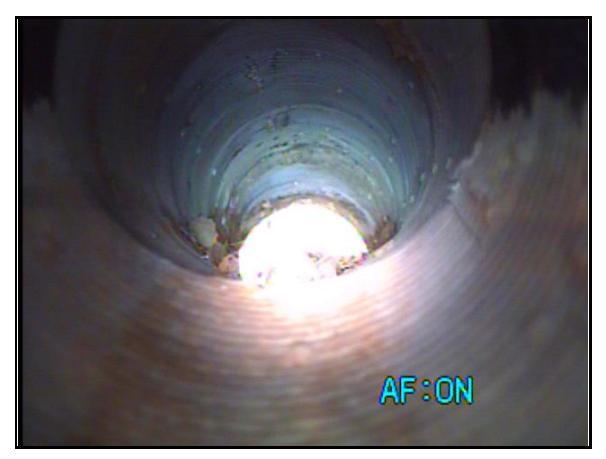
View inside outlet.

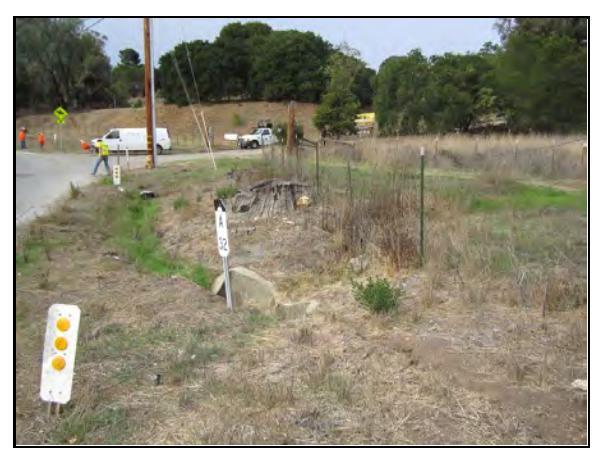
Culvert A-32

Two parallel culvert pipes under the road. Possible separated joint or hole within 18-in. line. Coating failure and moderate corrosion at invert of pipes. Portions of 24-in. culvert have cement mortar overlay at invert.

Area view.

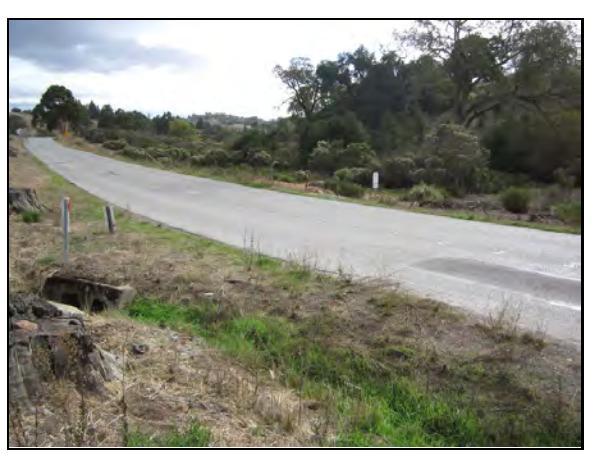
Area view.

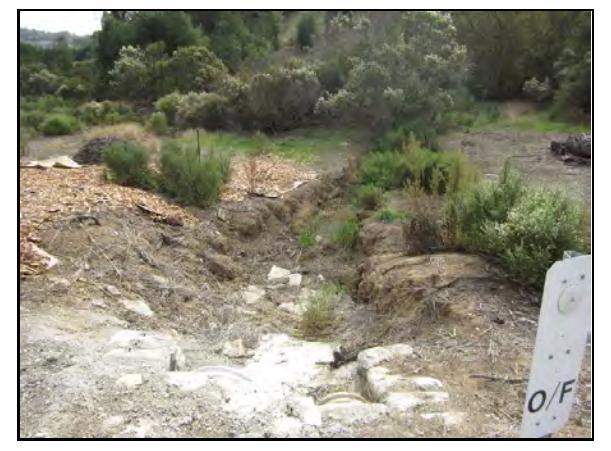
Culvert A-32

Area near outlet.

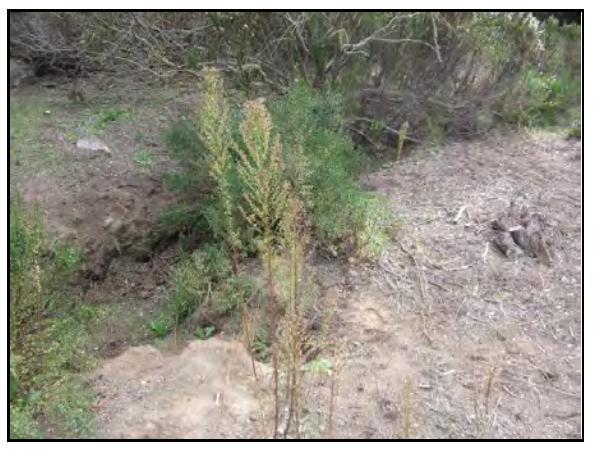
Area near outlet.

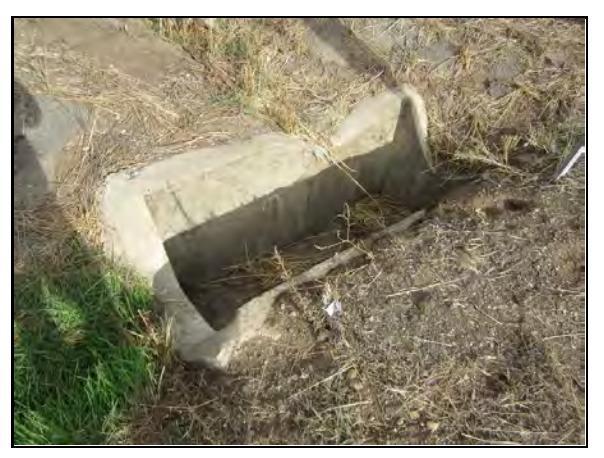
Inlet.

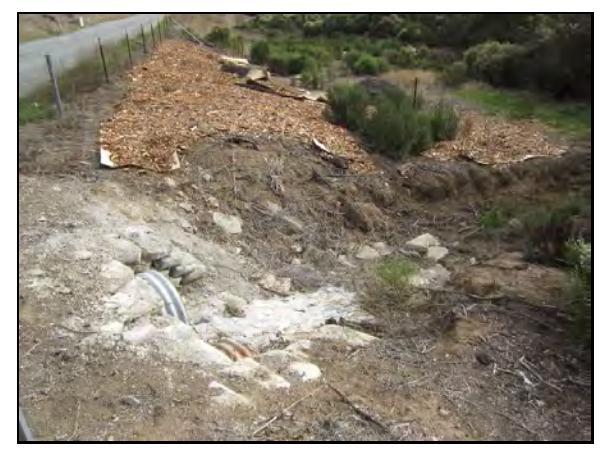
Area near outlet.

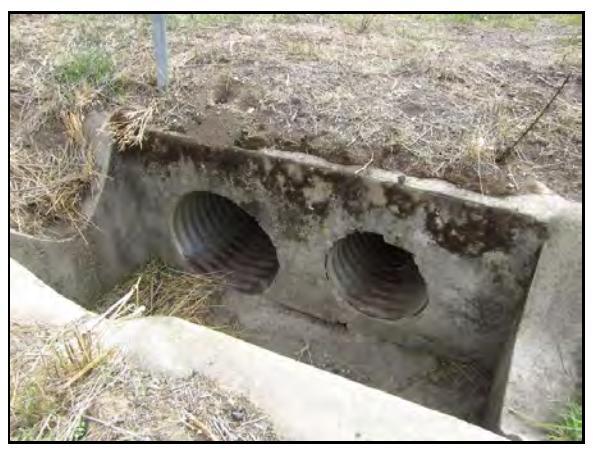
Inlet.

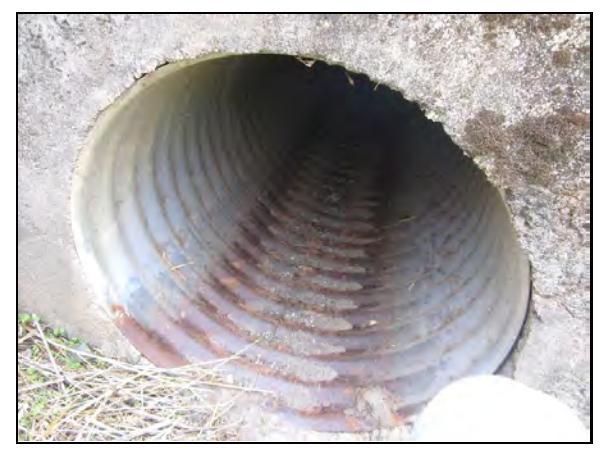
Inlet to 24-inch culvert.

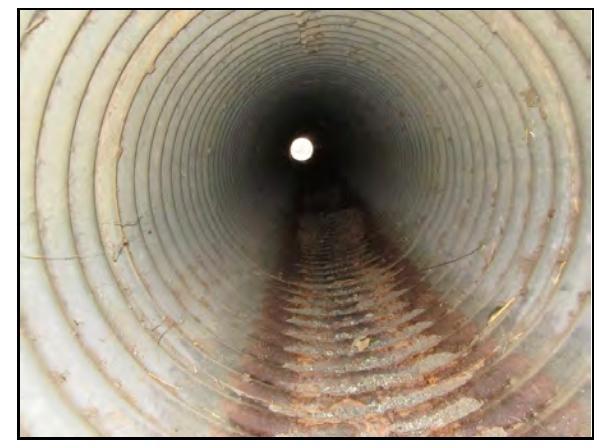
View inside 24-inch inlet.

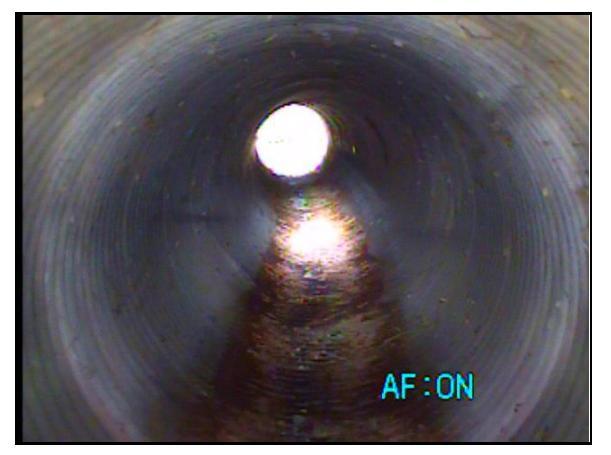
View inside 24-inch inlet.

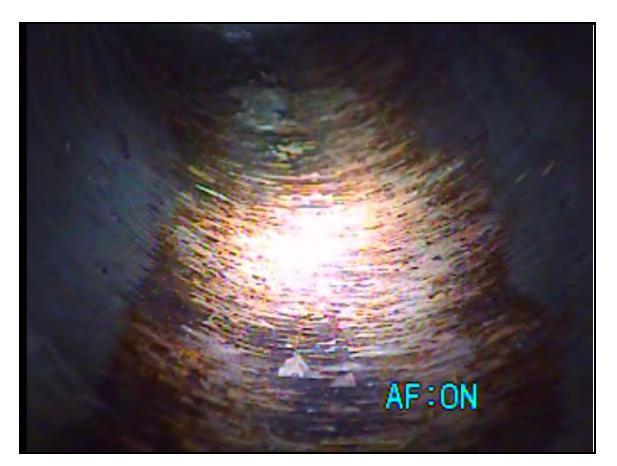
View inside 24-inch inlet.

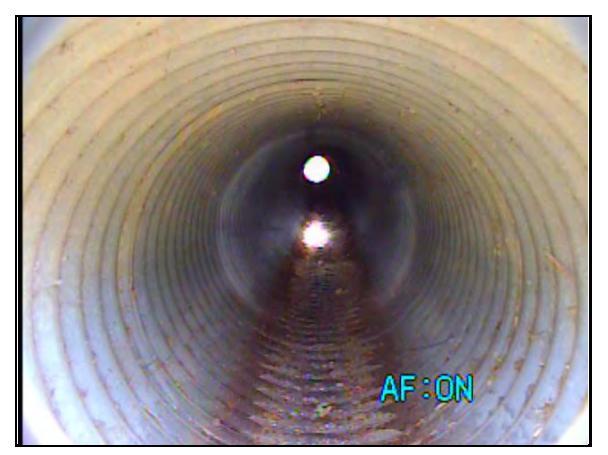
View inside 24-inch inlet.

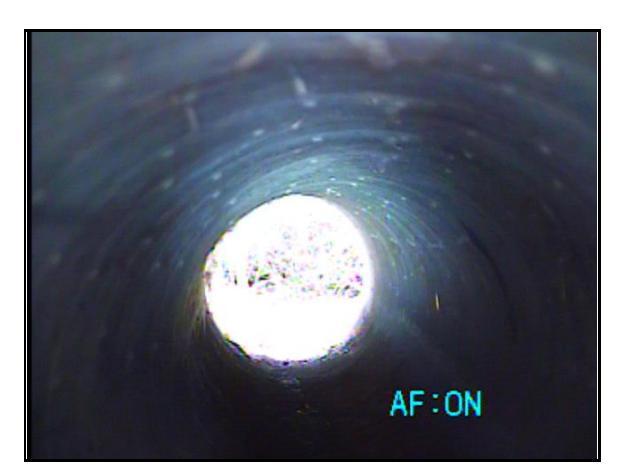
View inside 24-inch inlet.

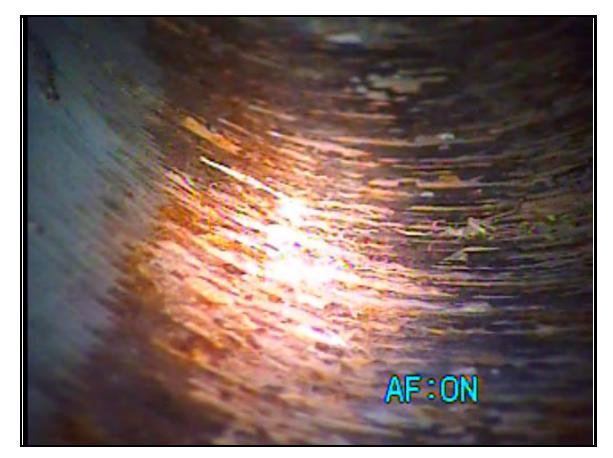
View inside 24-inch inlet.

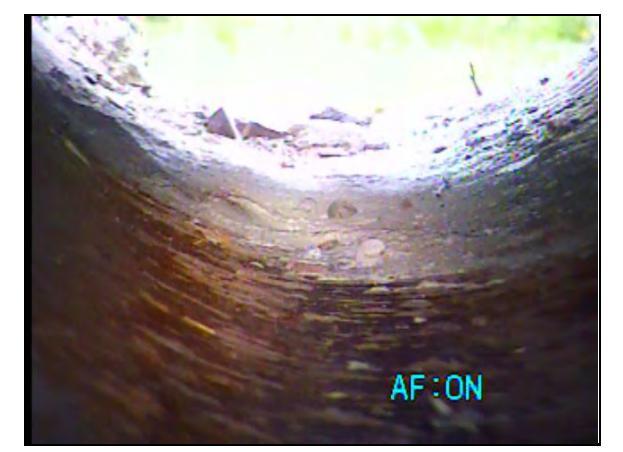
Culvert A-32

View inside 24-inch inlet.

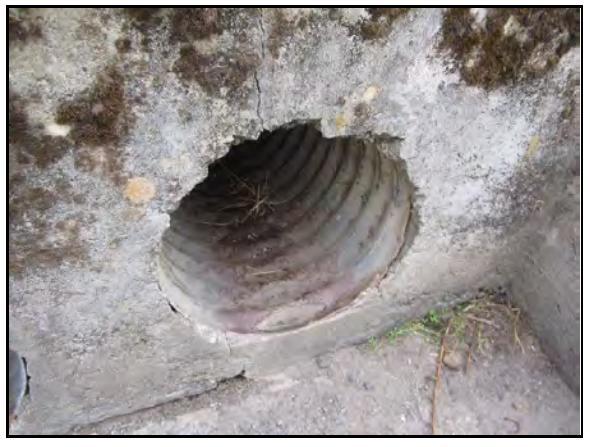
Inlet to 18-inch culvert. Note crack in headwall above pipe.

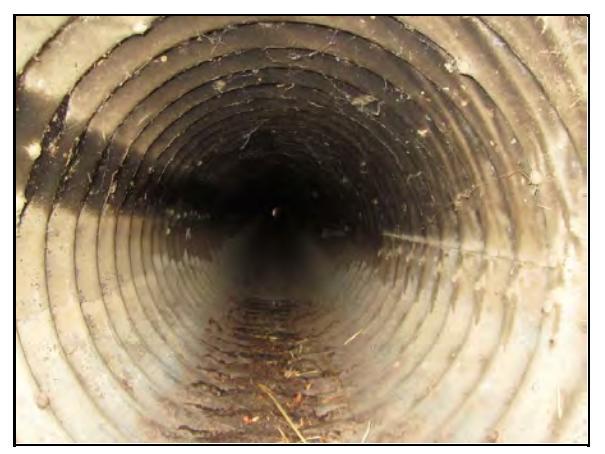
View inside 18-inch inlet.

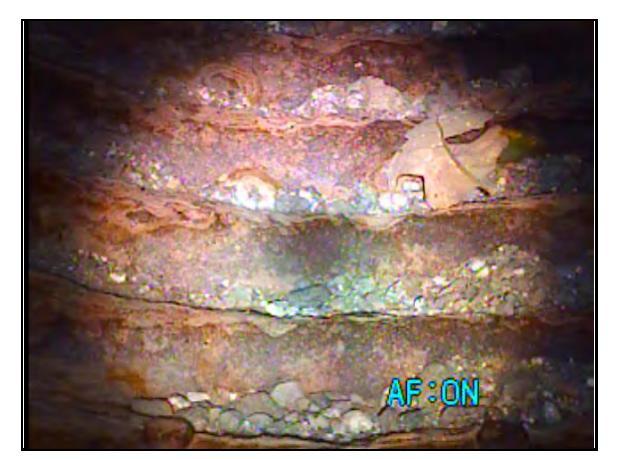
View inside 24-inch inlet.

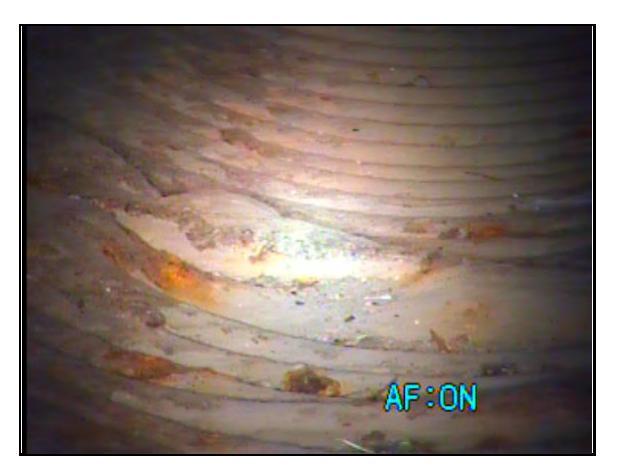
View inside 18-inch inlet. Apparent offset joint within pipe.

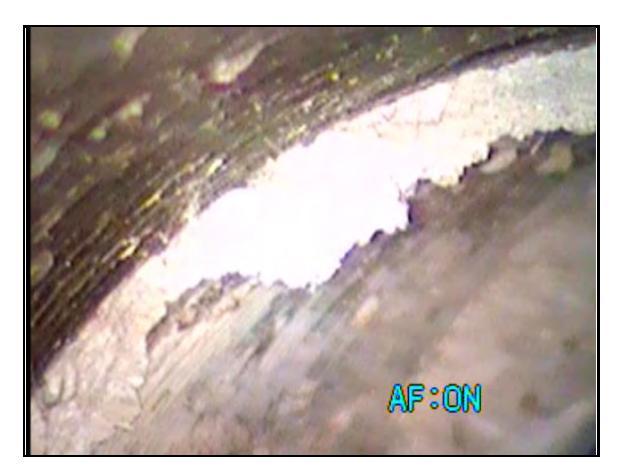
View inside 18-inch inlet. Deflection at invert within pipe.

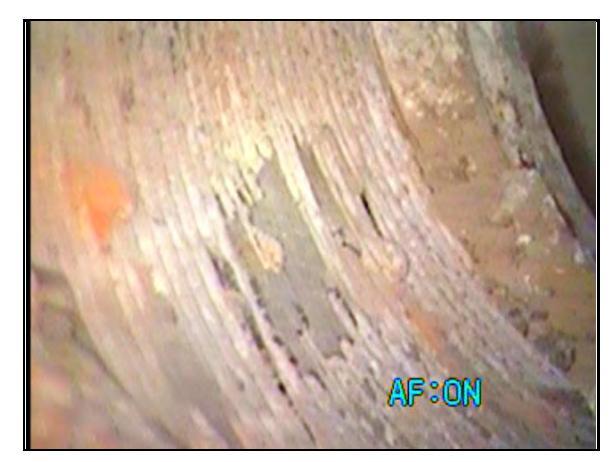
View inside 18-inch inlet. Apparent offset joint within pipe.

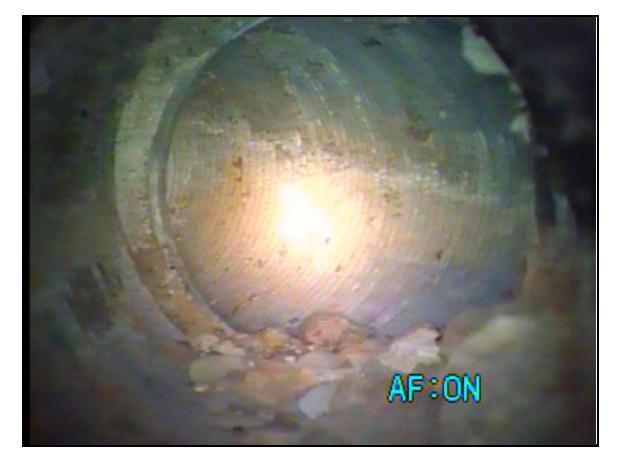
Culvert A-32

View inside 18-inch inlet. Apparent offset joint within pipe.

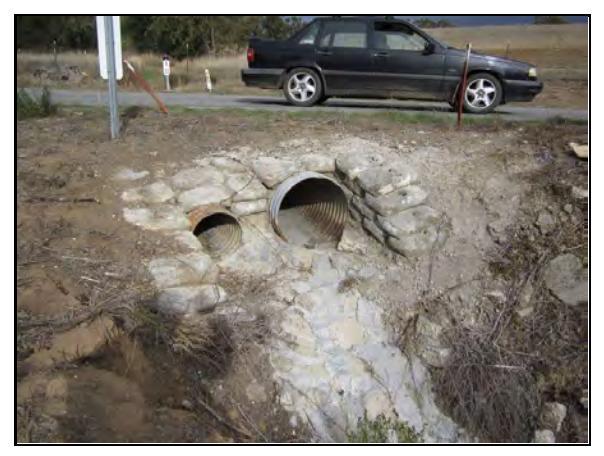
View inside 18-inch inlet. Apparent offset joint within pipe.

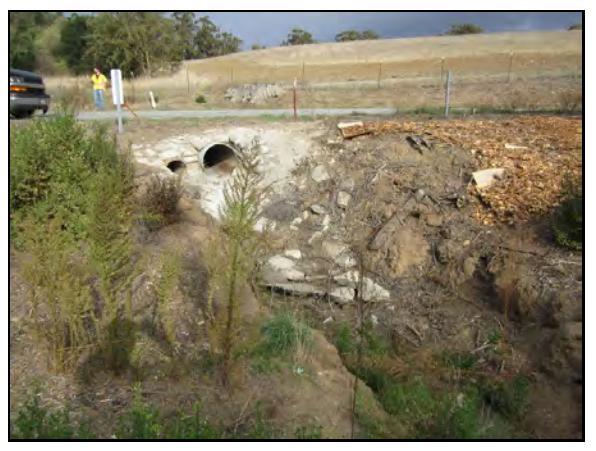
Concrete apron at outlet is cracked.

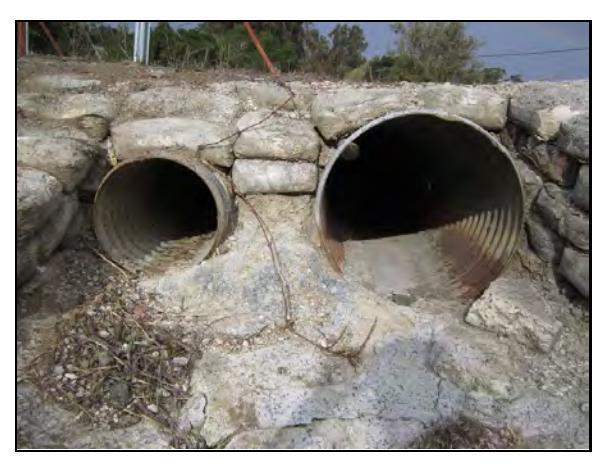
Outlet. End of concrete apron is slightly undermined.

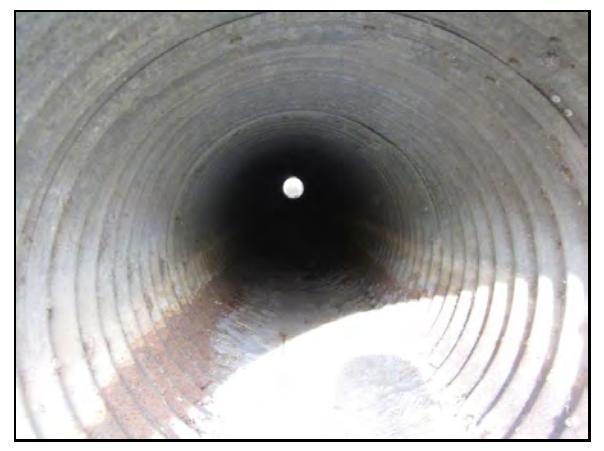
View inside 24-inch outlet. Invert paved with concrete.

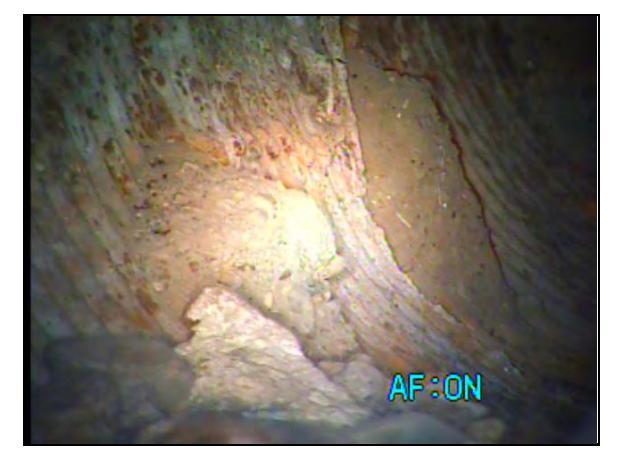
View inside 18-inch outlet. Debris inside pipe.

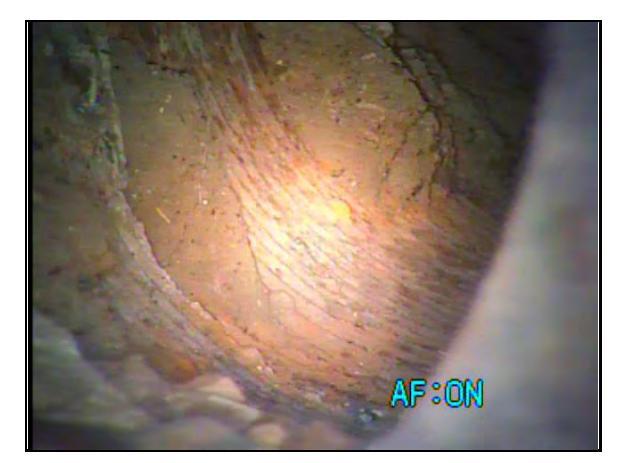
View inside 18-inch outlet. Possible separated joint or hole within pipe.

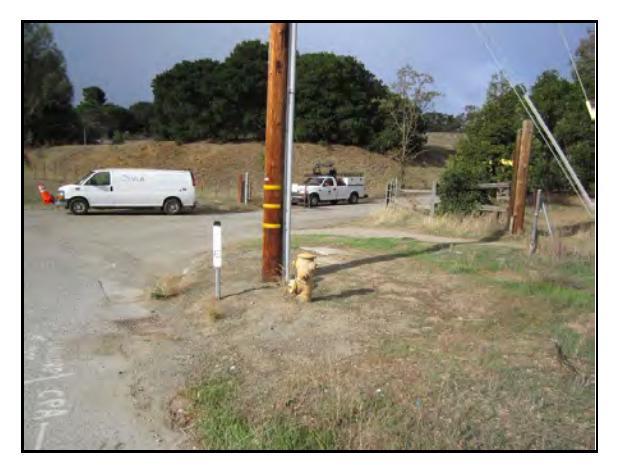
Area view.

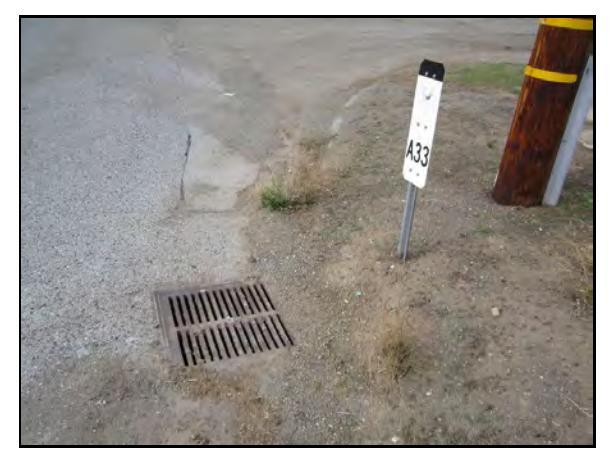
Inlet.

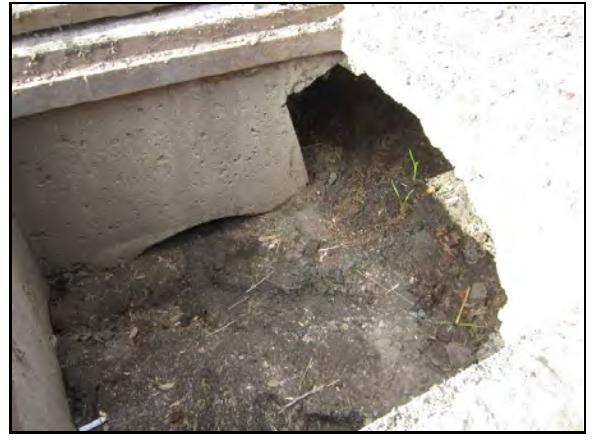
Upstream pipe has moderate corrosion. Downstream pipe has significant corrosion and possible perforations. Downstream pipe is about half full of sediment.

Pipes entering A-33 inlet structure. Pipe on left is the downstream pipe for A-34 and is almost completely obstructed with sediment. Pipe on right is the upstream pipe for A-33.

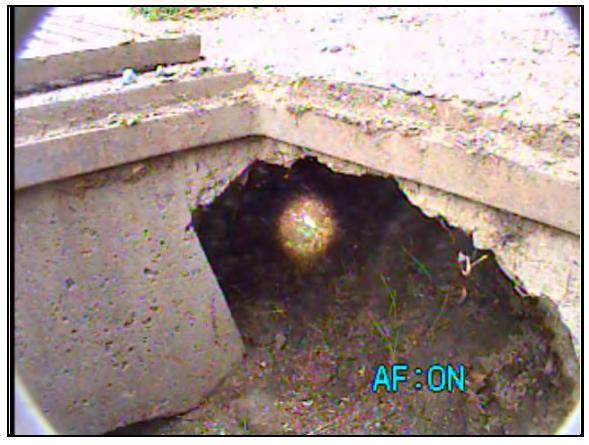
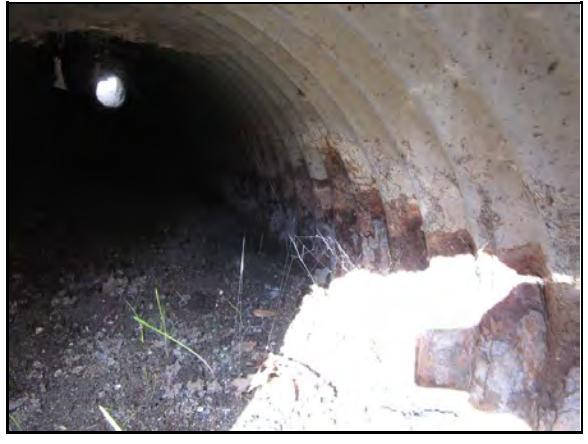
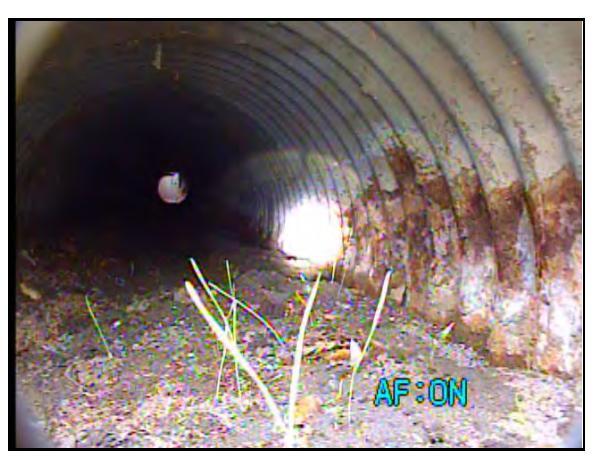
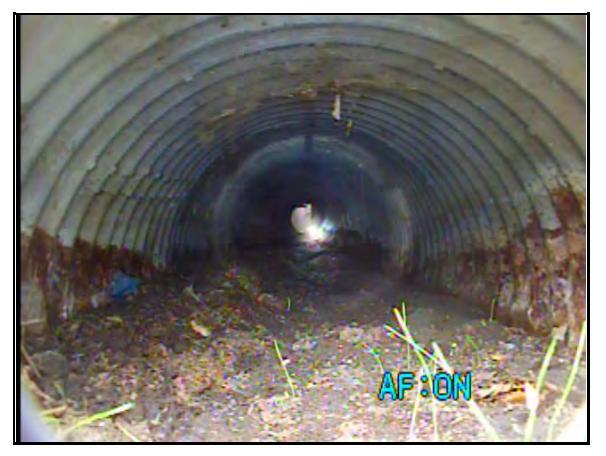
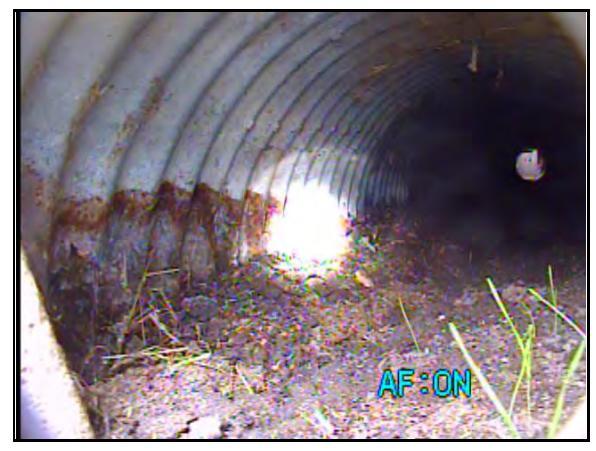
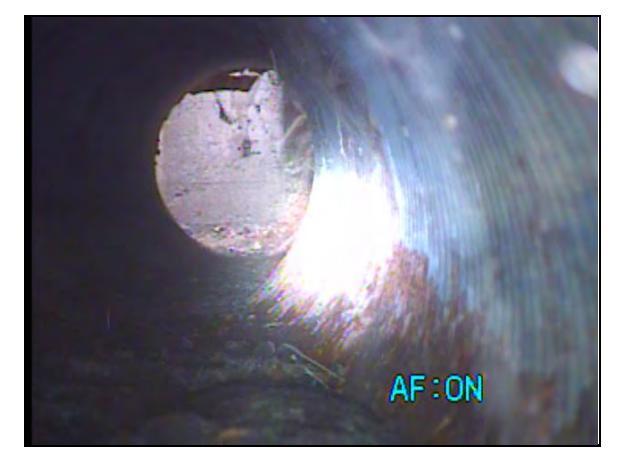
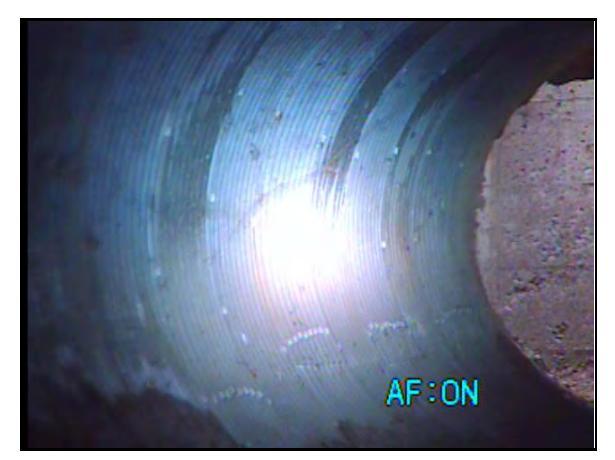
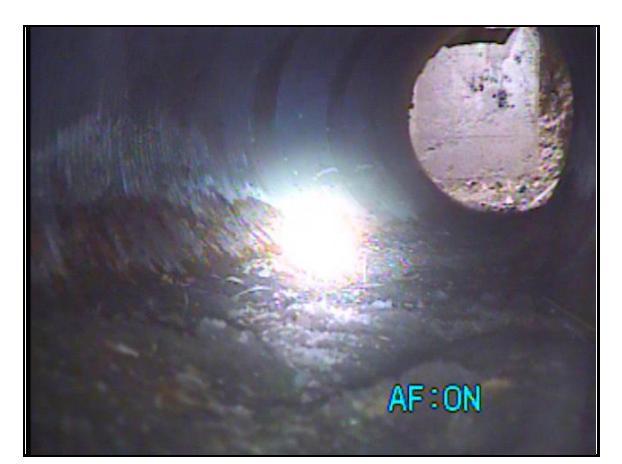
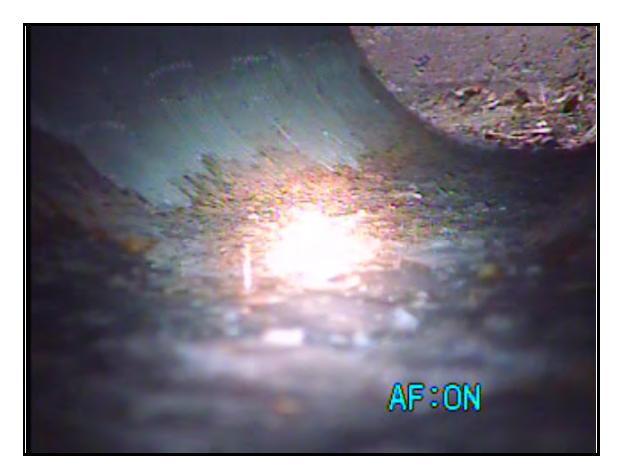
View inside upstream pipe from A-33.

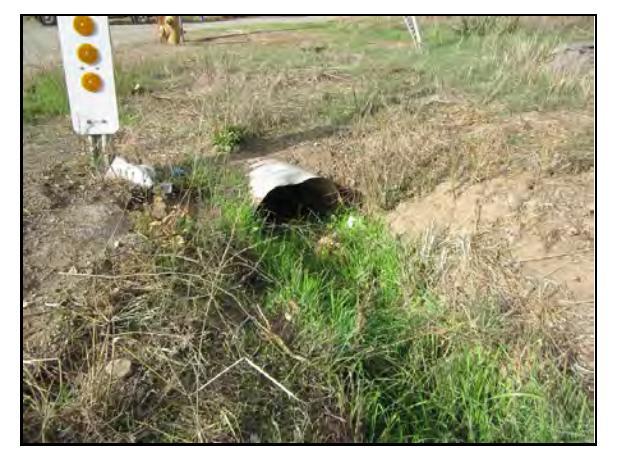
Outlet of downstream pipe.

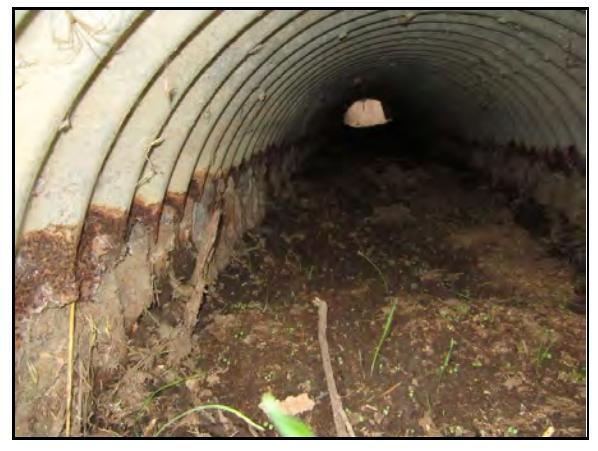
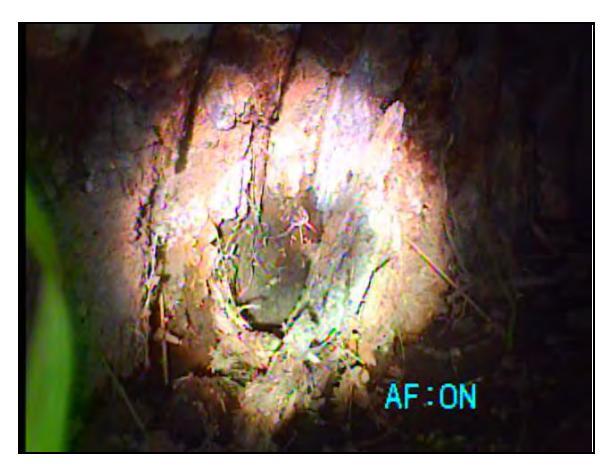
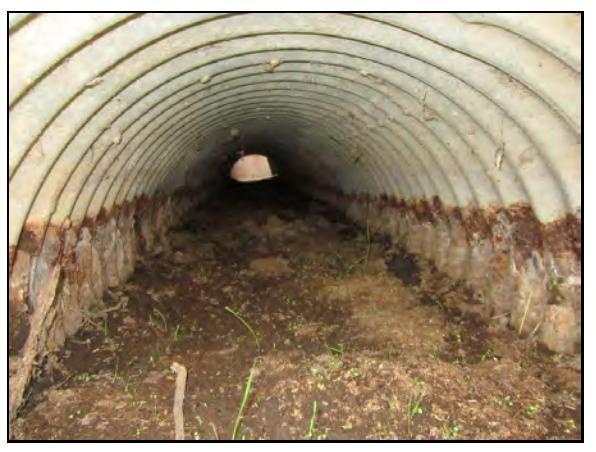
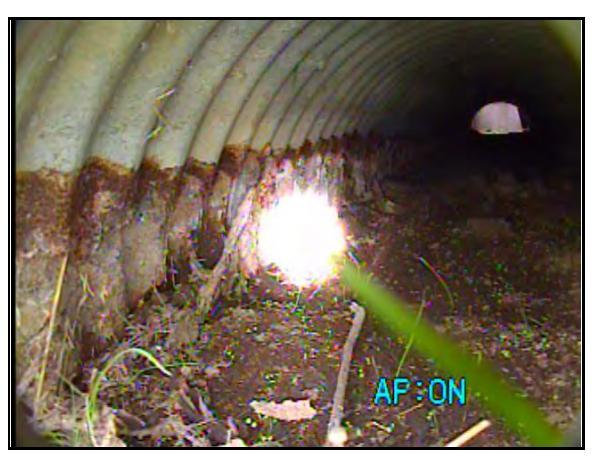
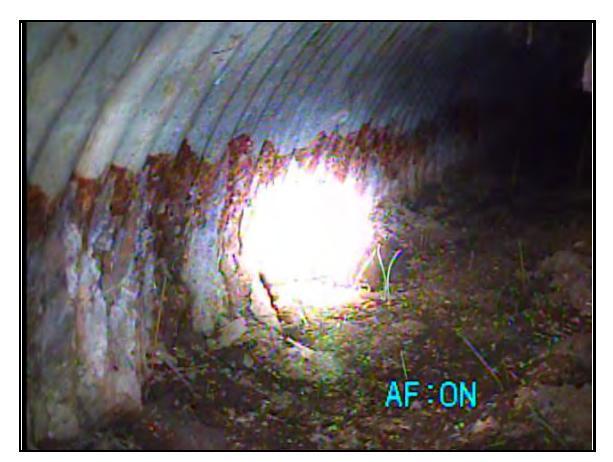
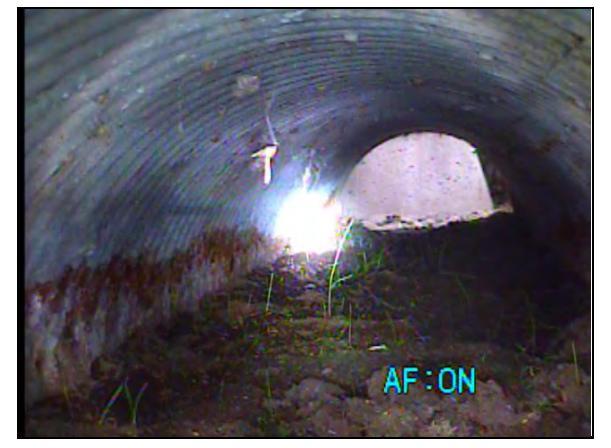
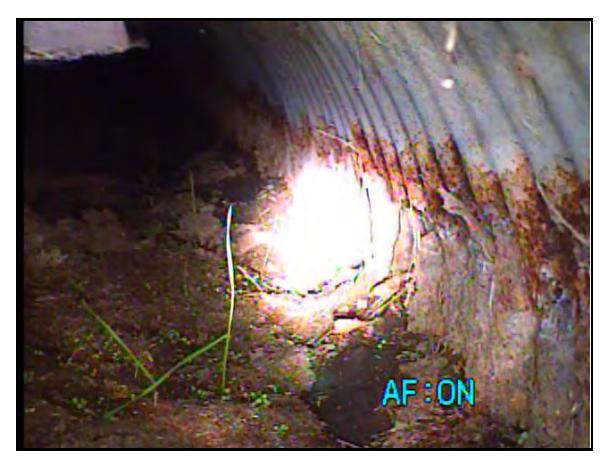
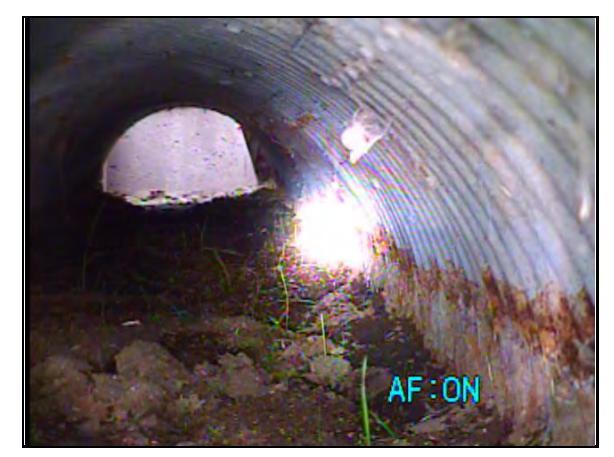
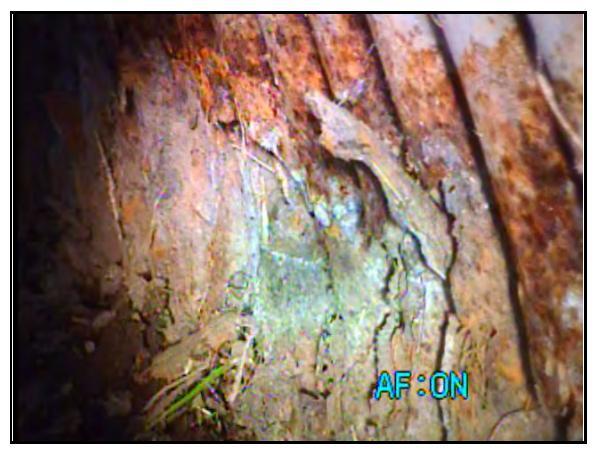
View inside outlet of downstream pipe.

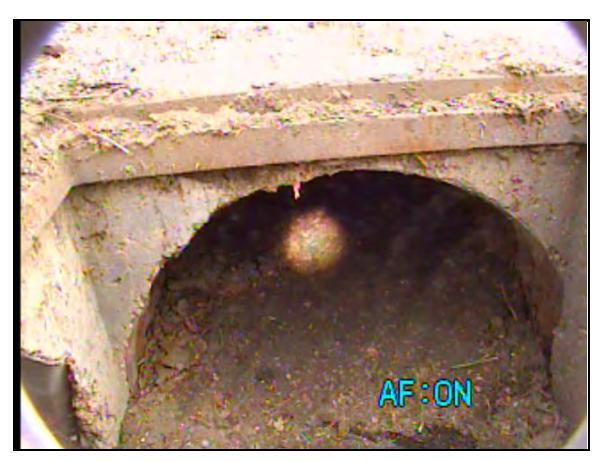
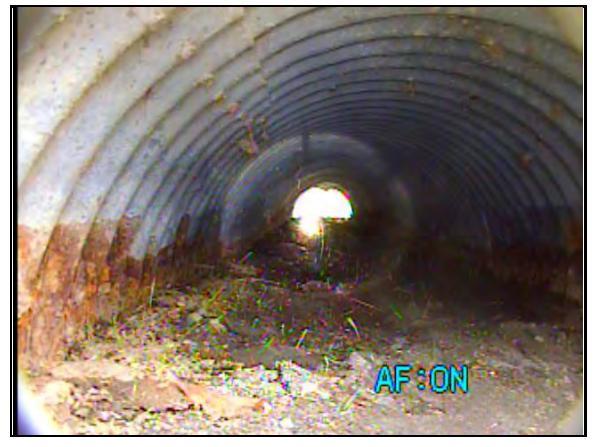
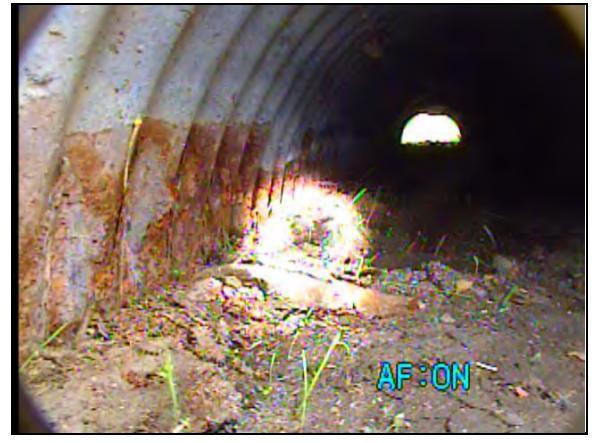
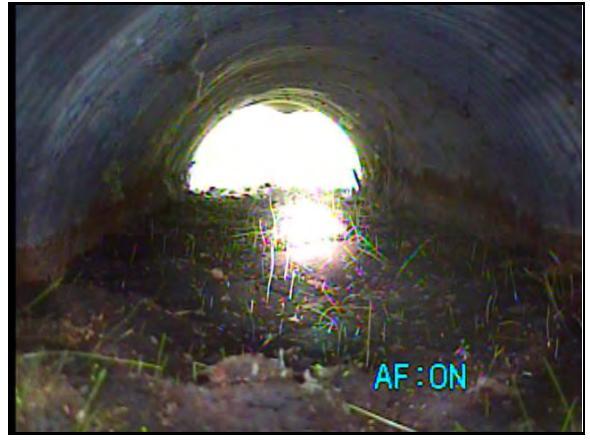
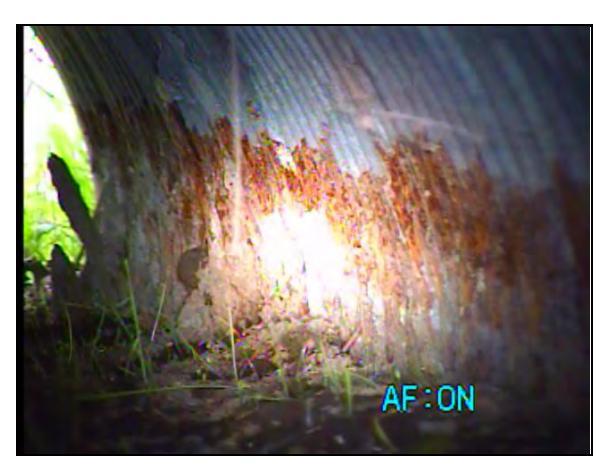
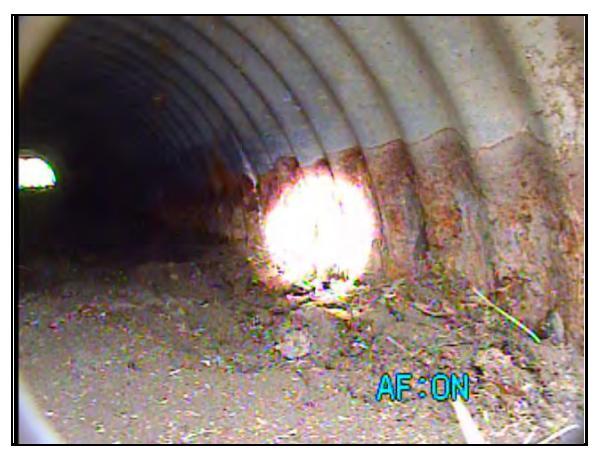
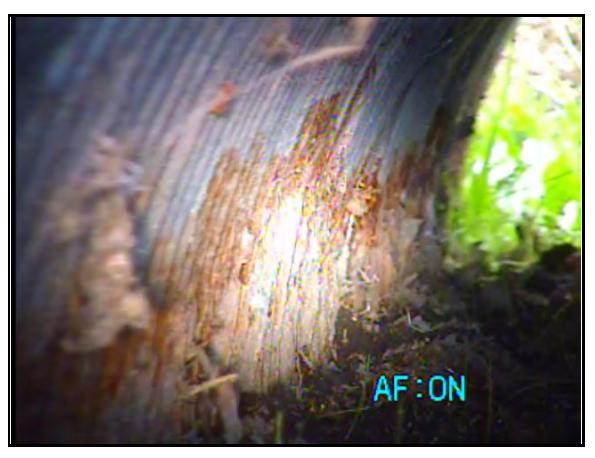
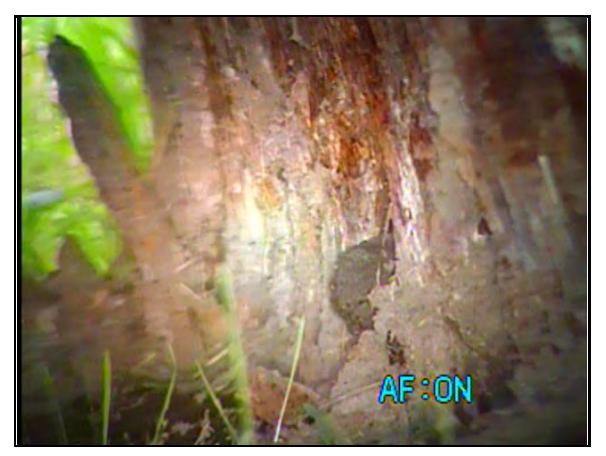
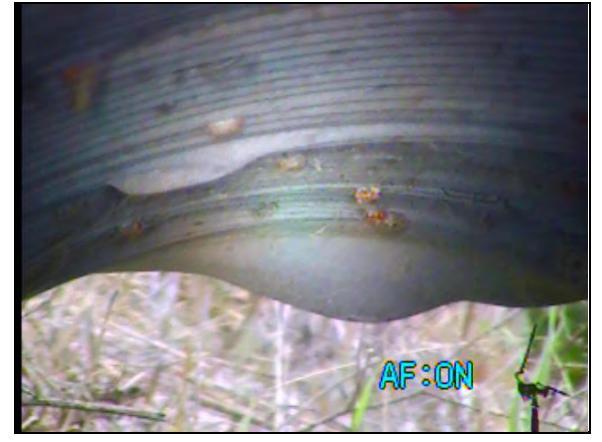
View inside downstream pipe from A-33.

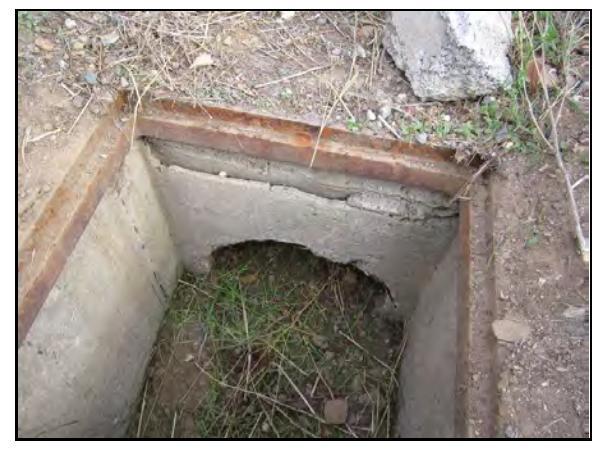
Concrete spalling on wall of inlet structure. Upstream end of upstream pipe could not be located. Pipe appears to have a pool of green liquid inside it. Upstream and downstream pipes appear to have experienced severe corrosion. Downstream pipe is almost completely obstructed with sediment where it enters the A-33 inlet structure.

Interior of inlet structure. Concrete spalling on wall surface.

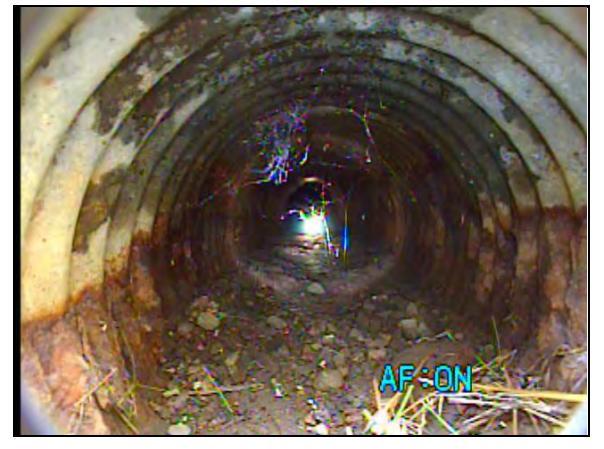
View inside upstream pipe.

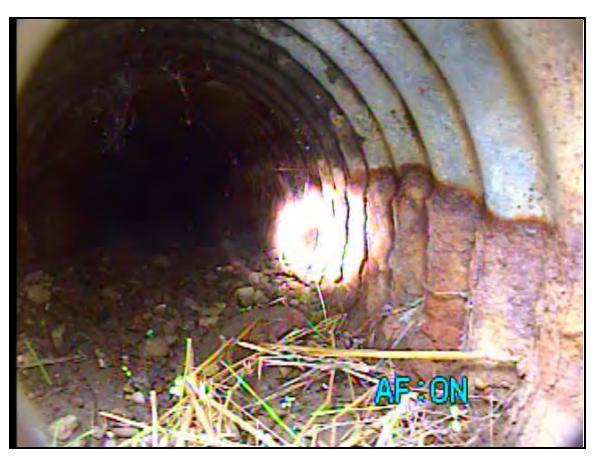
View inside upstream pipe. Pipe corroded near invert.

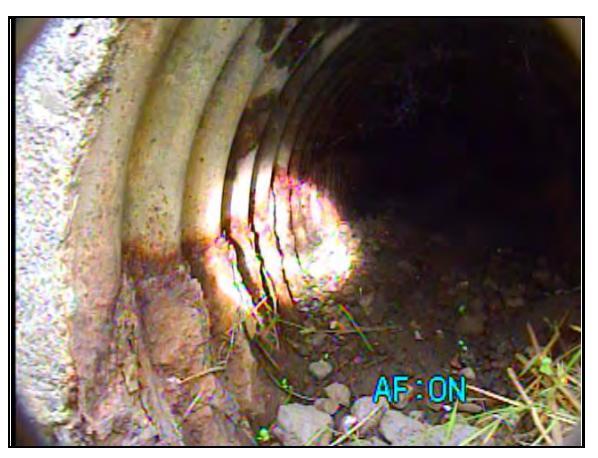
View inside upstream pipe. Pipe corroded near invert.

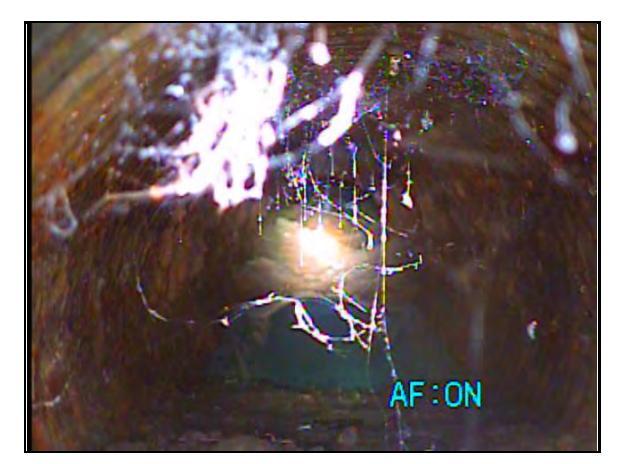
View inside upstream pipe.

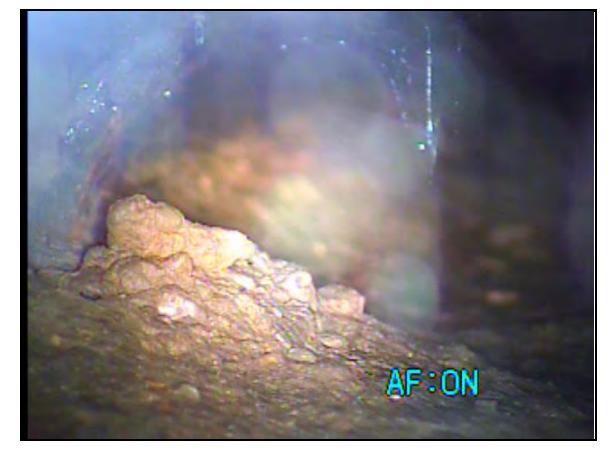
Debris inside upstream pipe.

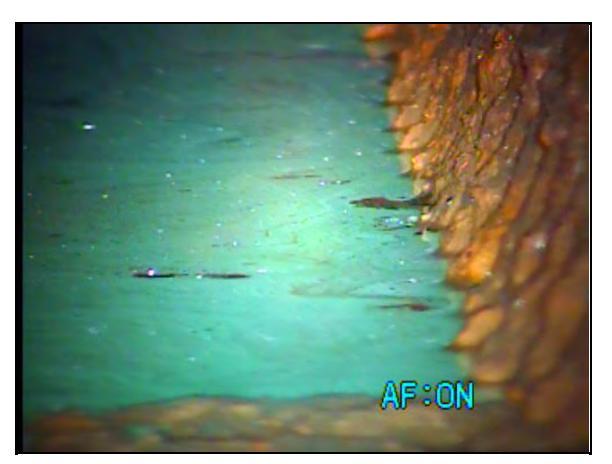
Green liquid inside upstream pipe.

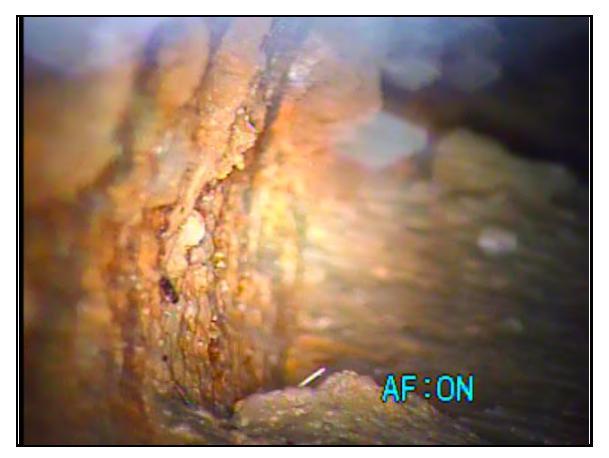
View inside upstream pipe. Pipe surfaces appear to be severely corroded.
