Storm Drain Master Plan Update

June 2015

Public Works Department/Engineering Services Division

Schaaf & Wheeler CONSULTING CIVIL ENGINEERS

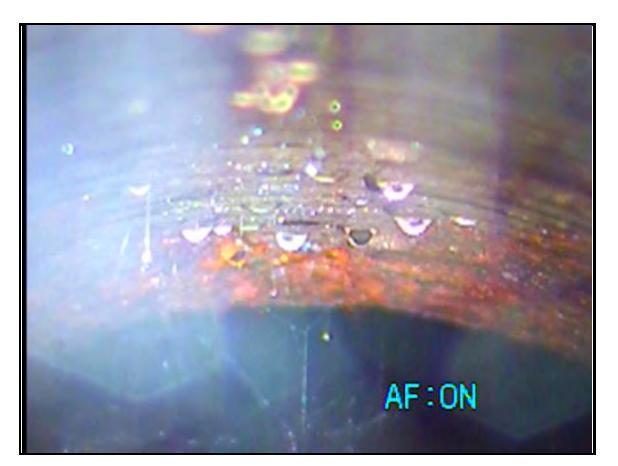
Crown of upstream pipe.

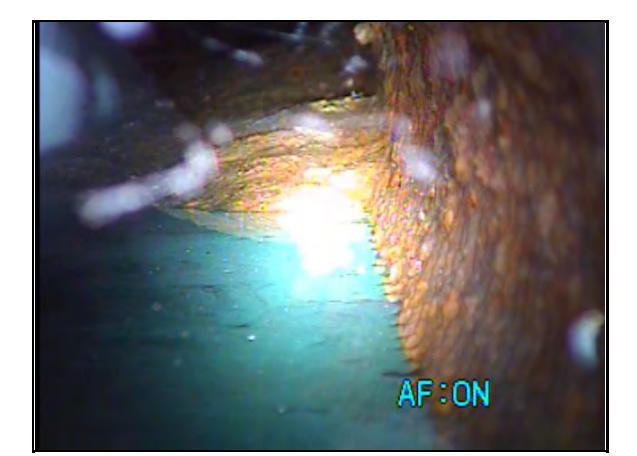
Green liquid inside upstream pipe.

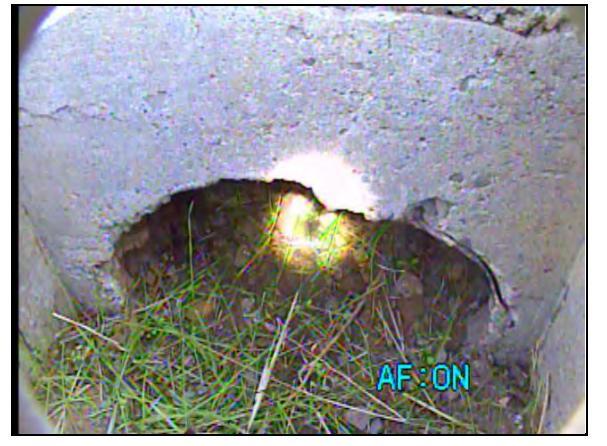
Outlet of structure.

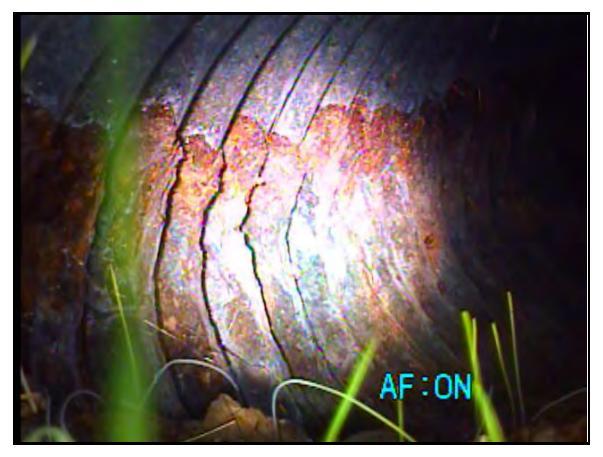
View inside downstream pipe. Significant corrosion.

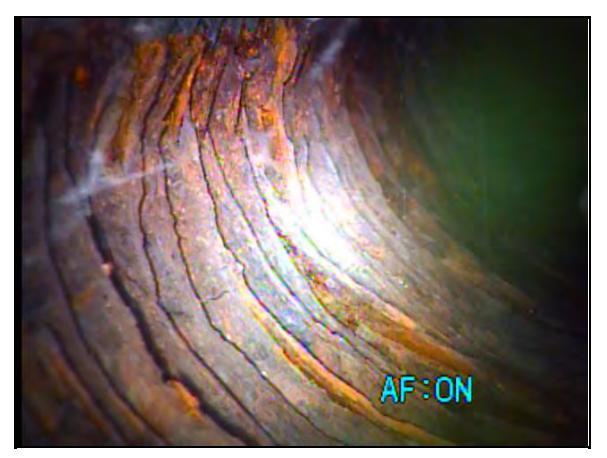
View inside downstream pipe. Significant corrosion.

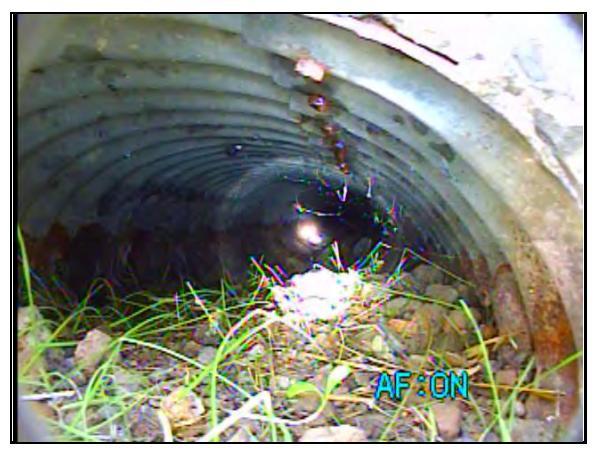
View inside downstream pipe.

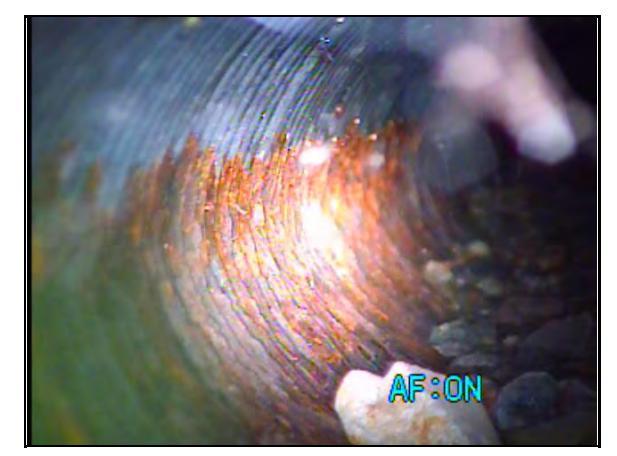
View inside downstream pipe.

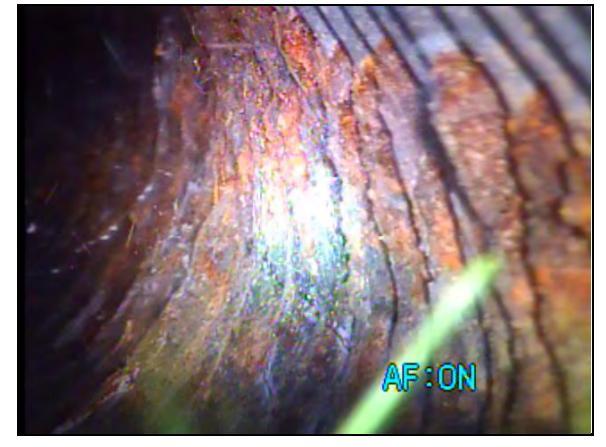
View inside downstream pipe. Significant corrosion.

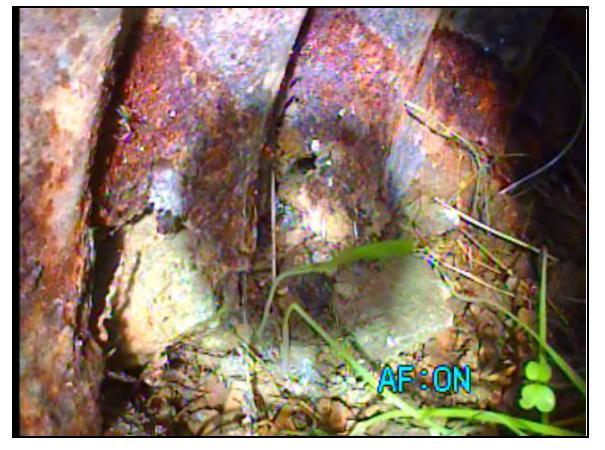
View inside downstream pipe. Significant corrosion.

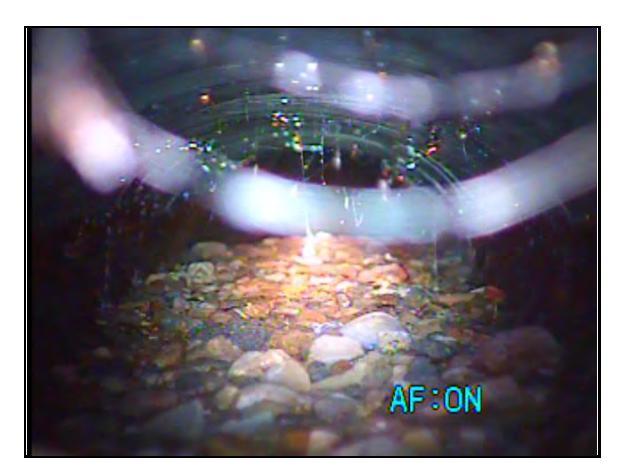
View inside downstream pipe.

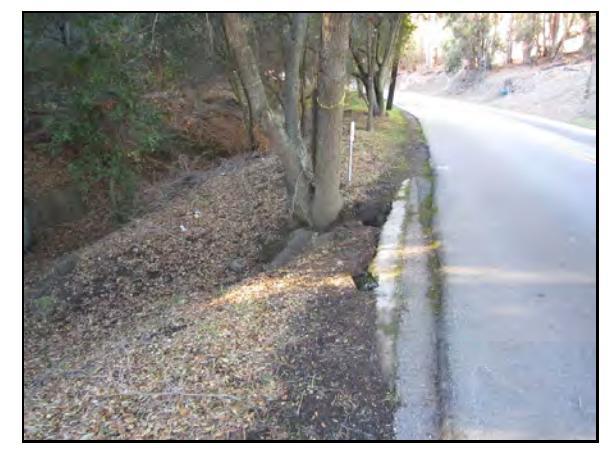
Pipe runs under roadway. Minor surface corrosion. Pipe appears to be obstructed near inlet, possibly due to construction (trenching) in street. Pipe is possibly damaged or collapsed at this location.

Area near outlet.

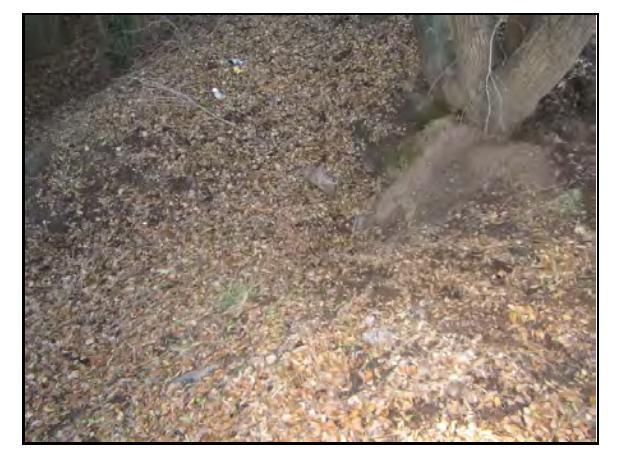
Area near outlet.

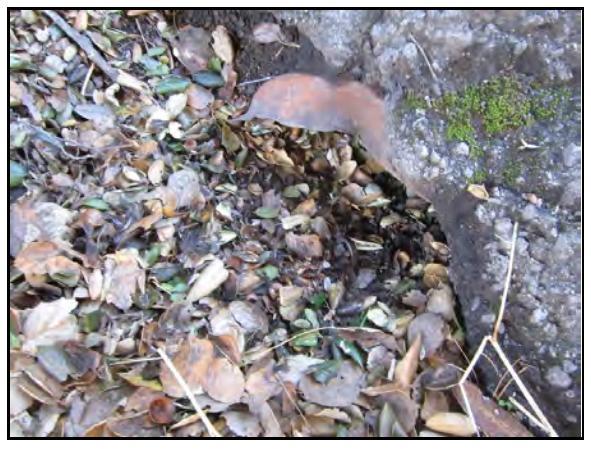
Inlet.

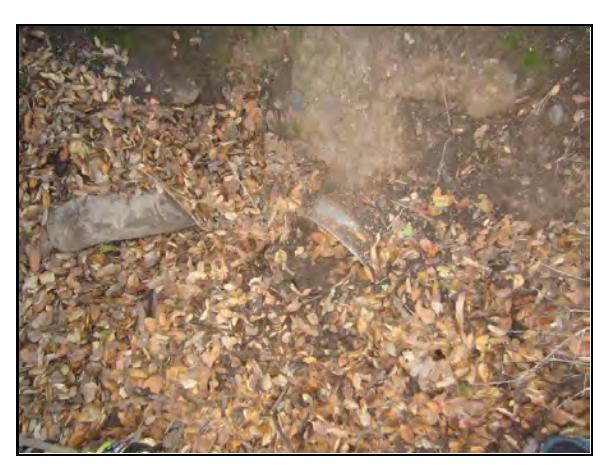
Outlet.

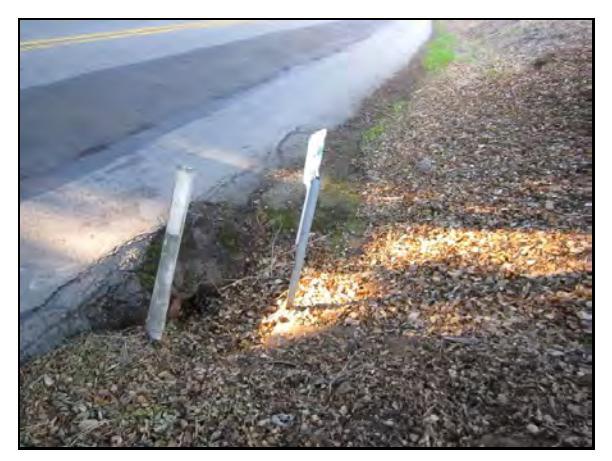
Inlet.

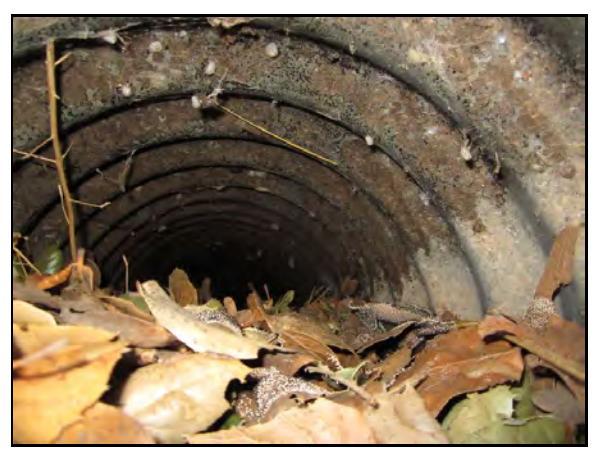
View inside inlet.

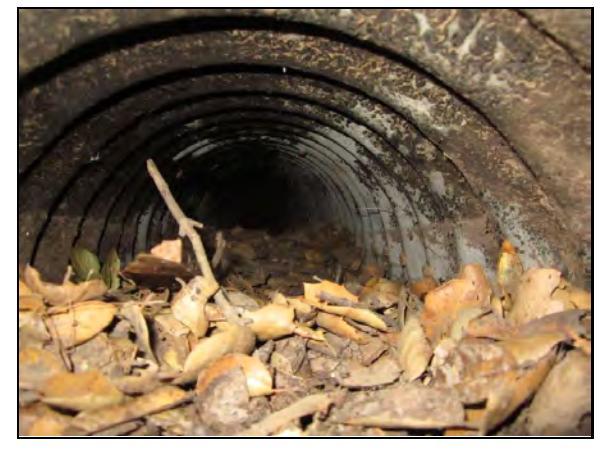
View inside outlet.

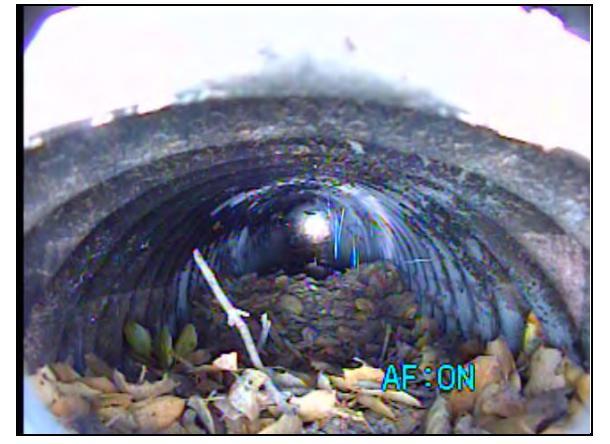
View inside outlet.

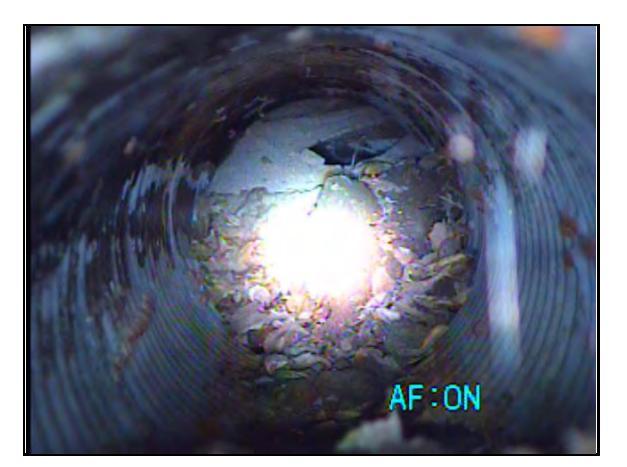
View inside outlet.

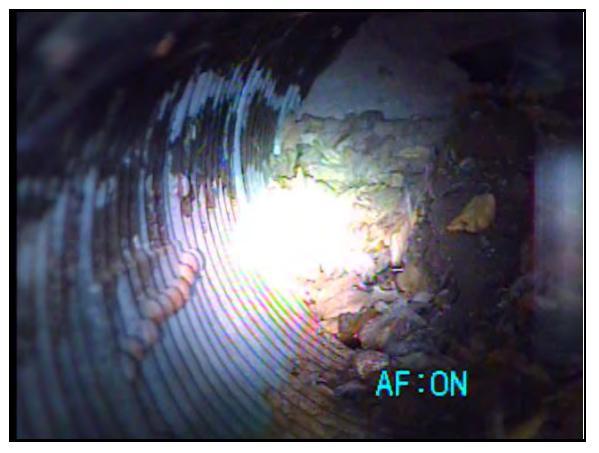
View inside outlet.

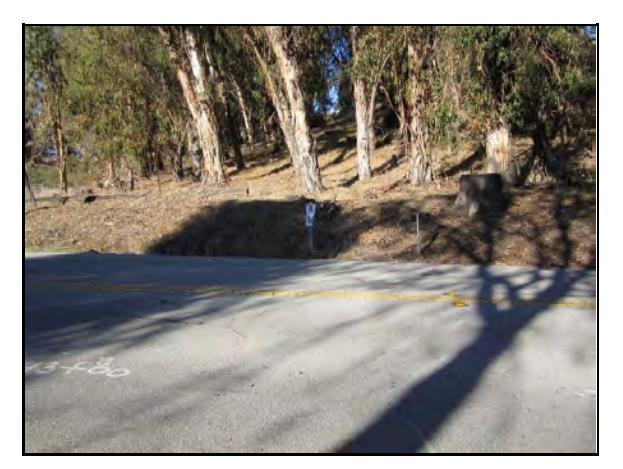
Area view.

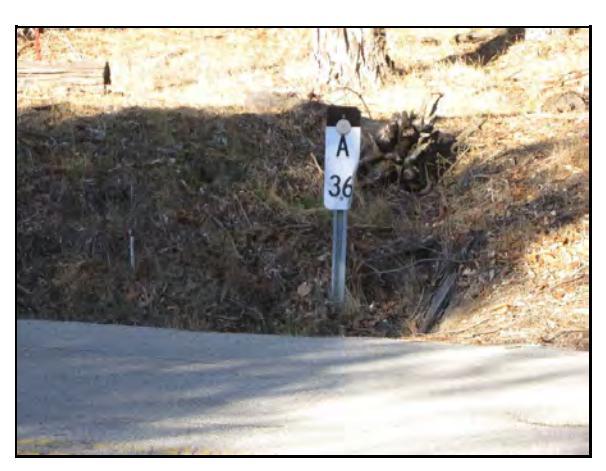
Area near inlet.

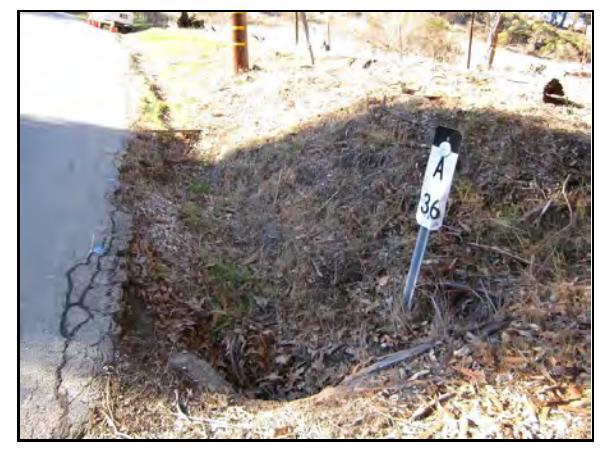
Area near inlet.

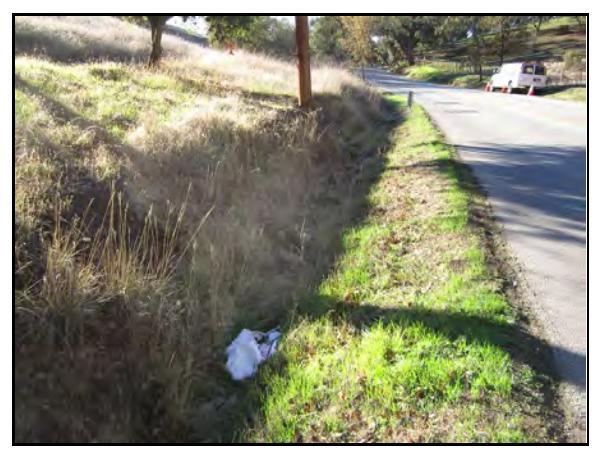
Area near outlet.

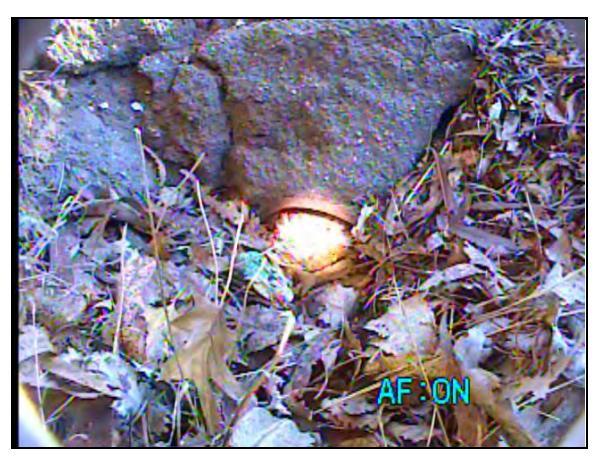
Inlet.

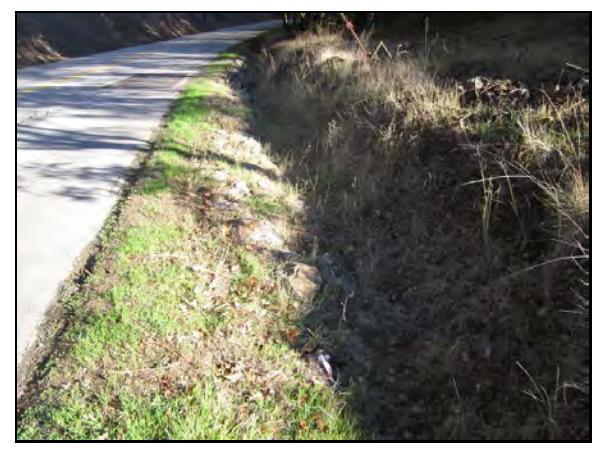
Area near outlet.

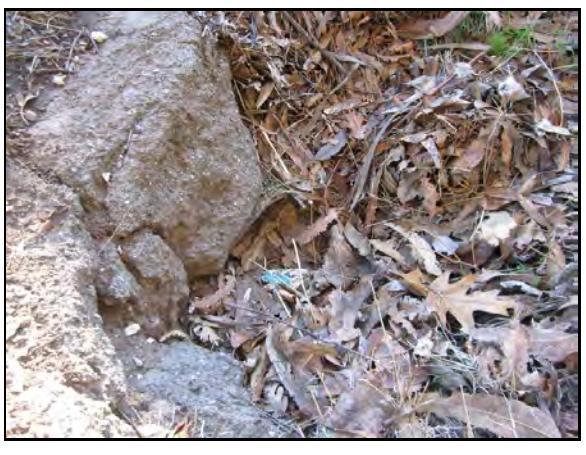
Inlet.

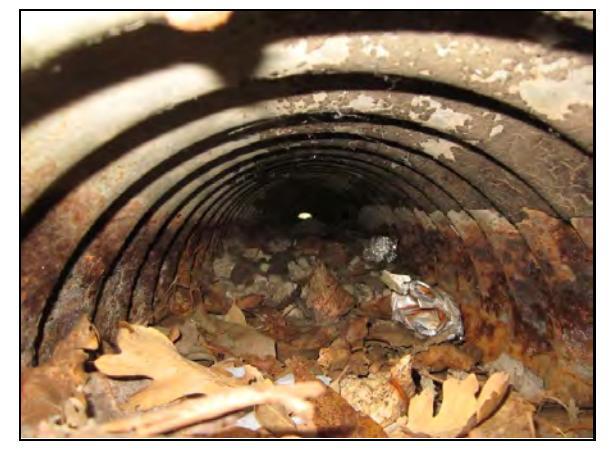
Pipe runs under the road. Pipe about half full of debris. Possible significant corrosion.

View inside inlet.

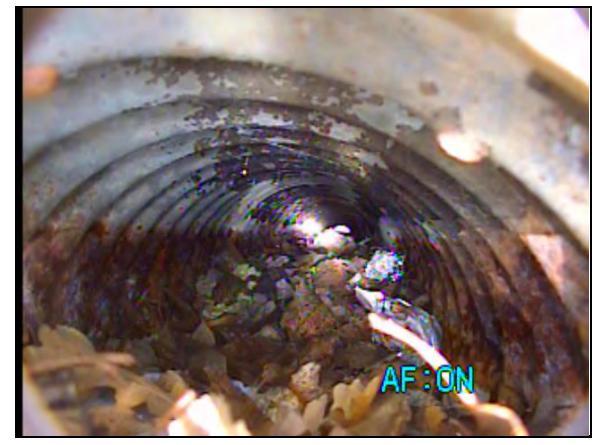
View inside inlet.

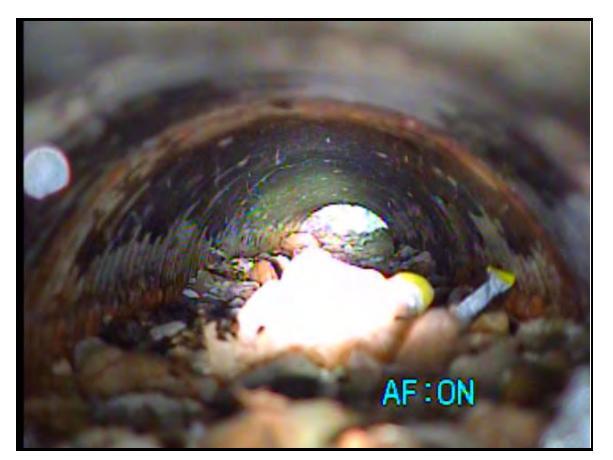
View inside inlet.

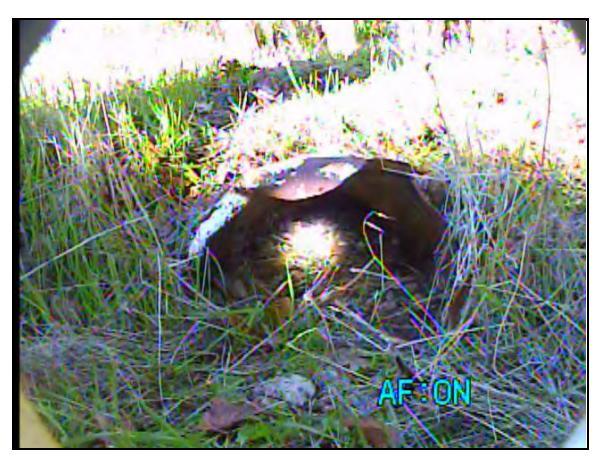
Outlet.

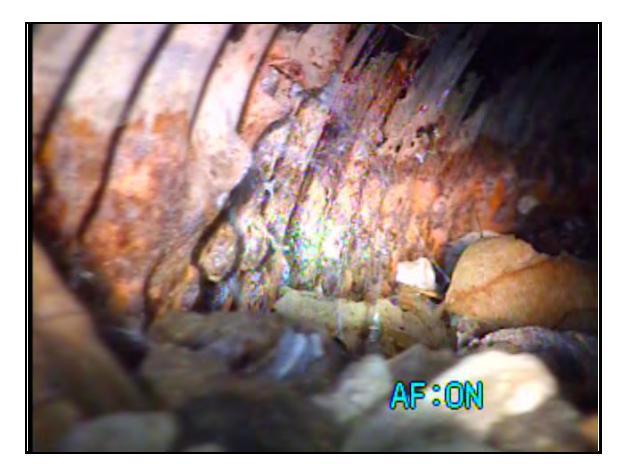
View inside inlet.

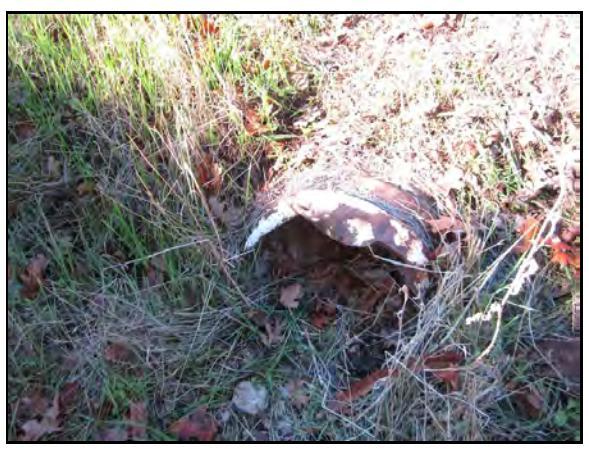
Outlet.

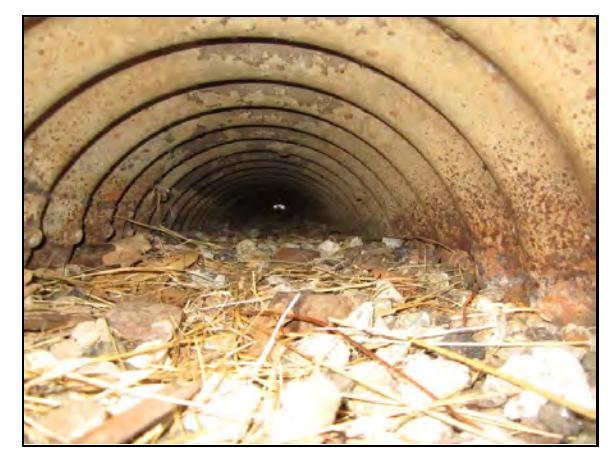
View inside outlet.

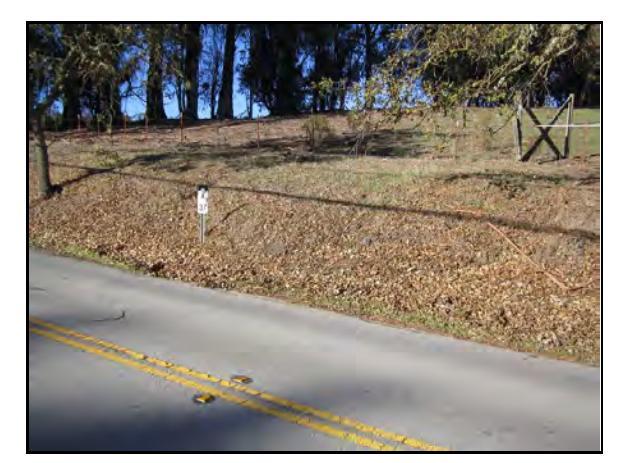
Area near inlet.

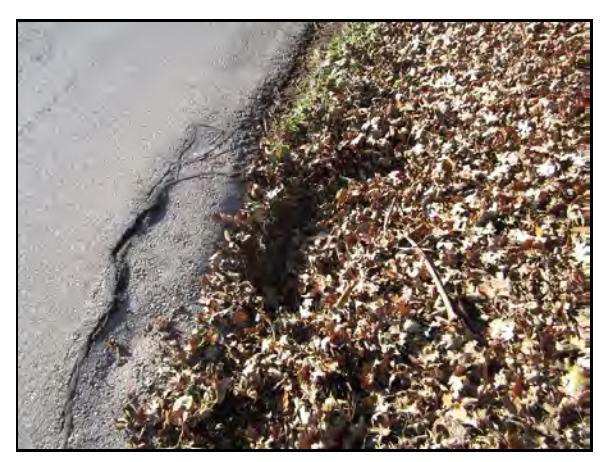
Pipe runs under roadway. Inlet not accessible; apparently buried under vegetation. Moderate corrosion on interior surfaces.

Inlet (apparently buried).

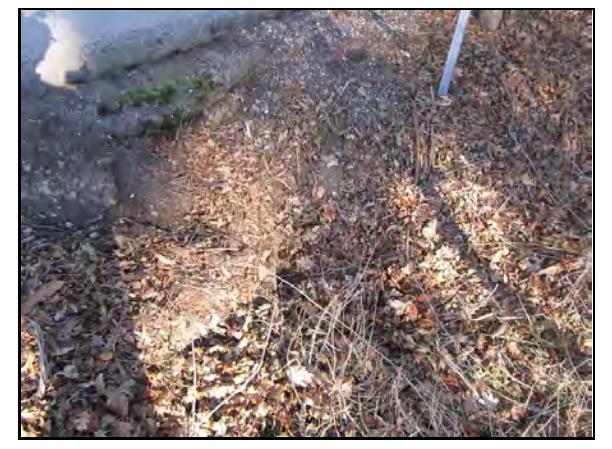
Outlet (nearly obstructed).

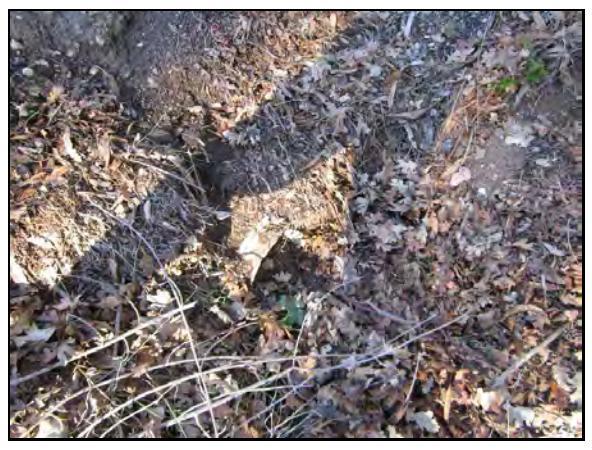
Outlet (nearly obstructed).

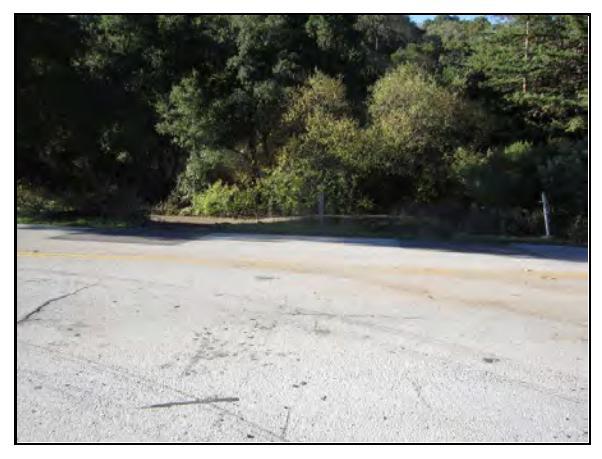
Area view.

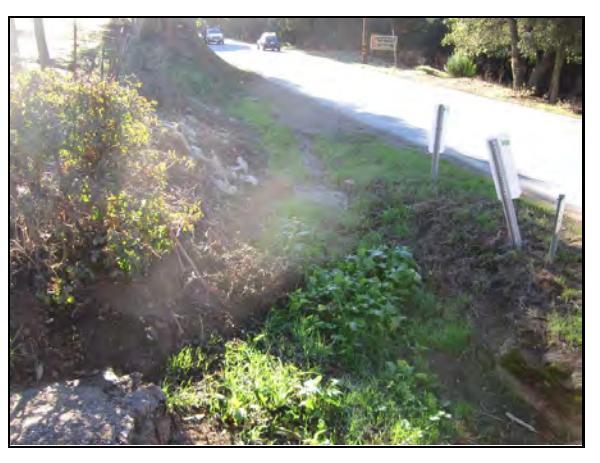
Area near inlet.

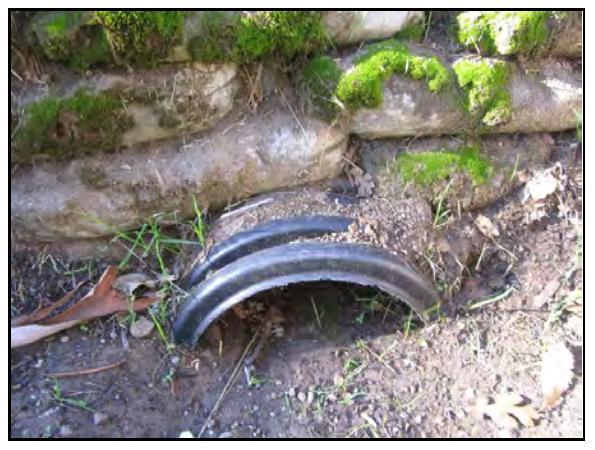
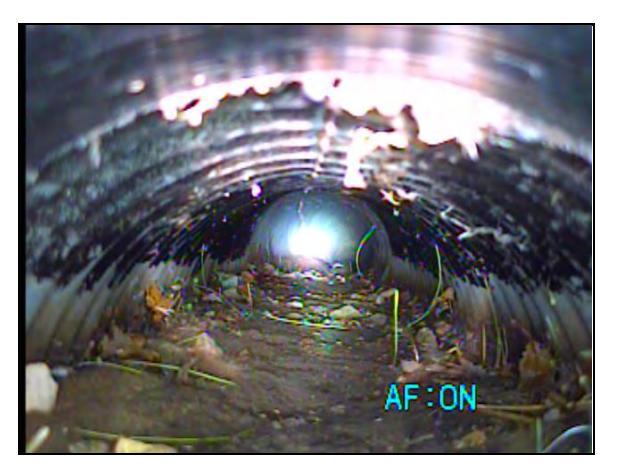
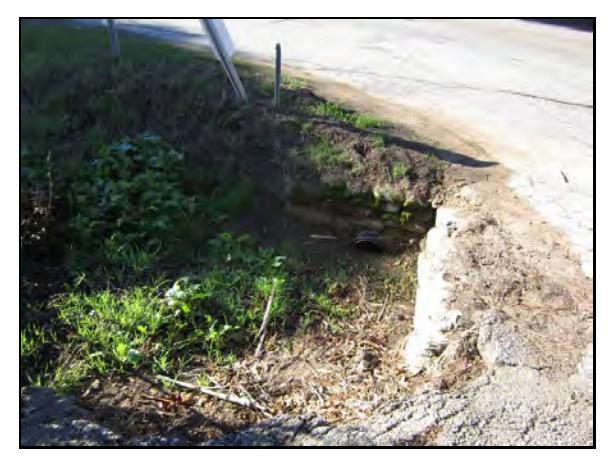
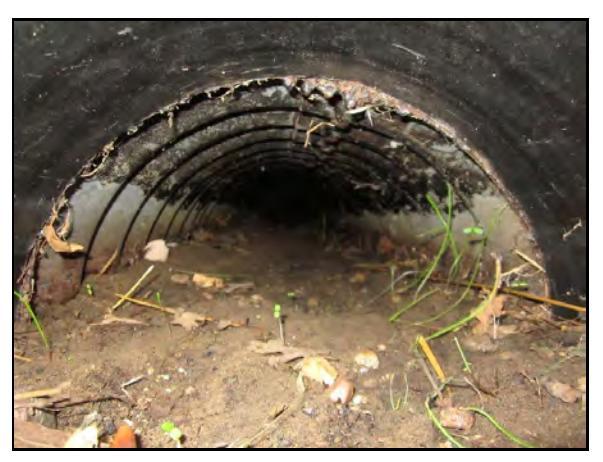
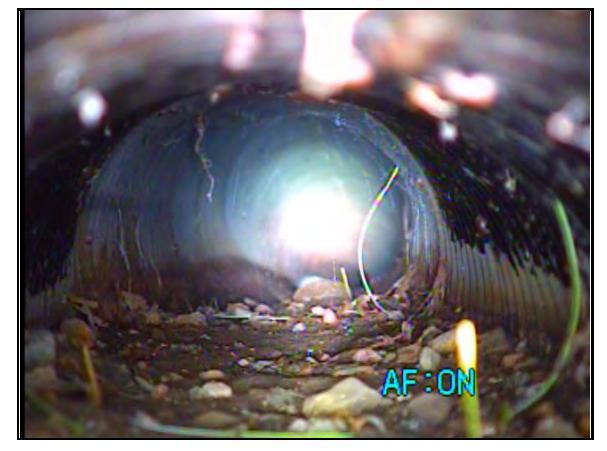
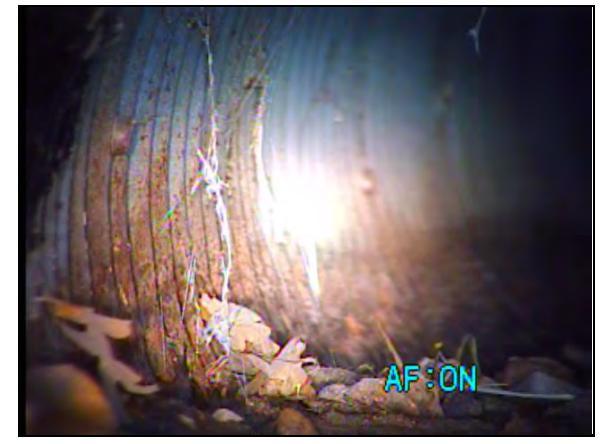
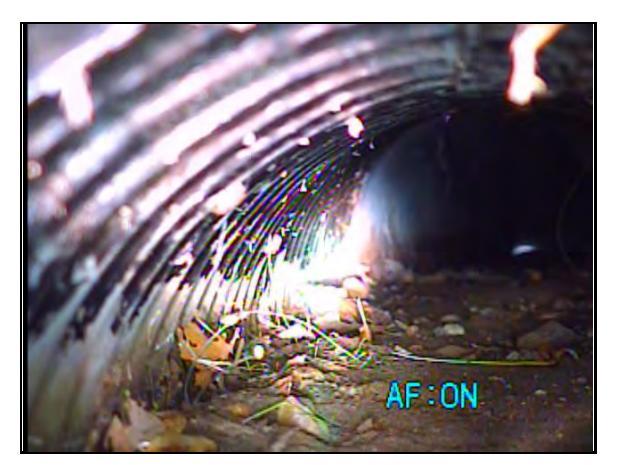
Pipe runs under the road. Coating failure and minor corrosion at invert. About half full of dirt at inlet. Inlet has short section of plastic pipe and then transitions to CMP.

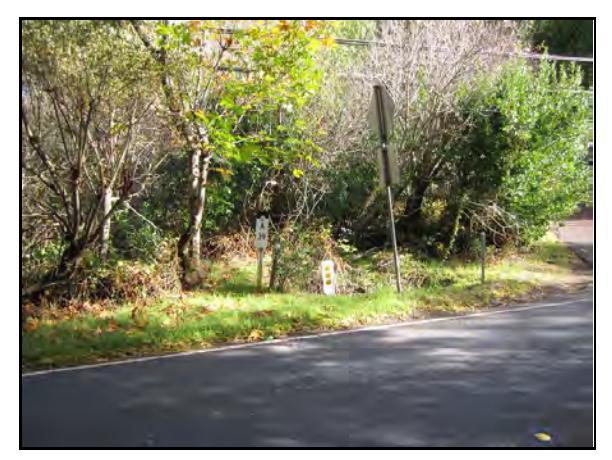
Area view.

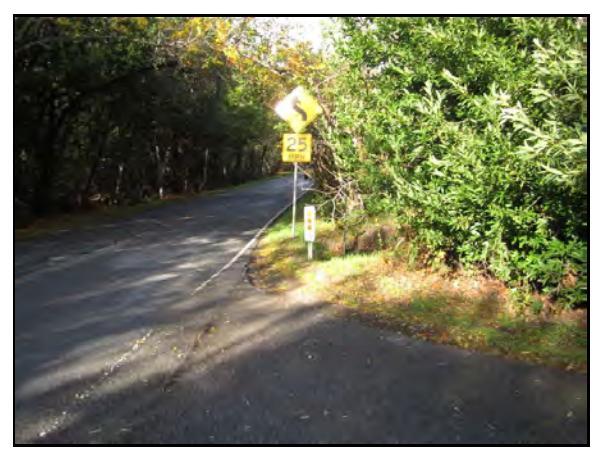
Pipe appears to be blocked. Outlet not accessible. Inlet deflected. Minor corrosion on interior pipe surfaces. There is another culvert near the inlet under a nearby driveway.

Area near inlet.

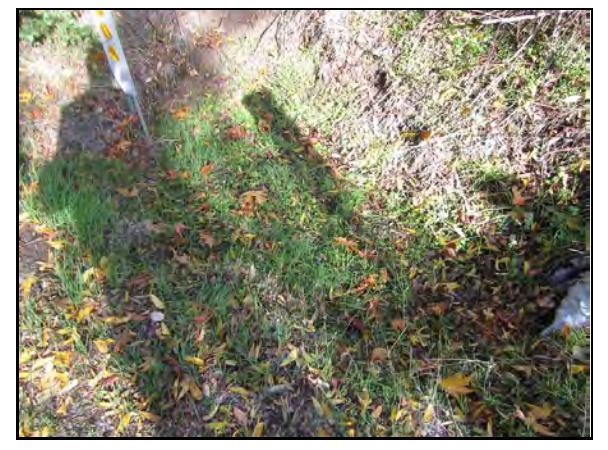
Culvert A-39

Area near inlet. Inlet to A-39 at upper left. Outlet of culvert under driveway at lower right.

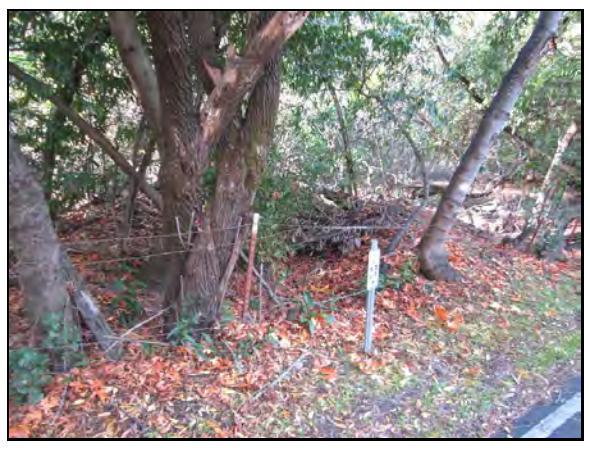
Area near outlet.

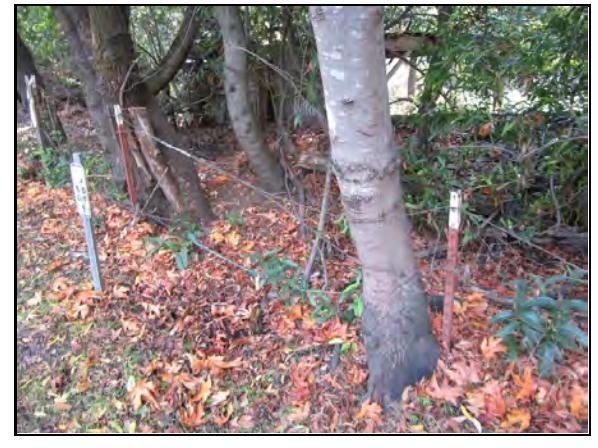
Area near outlet.

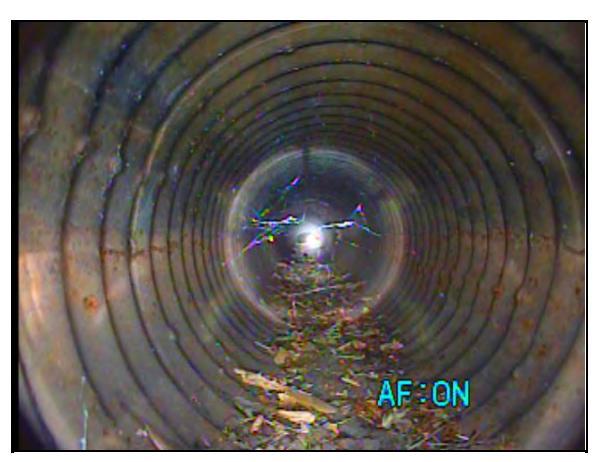
View inside inlet.

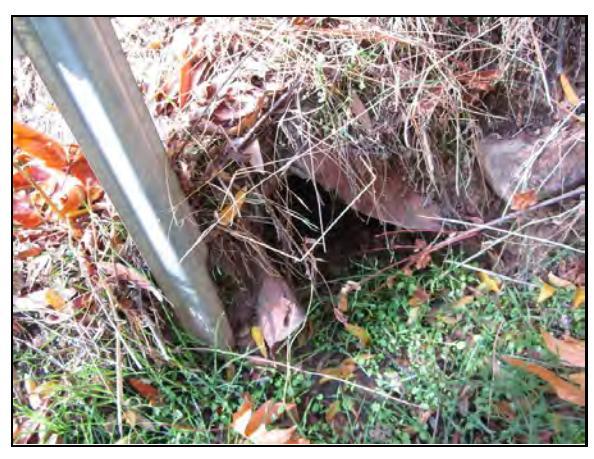
Inlet.

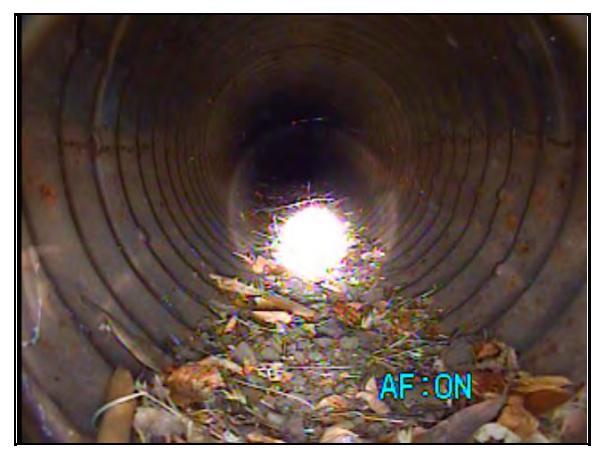
View inside inlet.

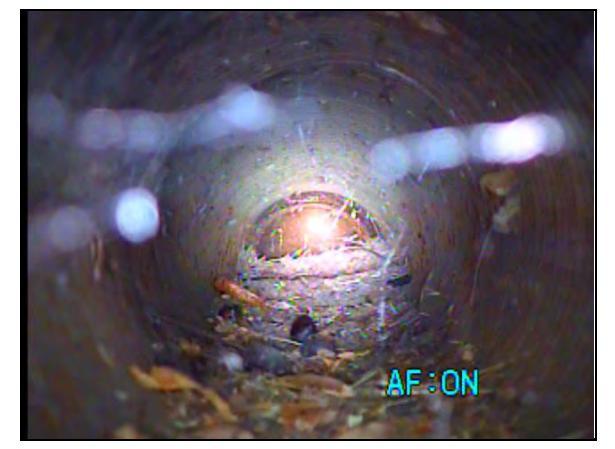
View inside inlet.

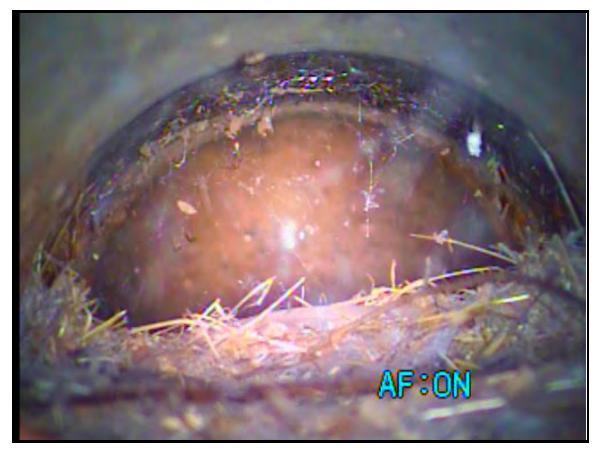
View inside inlet. Culvert appears to be blocked.

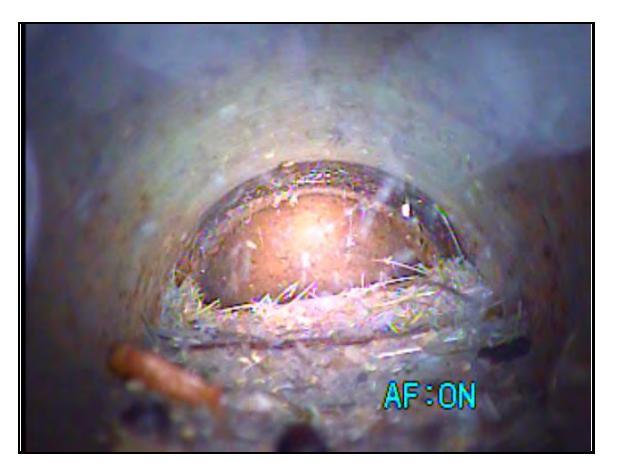
View inside inlet. Culvert appears to be blocked.

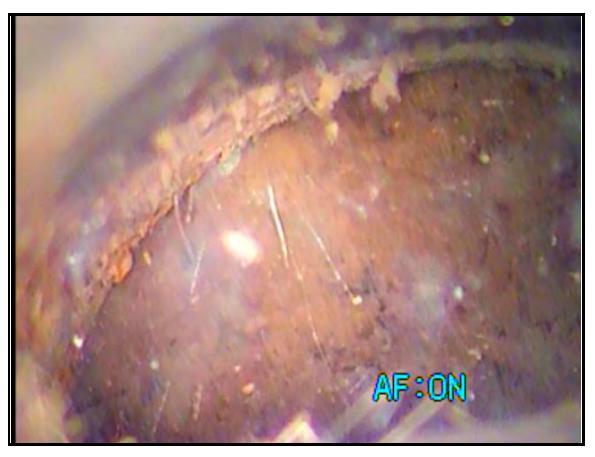
View inside inlet. Culvert appears to be blocked.

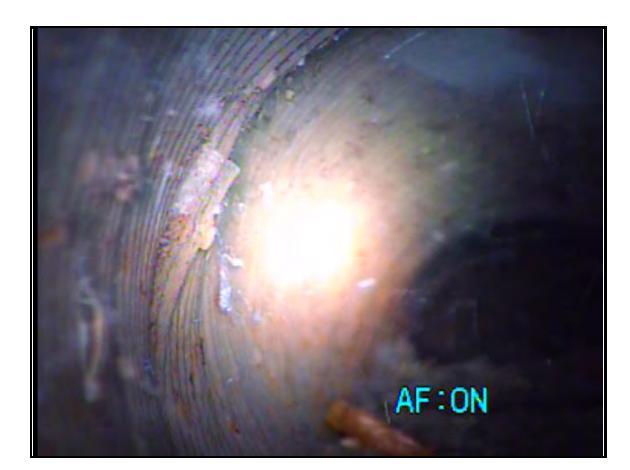
View inside inlet.

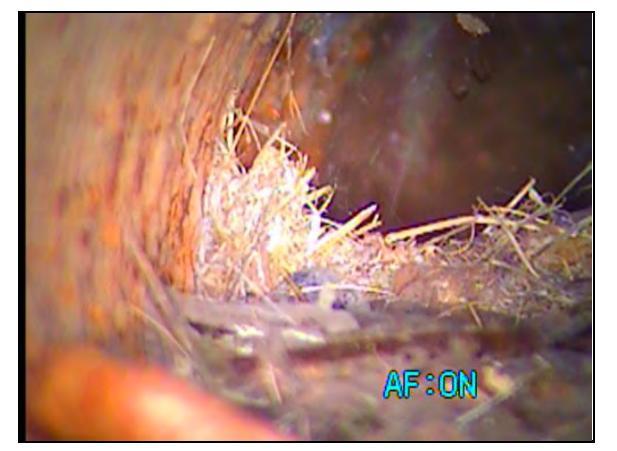
View inside inlet.

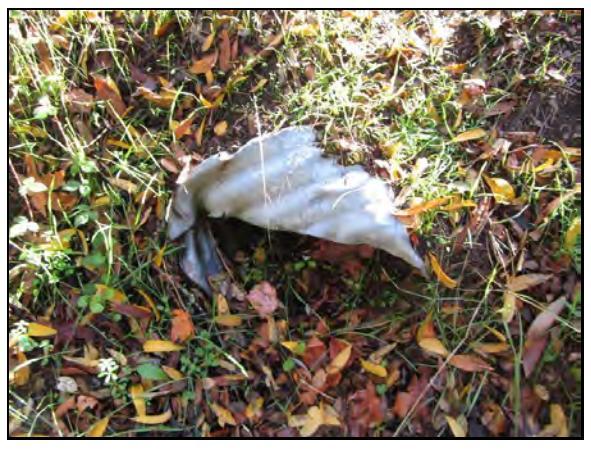
Outlet of culvert under driveway.

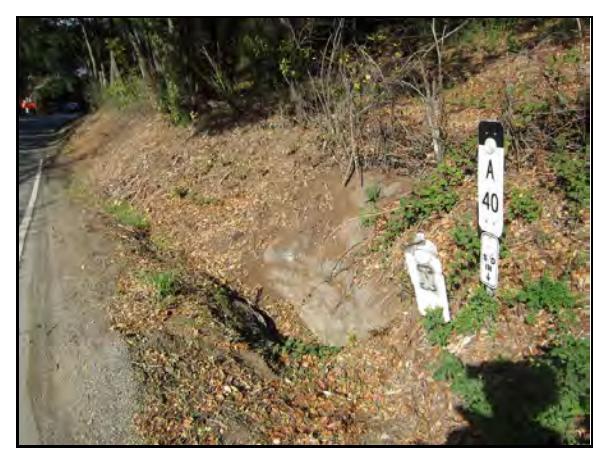
Area near inlet.

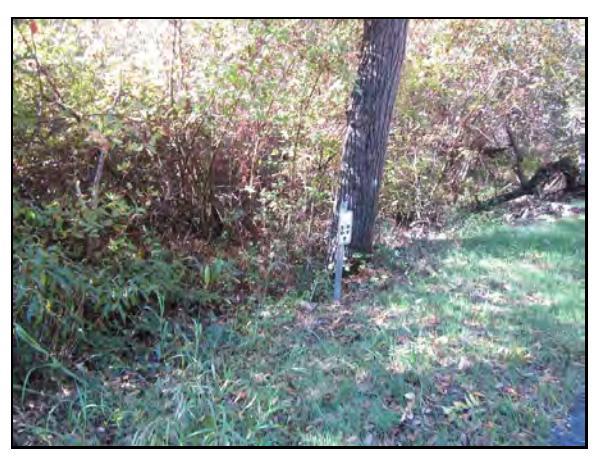
Area near outlet.

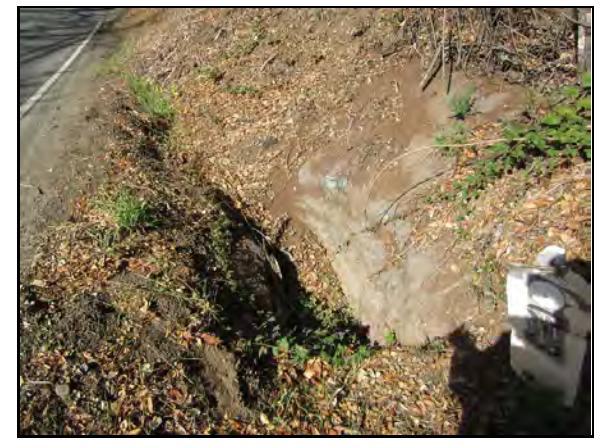
Inlet.

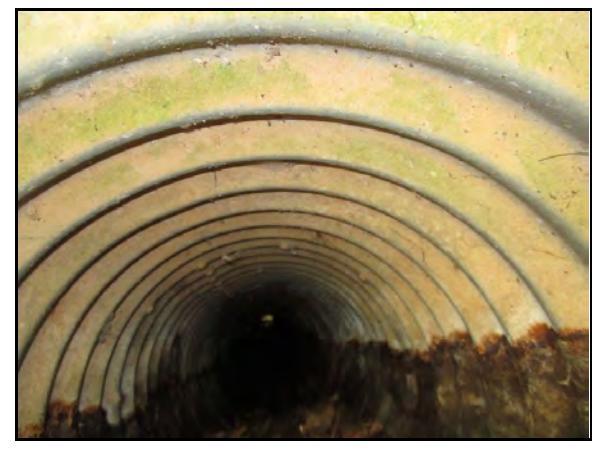
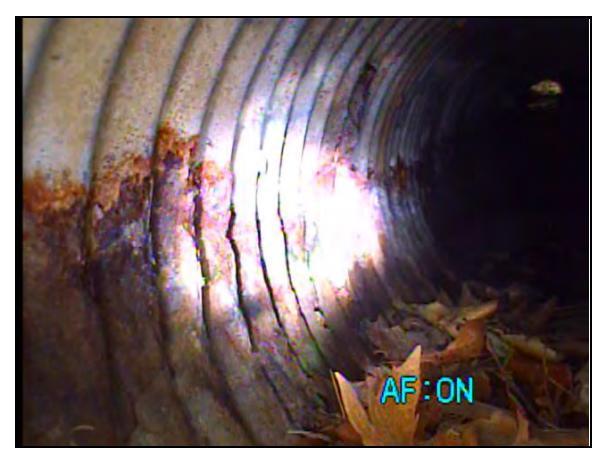
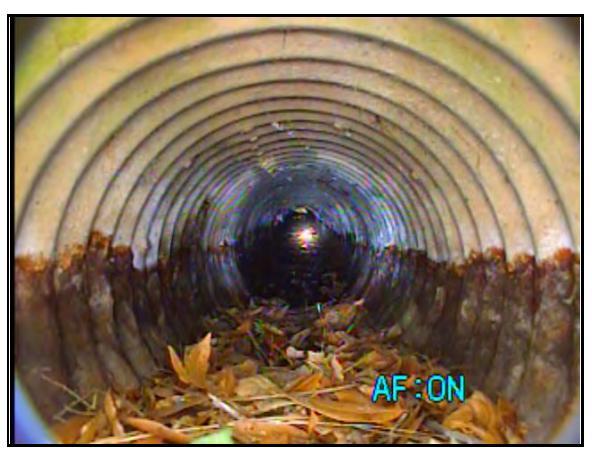
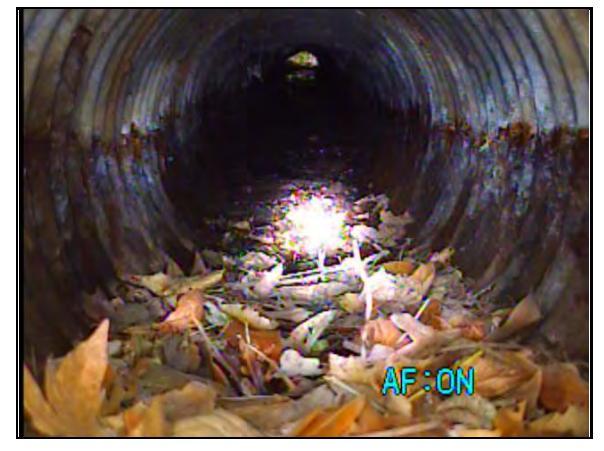
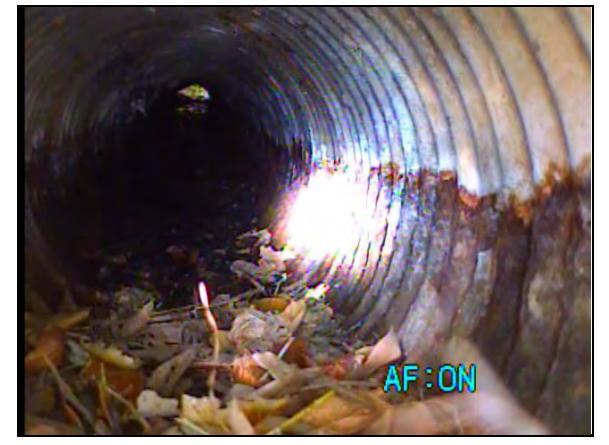
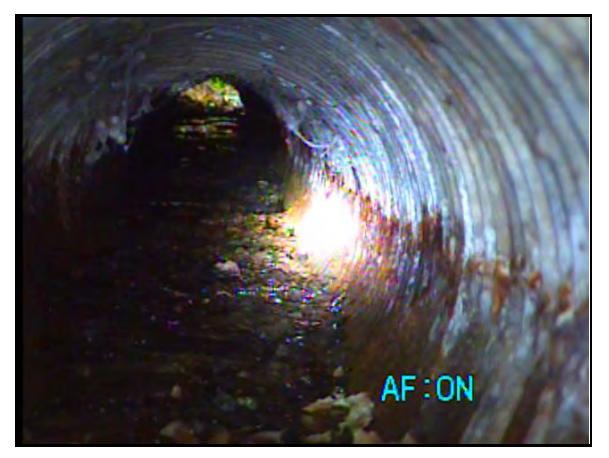
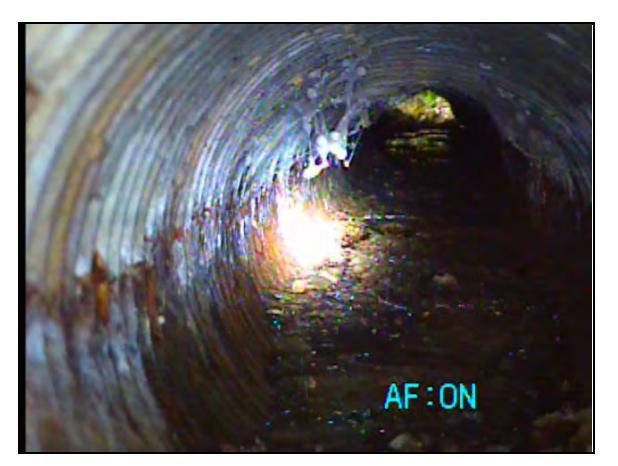
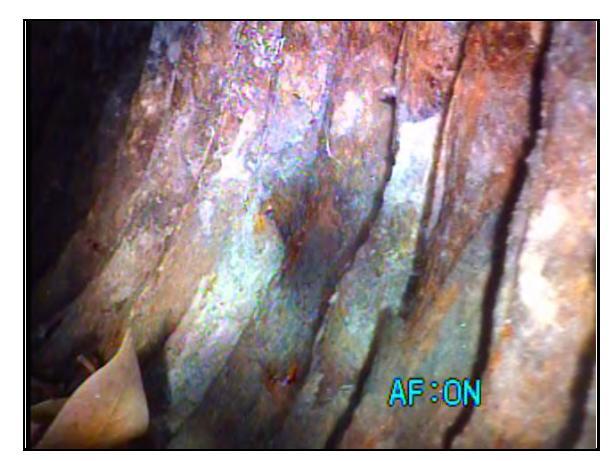
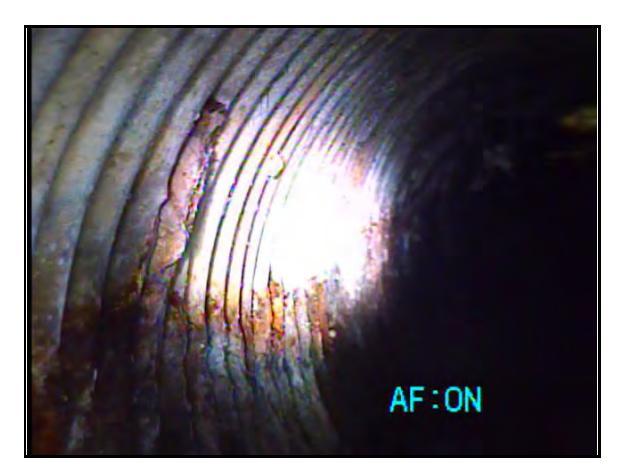
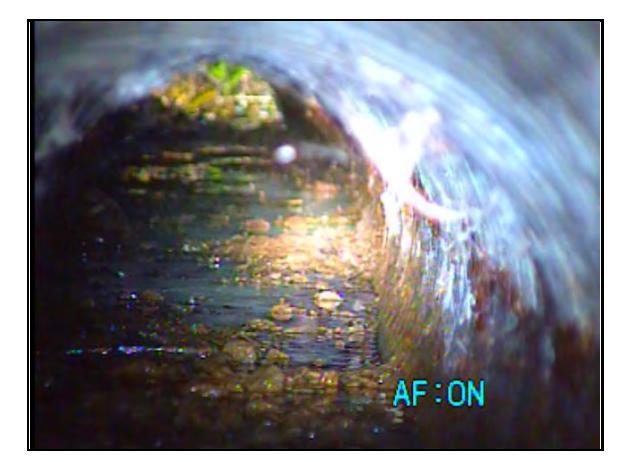
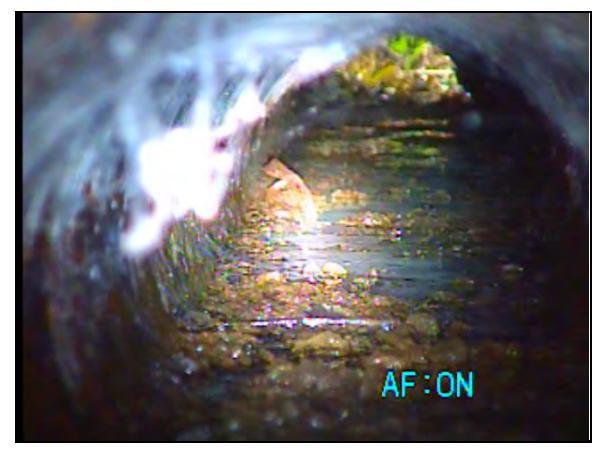
Pipe runs under the road. Could not locate outlet. Pipe appears to have experienced significant corrosion and may be perforated. Pipe is about half full with sediment or standing water.

View inside inlet.

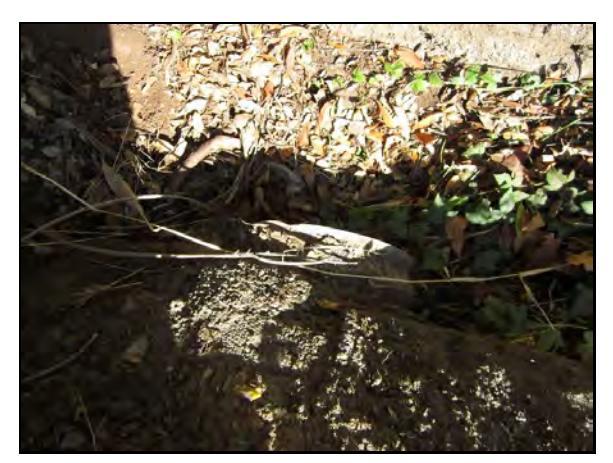
Inlet.

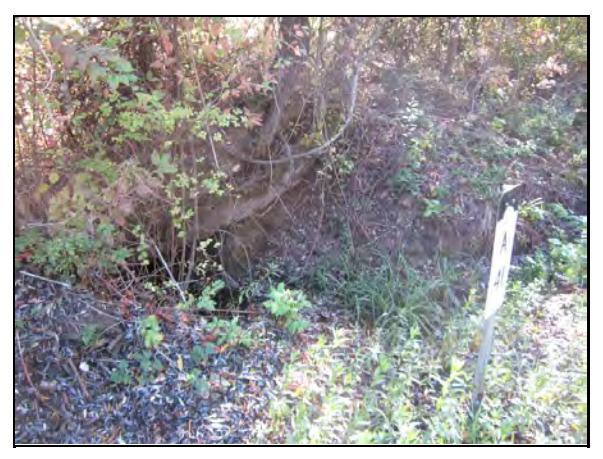
Area near inlet.

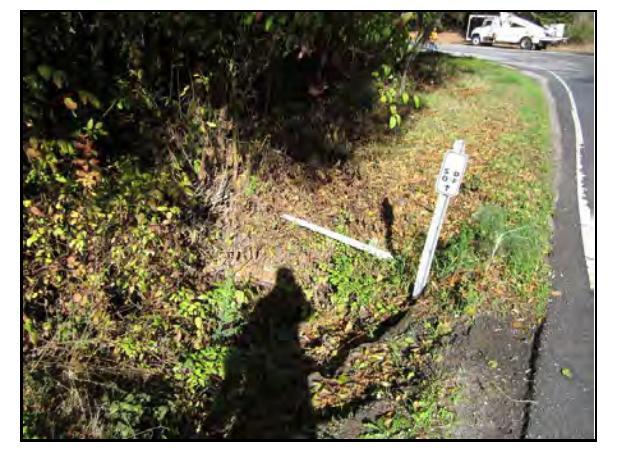
Area near outlet.

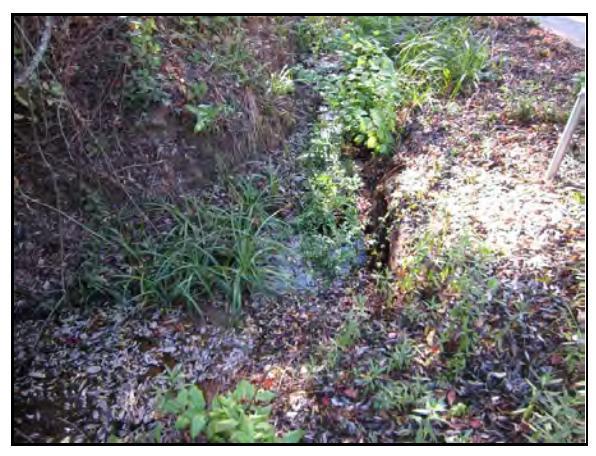
Inlet.

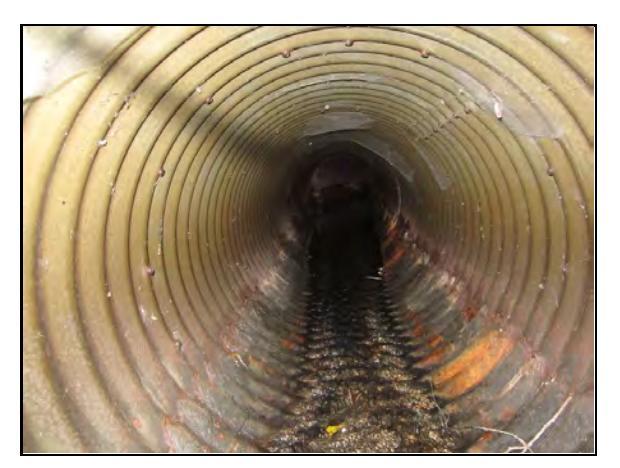
View inside inlet.
