Storm Drain Master Plan Update

June 2015

Public Works Department/Engineering Services Division

Schaaf & Wheeler CONSULTING CIVIL ENGINEERS

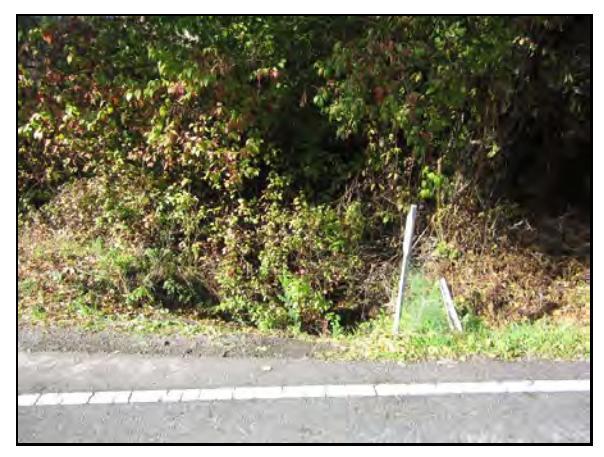
Area near outlet.

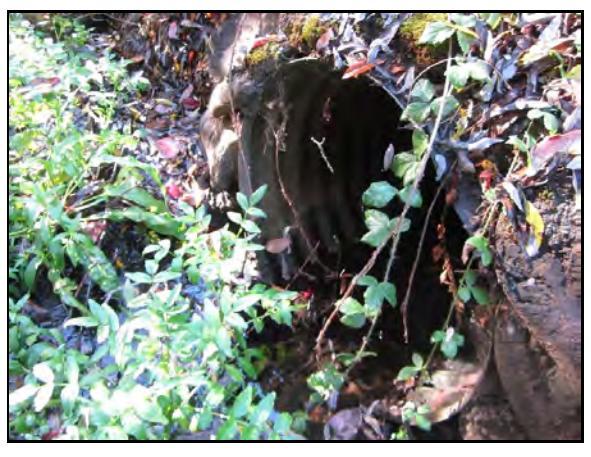
Inlet.

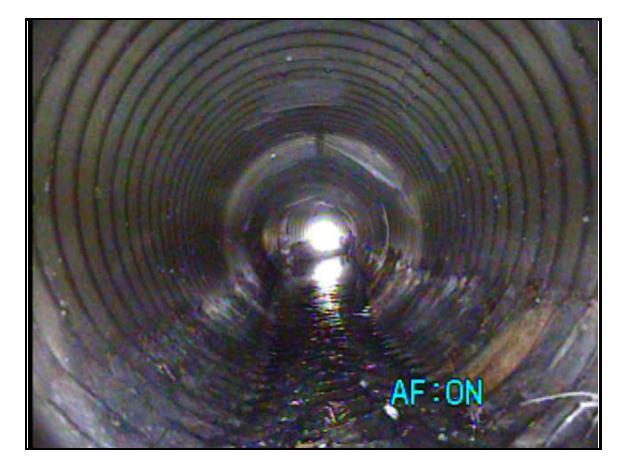
View inside inlet.

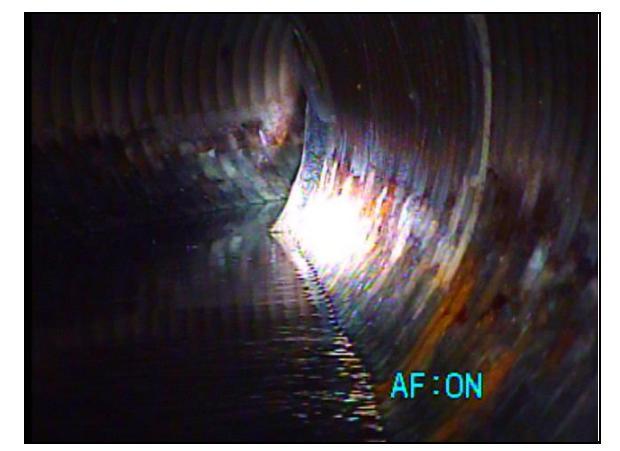
View inside inlet.

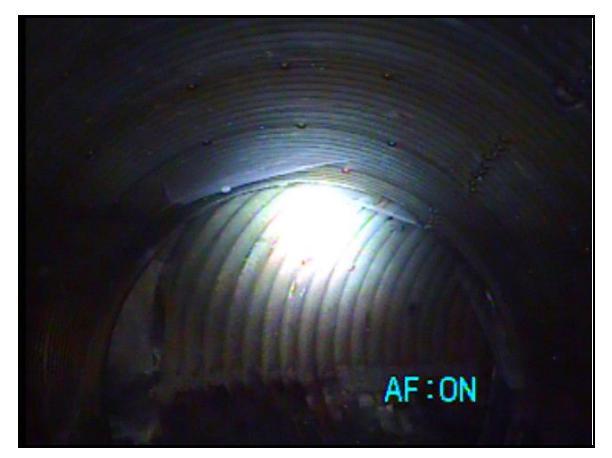
View inside inlet.

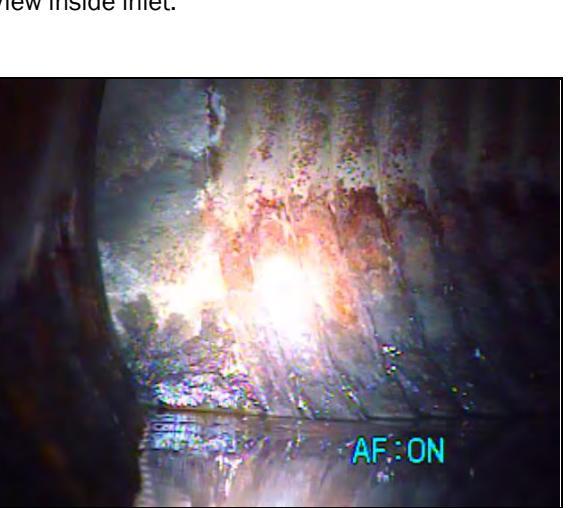
View inside inlet. Possible void at bend downstream.

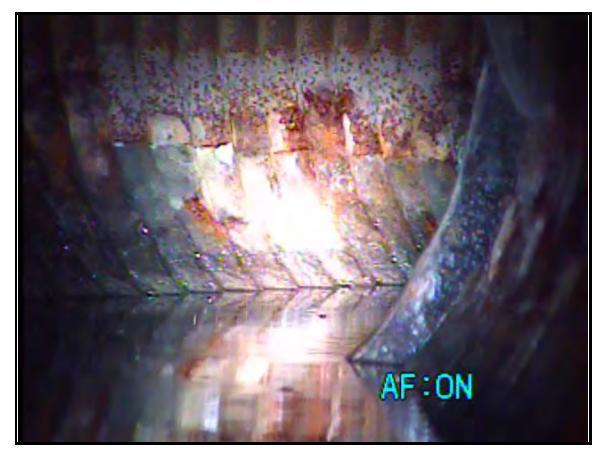
View inside inlet. Possible void at bend downstream.

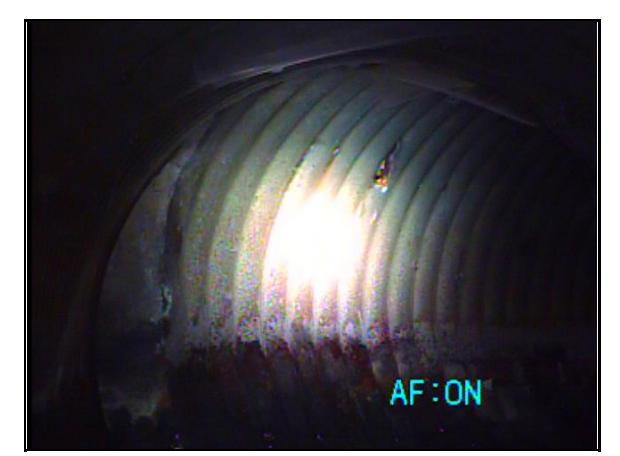
View inside inlet. Possible void at bend downstream.

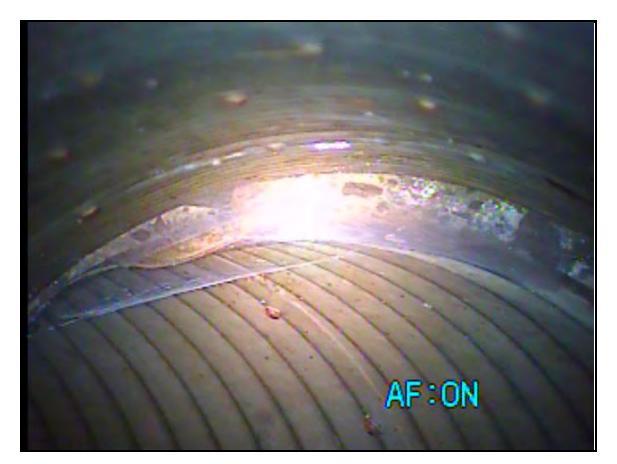
View inside outlet. Possible void at bend.

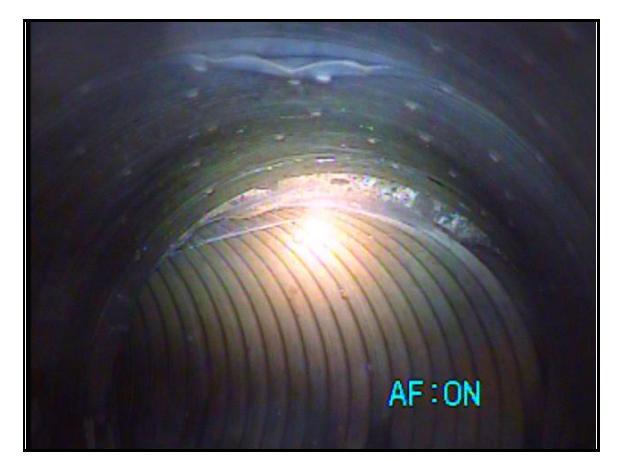
View inside outlet. Possible void at bend.

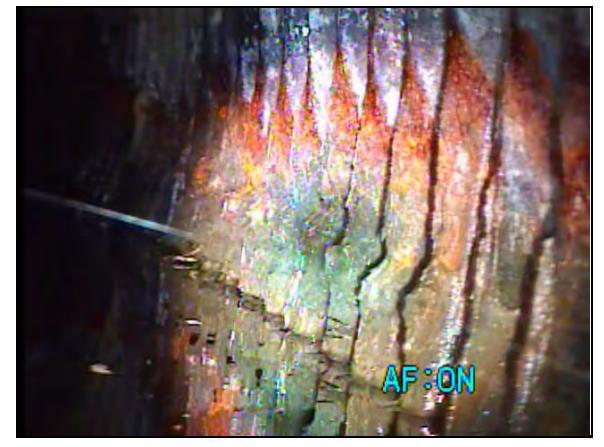
View inside outlet. Significant corrosion.

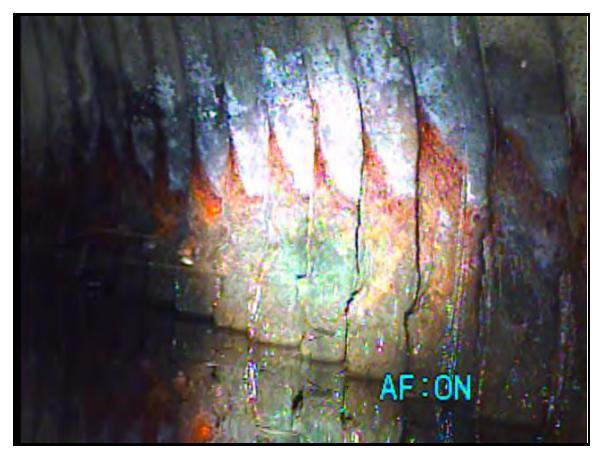
View inside outlet. Significant corrosion.

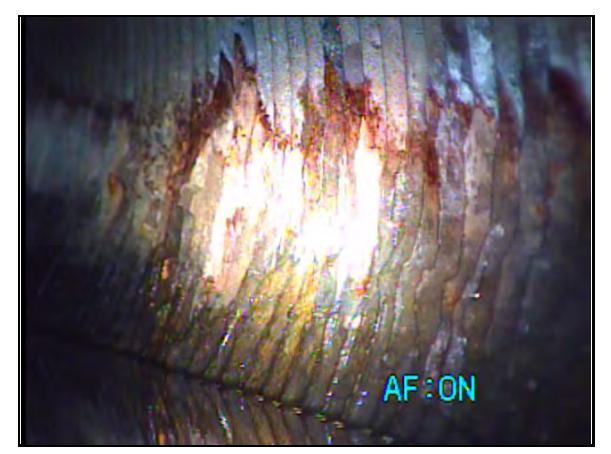
View inside outlet. Significant corrosion.

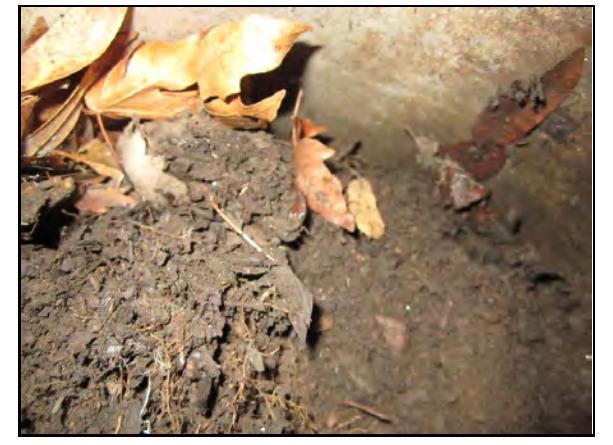
Pipe nearly completely full of sediment. Concrete pipe is in good condition.

View inside inlet.

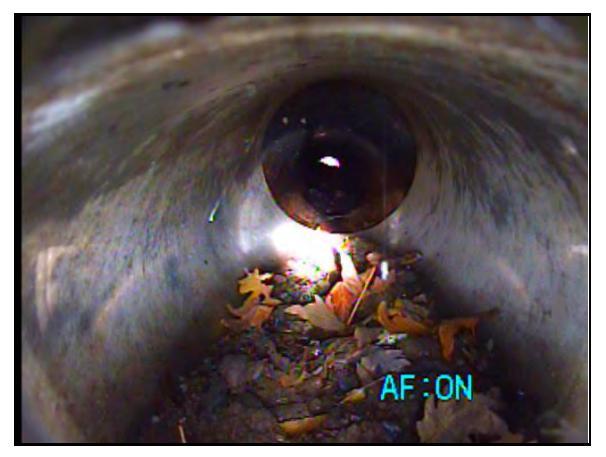
Ends of culvert appear to be RCP. Middle section under roadway is CMP, which is in poor condition. Joints are offset at transitions to CMP. Invert of CMP may be perforated.

View inside inlet. Offset joint at transition to CMP. CMP appears to be significantly corroded.

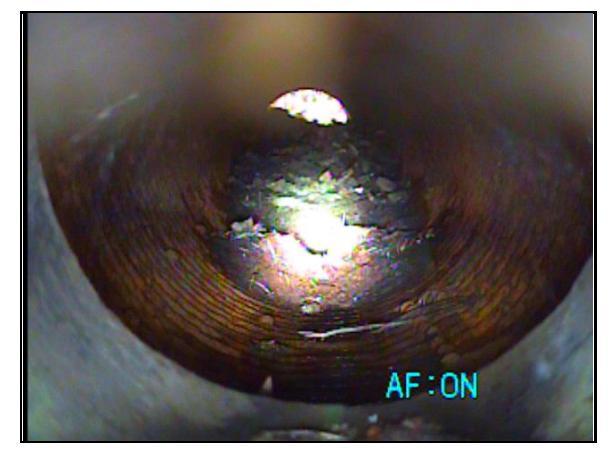
View inside inlet. Offset joint at transition to CMP. CMP appears to be significantly corroded.

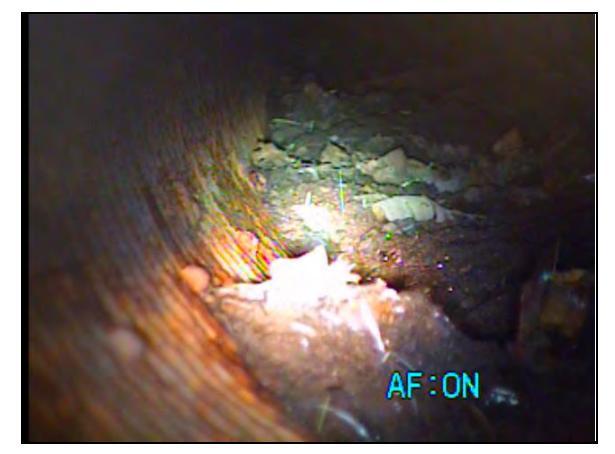
View inside inlet. Offset joint at transition to CMP. CMP appears to be significantly corroded.

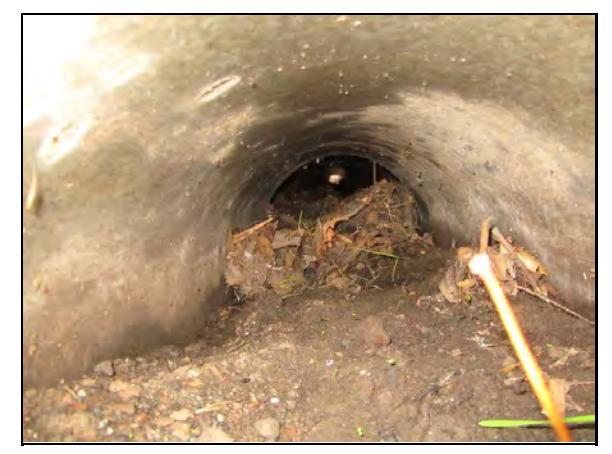
View inside outlet.

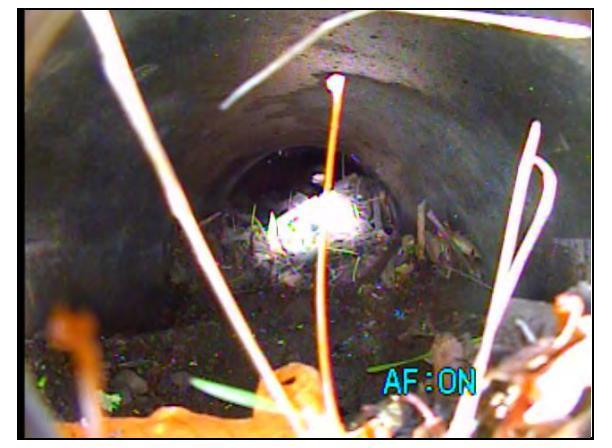
View inside outlet.

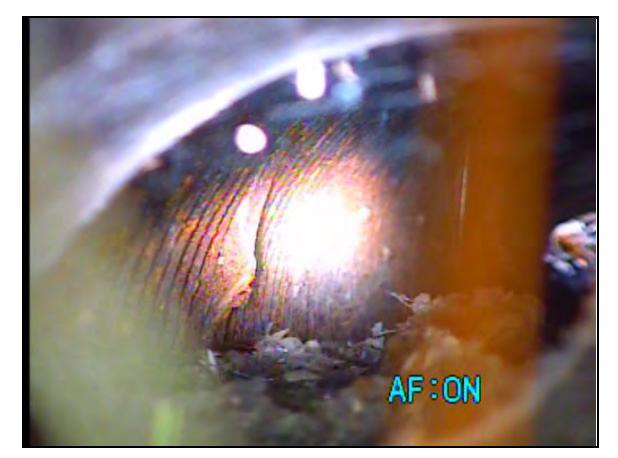
View inside outlet. Offset joint at transition to CMP.

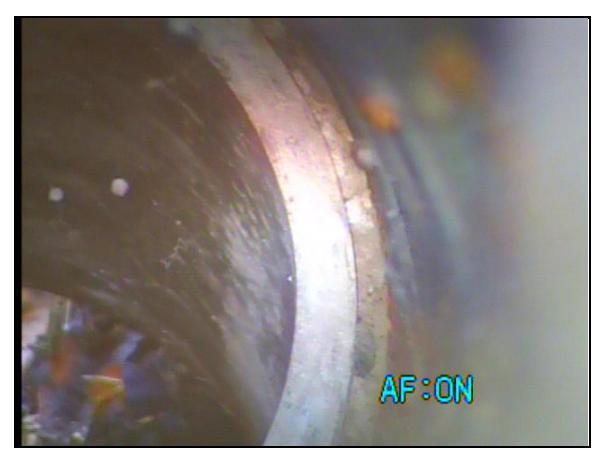
View inside outlet. Offset joint at transition to CMP.

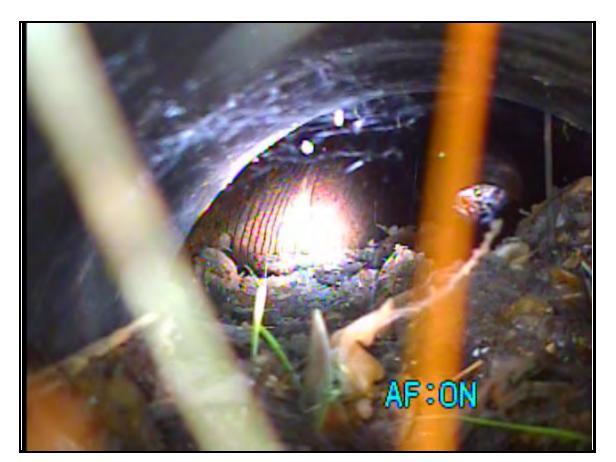
View inside outlet. Offset joint at transition to CMP.

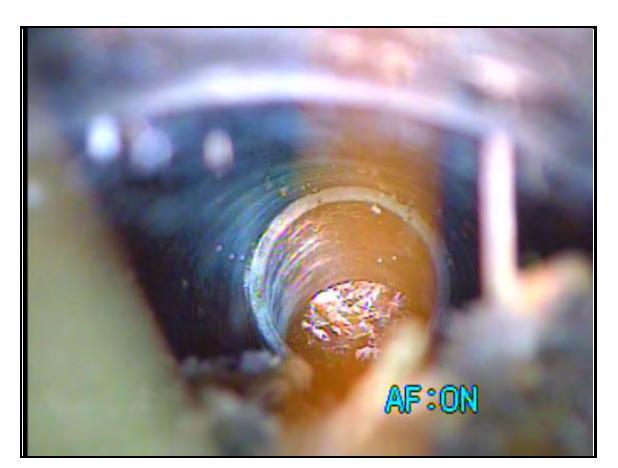
View inside outlet. Offset joint at transition to CMP.

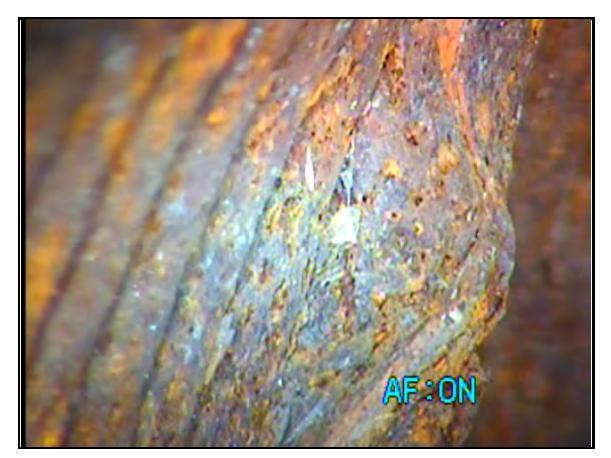
View inside outlet. Apparent damage to CMP.

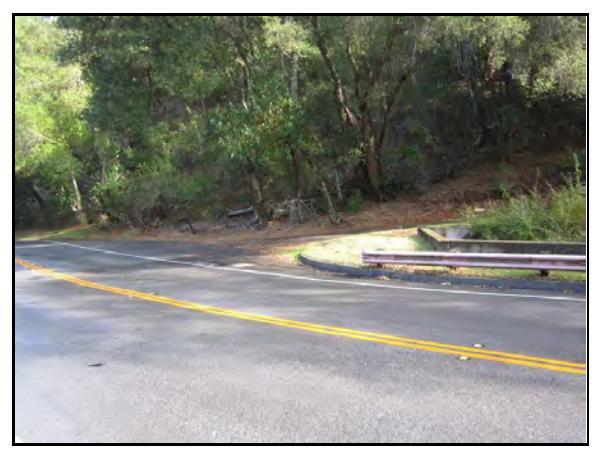
Area view.

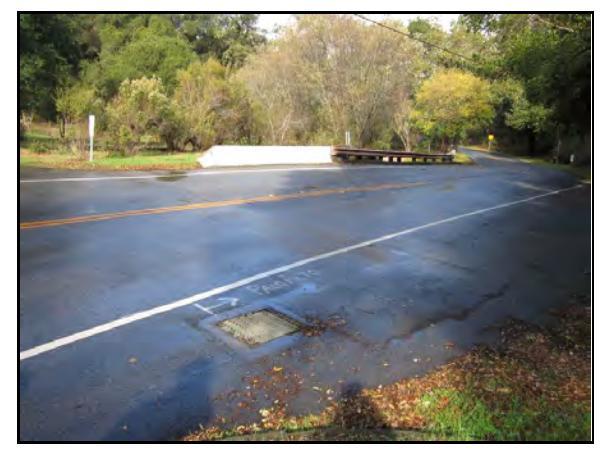
Storm drain inlet on bridge.

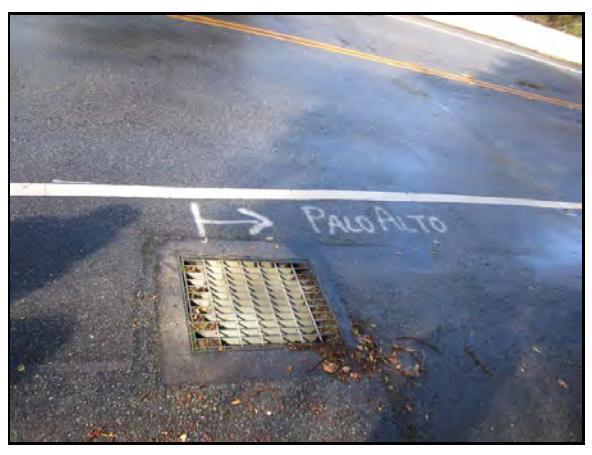
Storm drain inlet on bridge.
